# Conewago Creek Watershed Stream Corridor Assessment

Winter 2014

Prepared By  
Carroll County Bureau of Resource Management

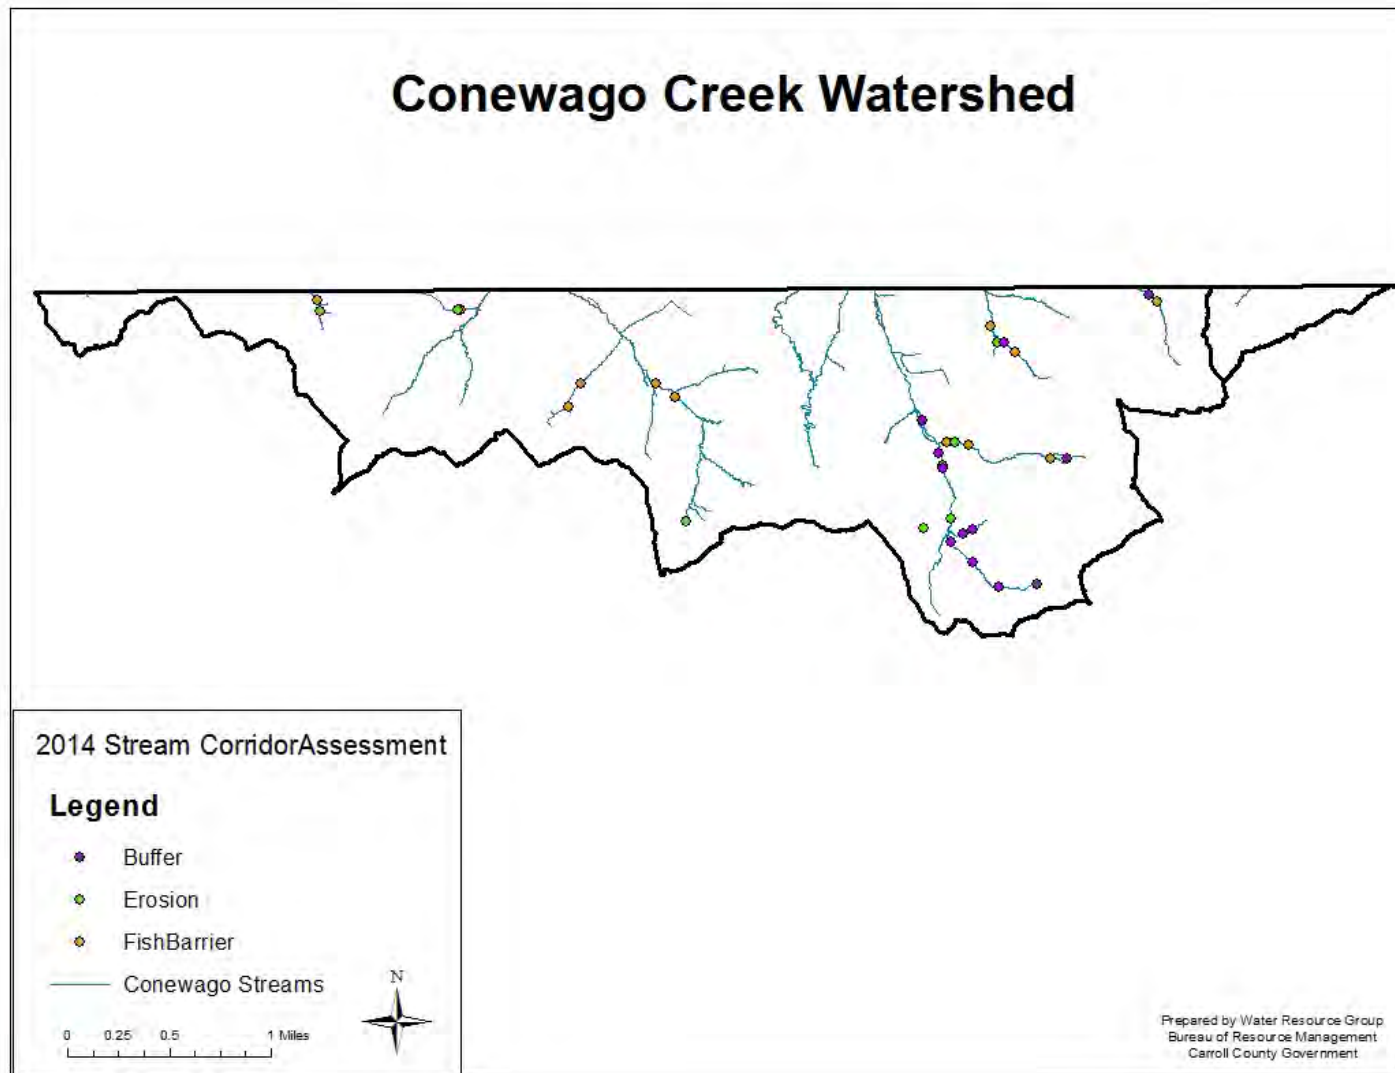
**Figure 1-3: Most Commonly Identified Impact**

A total of 36 data points were collected across the watershed. Inadequate buffers and fish barriers were the most frequently identified problems. Stream bank erosion was also regularly present throughout the watershed. Table 1-2 lists the data points by severity across the entire watershed. The most commonly identified impacts are shown in Figure 1-3. Criteria for ranking each impairments severity can be found in Appendix B.

The most common problem identified through the stream corridor assessment was inadequate stream side buffers. Buffer areas were identified as inadequate for 1.2 miles, or less than 10% of the streams assessed, with 7% of the entire watershed classified as having inadequate buffers. 7 of the sites identified the stream as unshaded, and livestock was noted to be present at 5 different sites. Of the 12 sites identified, none had been recently planted.

Another common problem identified through the stream corridor assessment was presence of fish barriers. A total of 12 locations were noted as having a fish barrier. 75% of the fish barriers were noted as total blockages with too high of a drop, averaging approximately 26 inches. The most common causes of fish barriers were road crossings, followed by natural falls.

Approximately a quarter mile of streams were noted to have an erosion problem, primarily caused by bends at steep slope. Most were noted as low to minor impacted downcuts.
