Liberty Reservoir Watershed Stream Corridor Assessment

Winter 2012

**Prepared By
Carroll County Bureau of Resource Management**

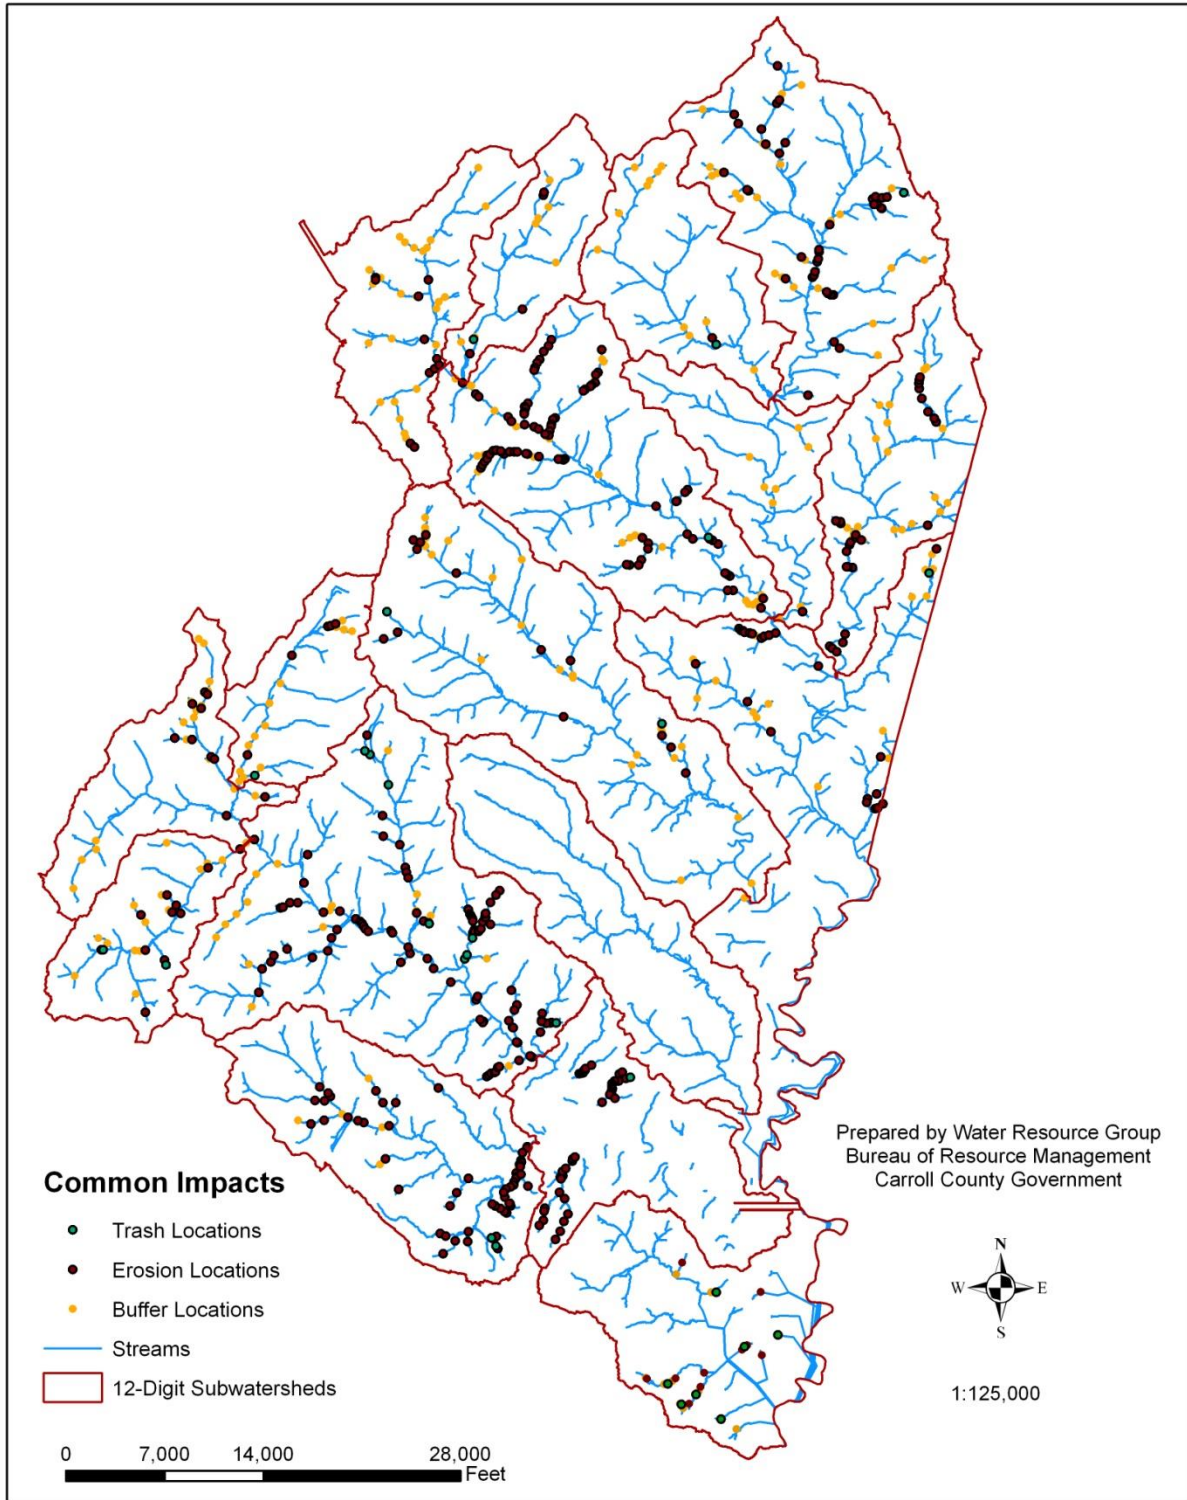
Figure 1-3: Most Commonly Identified Impacts

A total of 1,041 data points were collected across the watershed. Inadequate buffers and stream bank erosion were the most frequently identified problems. Drainage pipe outfalls were also regularly present throughout the watershed. Table 1-2 lists the data points by severity across the entire watershed. The most commonly identified impacts are shown in Figure 1-3 and Table 1-3 presents a summary of the number of impacts identified in each subwatershed. Criteria for ranking each impairments severity can be found in Appendix B.

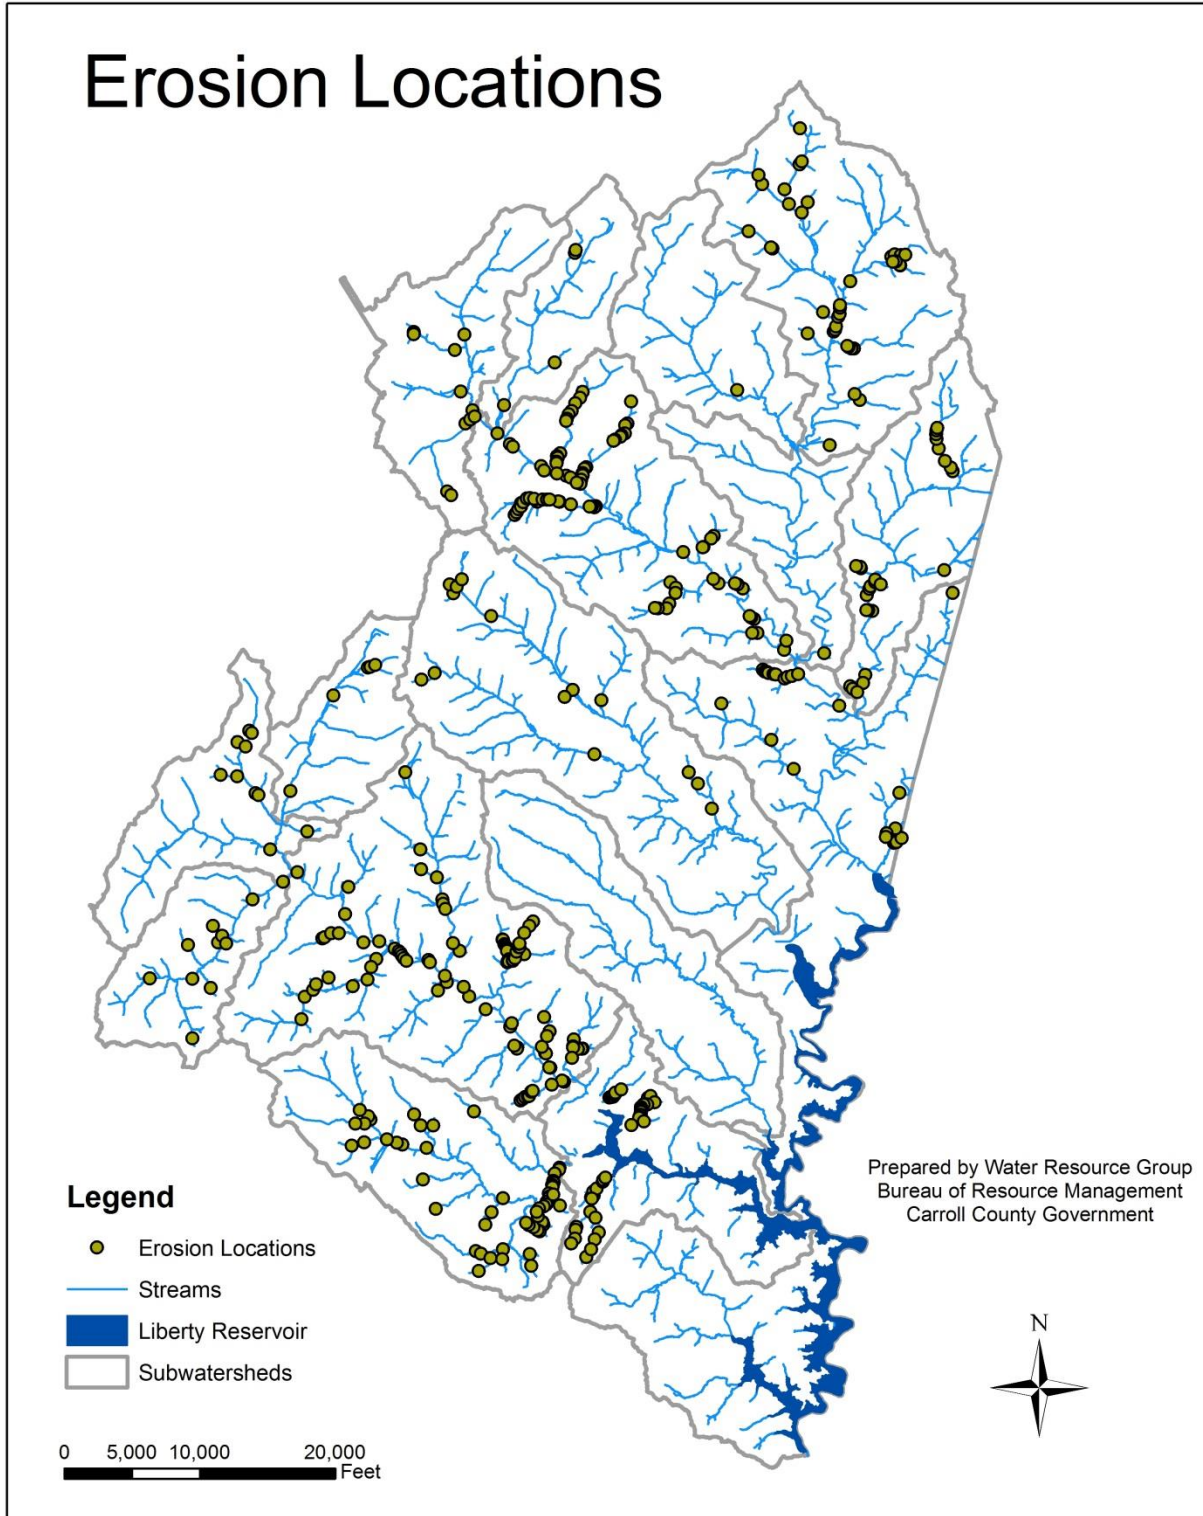
Figure 1-4: Erosion Locations

The most common problem identified through the Stream Corridor Assessment was erosion. A total of 17.8 miles (8%) of the 235 miles assessed were found to have an erosion problem, with approximately 2 percent of the watershed categorized as having a severe erosion problem. Figure 1-4 shows the location of active erosion sites identified during the Stream Corridor Assessment.

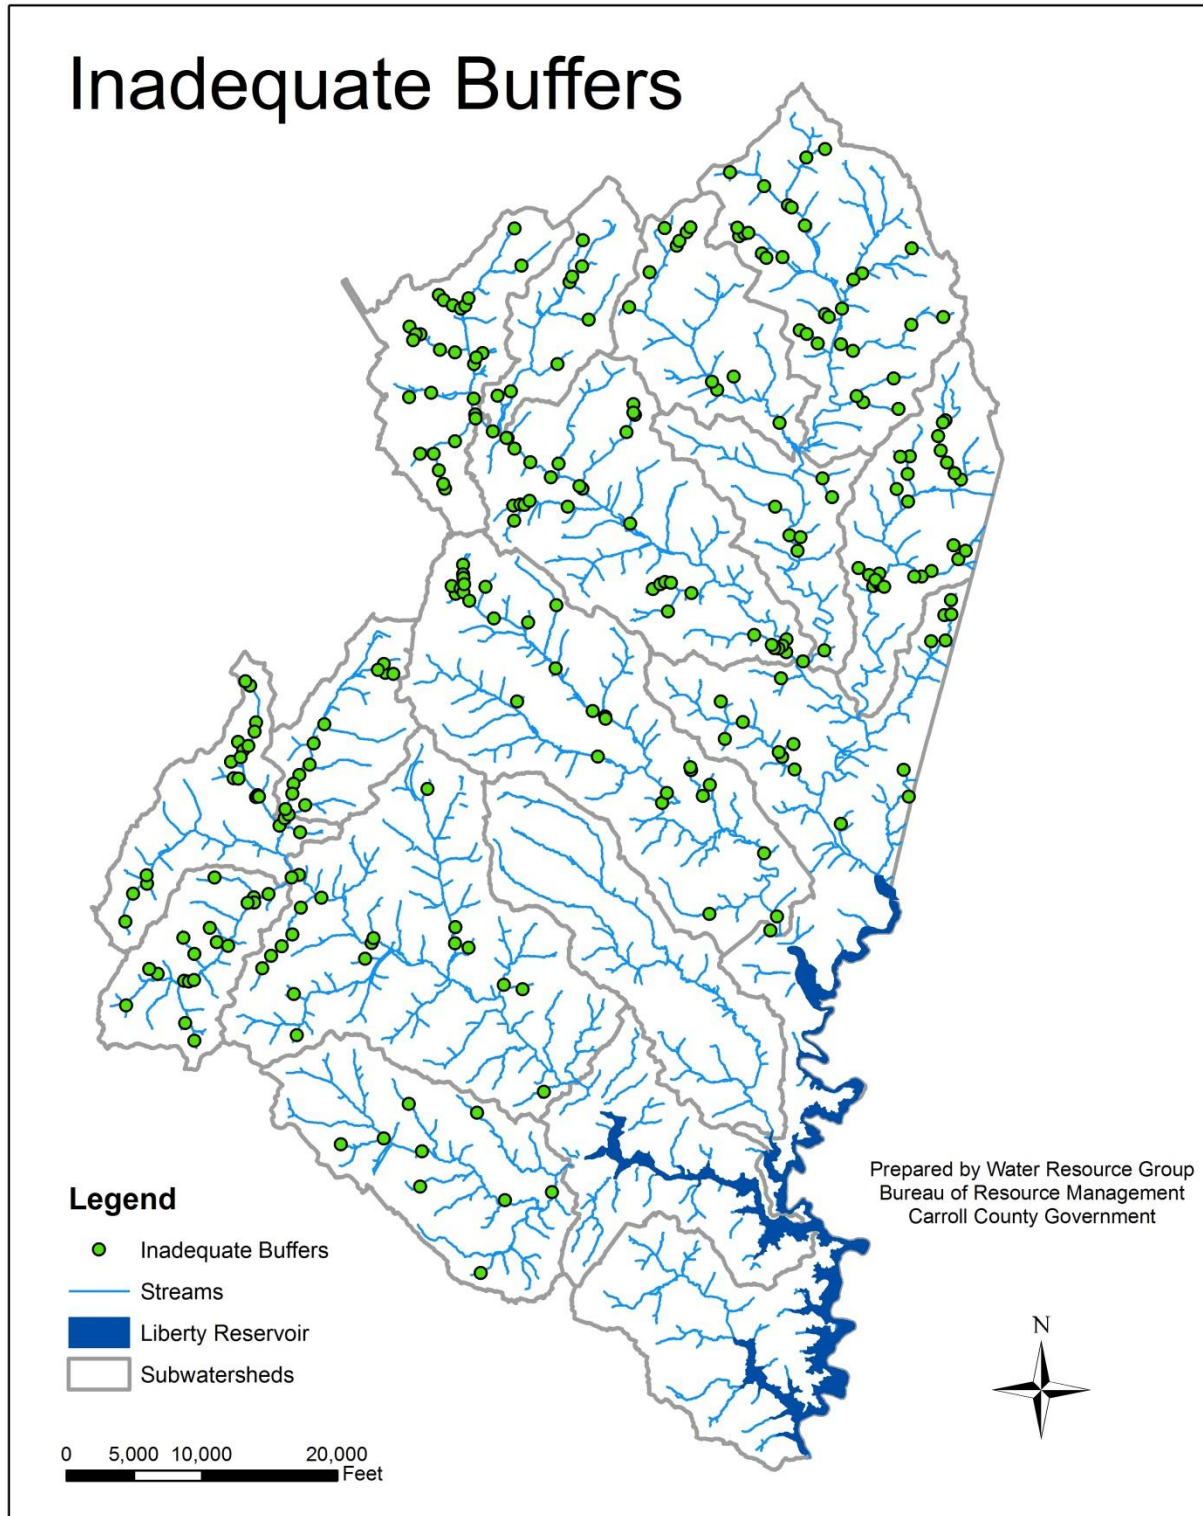
Figure 1-5: Inadequate Buffers

Buffer areas were identified as inadequate for 58 miles (25%) of the streams assessed, with 17 percent of the entire watershed classified as severely un-buffered. 118 of the sites identified both sides of the stream as completely unshaded, and livestock was noted to be present at 27 different sites. Of the 272 sites identified, 10 had been recently planted but were not yet established. Figure 1-5 shows the location of identified inadequate buffers.

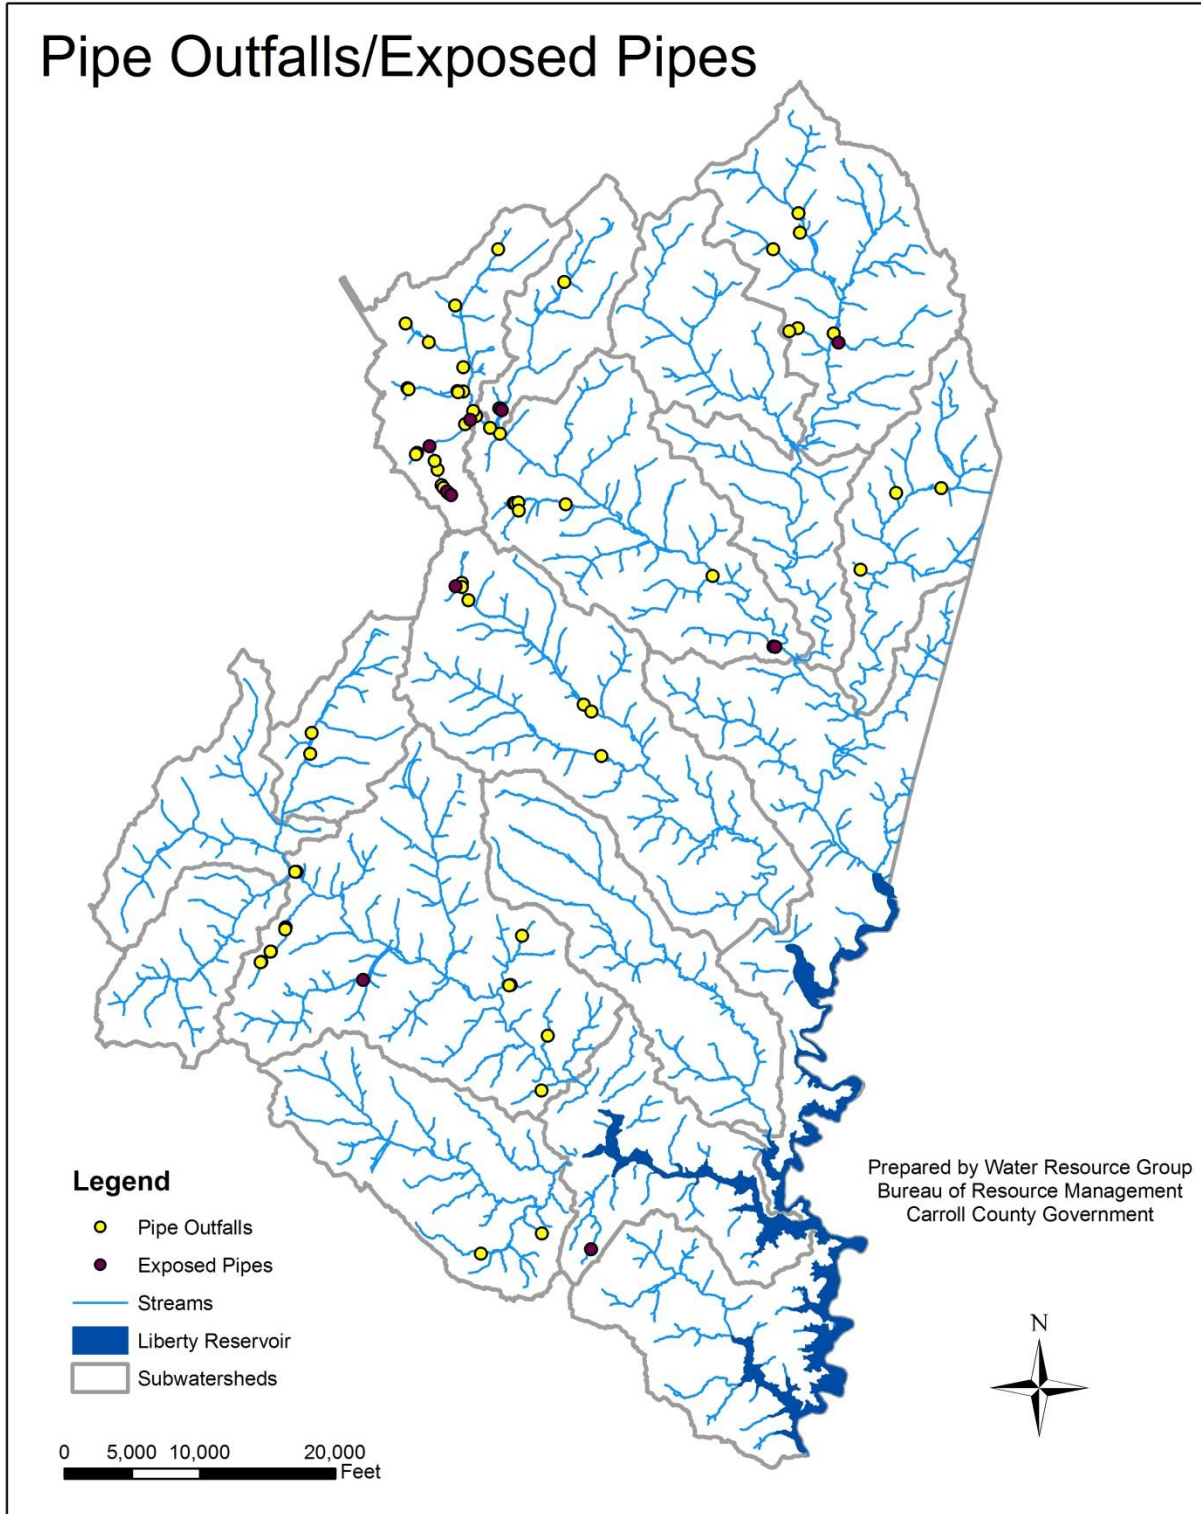
Figure 1-6: Pipe Outfalls and Exposed Pipes

Outfalls were found throughout the entire watershed, but the highest concentrations were located in the West Branch Patapsco River subwatershed. This higher concentration can be attributed to the city of Westminster, which makes up the headwaters of this subwatershed. The majority of the outfalls identified were 6” or less in diameter and were given a low impact rating. The location of identified pipe outfalls can be found in Figure 1-6.

Exposed pipes were identified at 11 different locations within the watershed, with the majority being concentrated around the City of Westminster. Any exposed pipe identified during the SCA is reported to the appropriate public works department for additional investigation.

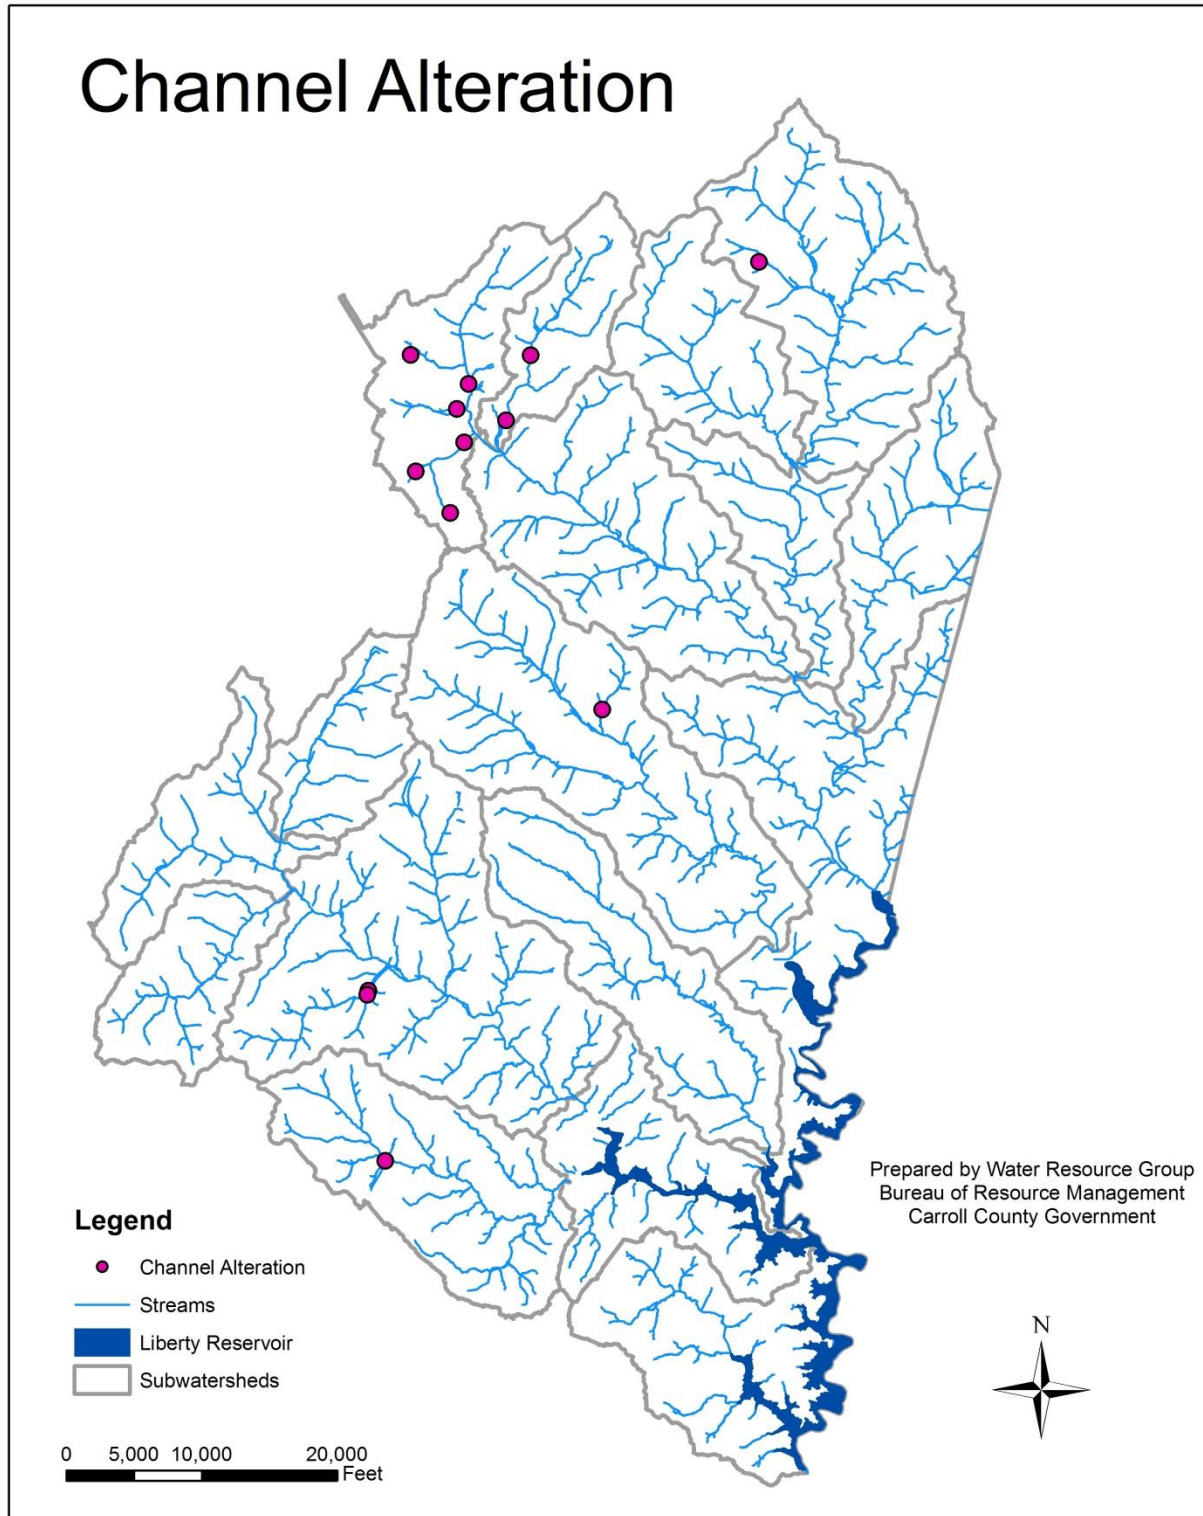
Figure 1-7: Channel Alteration

Impacts from channel alterations were found at 13 different sites within the watershed and totaled 4,995 linear feet. The alterations identified were associated with the protection of infrastructure and were given a minor severity ranking. Figure 1-7 shows the location of identified channel alterations within the watershed.

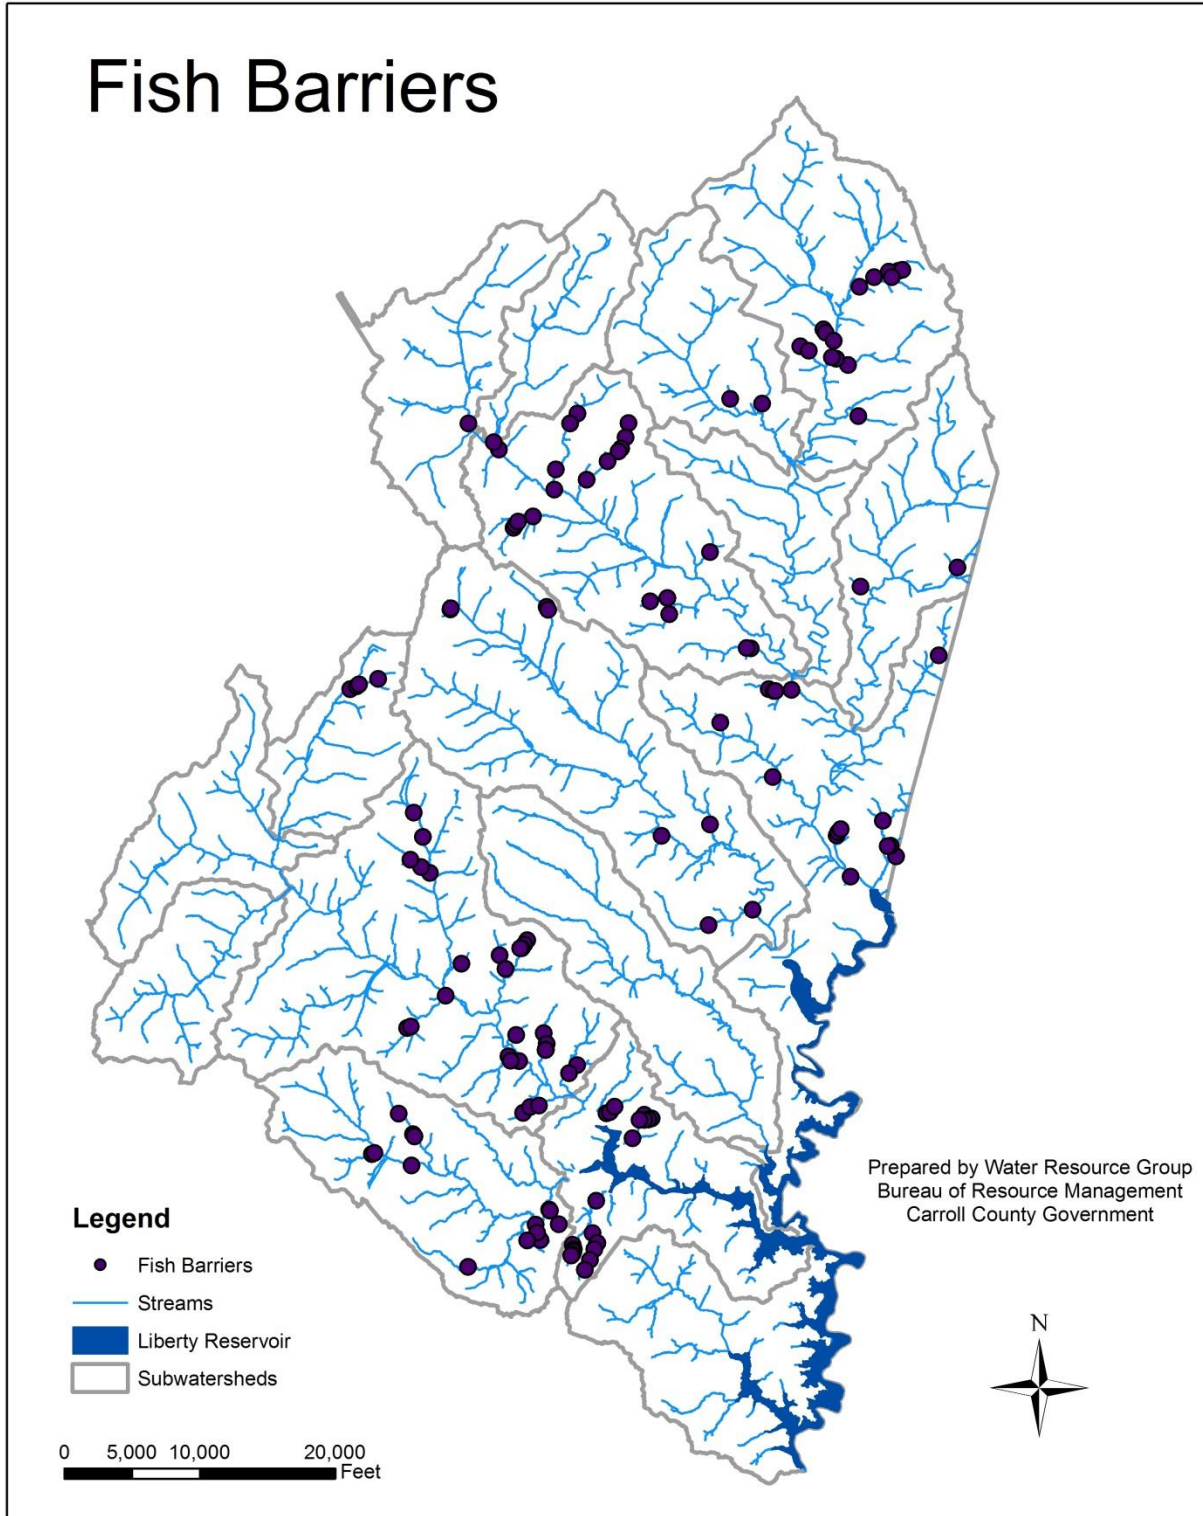
Figure 1-8: Fish Barriers

There were 138 fish barriers identified during the survey; all of the sites were associated with temporary debris dams, perched road culverts, or natural falls. Thirty-four of the identified sites significantly restricted upstream fish movement and received a moderate severity rating. Figure 1-8 shows the location of identified fish barriers.

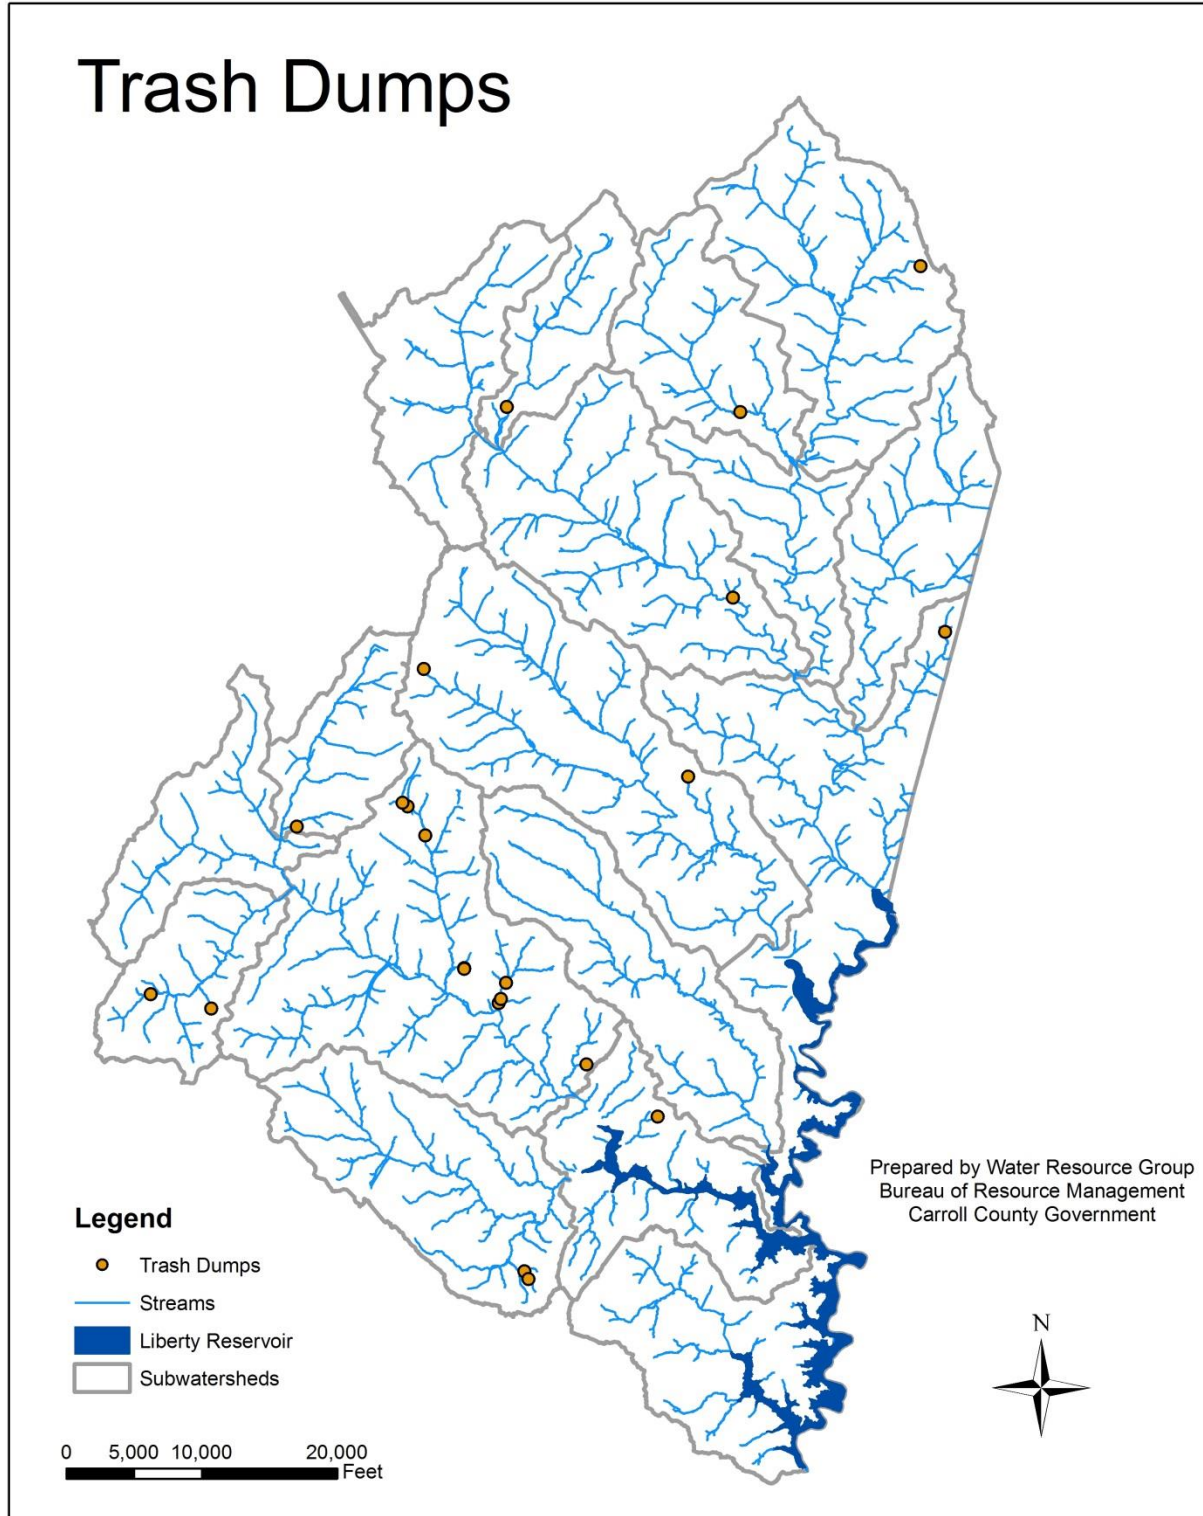
Figure 1-9: Trash Dumps

Impacts from trash were minimal with 27 identified locations within the watershed; all of the sites had a moderate to minor severity rating, with the largest site estimated to have approximately 5 truckloads of waste. The location of identified trash sites can be found in Figure 1-9.

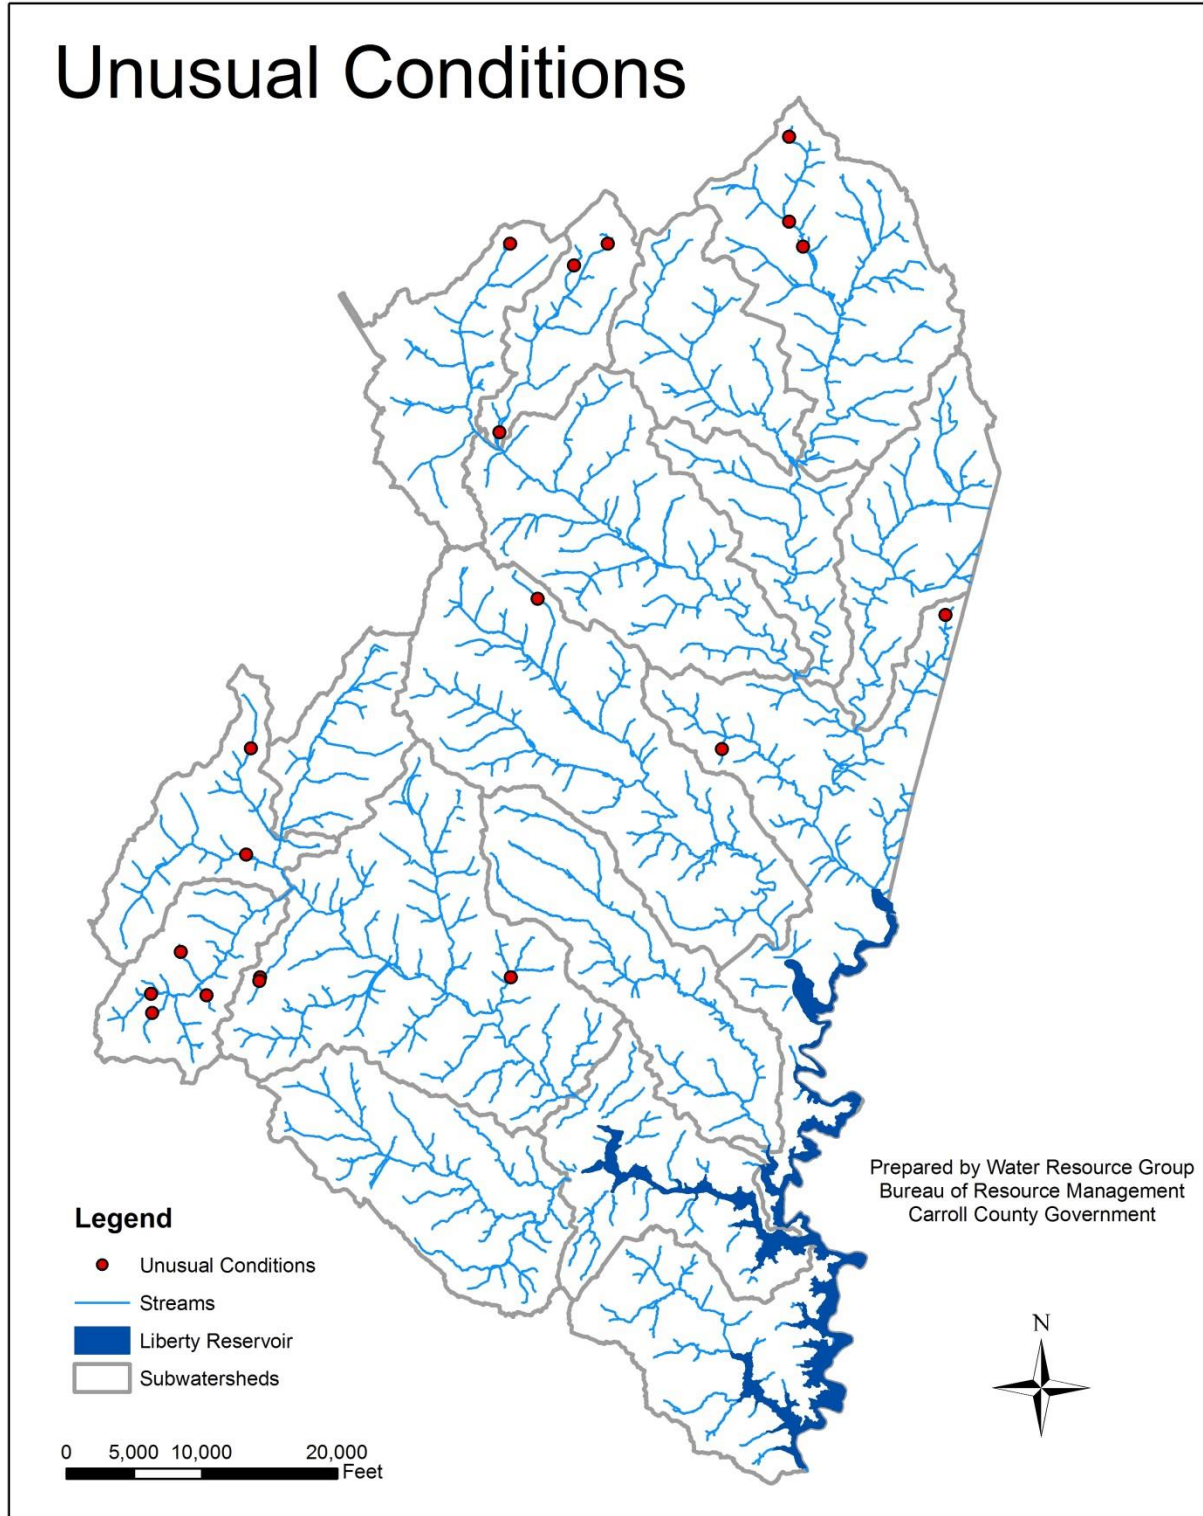
Figure 1-10: Unusual Conditions

Field crews identified 19 unusual conditions during the assessment. The majority of the unusual conditions were comment based, noting or describing something out of the ordinary. The location of these can be found in Figure 1-10.
