## **NATIONAL POLLUTANT DISCHARGE ELIMINATION SYSTEM MUNICIPAL SEPARATE STORM SEWER SYSTEM DISCHARGE PERMIT**

**ANNUAL REPORT  
JULY 15, 2014**

**CARROLL COUNTY, MARYLAND  
NATIONAL POLLUTANT DISCHARGE ELIMINATION SYSTEM (NPDES)  
MUNICIPAL SEPARATE STORM SEWER SYSTEM (MS4)  
PERMIT**

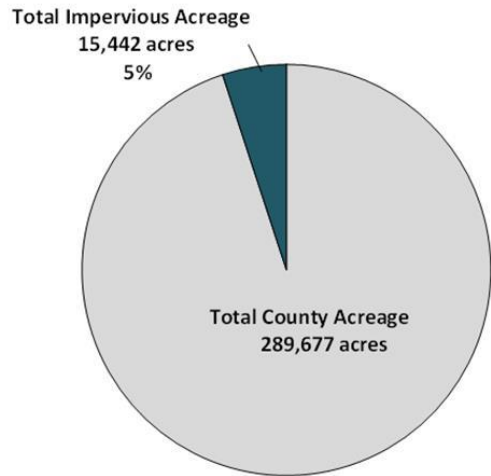
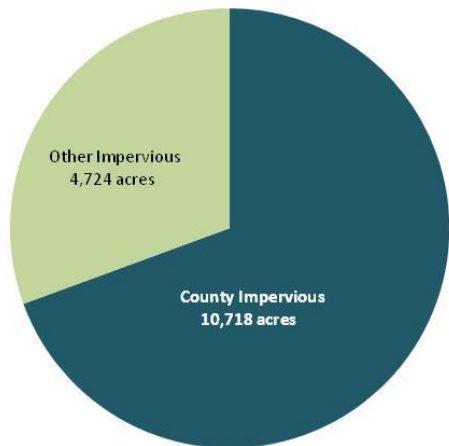
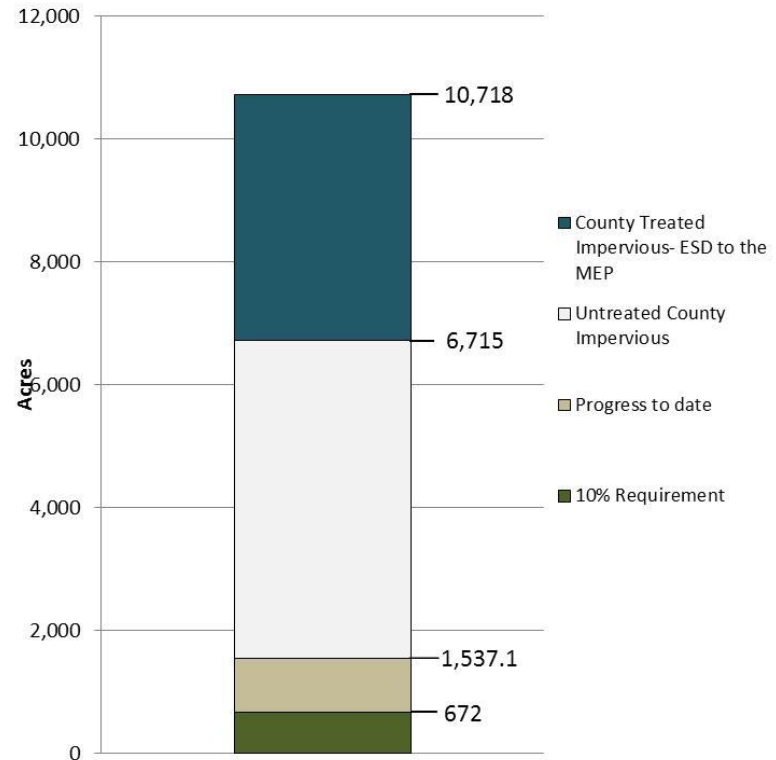
**Carroll County Total Impervious Acres**

**Breakdown of Impervious Acres in Carroll County**

**Carroll County Impervious Acres Treatment Breakdown**

**Figure 1** presents the total unincorporated county impervious of 10,718 acres. A total of 6,715 acres of impervious remains after subtracting the 4,003 acres considered treated through ESD to the MEP. These 4,003 acres include acres of approved stormwater management since 2002, plus the 2,570 acres of historically rural treated acres per the report found in Appendix C. This is actually a reduction in the number of impervious acres proposed in previous annual reports (2,836 acres). The result is a revised baseline of untreated imperviousness at 6,715 acres. Applying this new baseline to the current 10 percent restoration requirement, per Part III G.1. in the permit, would result in 672 acres to be restored. The County was to begin implementation of restoration efforts on an additional 10% (672 acres) per Part III G.2. of the permit. This would equate to a total of 1,344 acres to be or begun to be restored through the current permit cycle. As seen in **Figure 1** and discussed in further detail in Part III B. of this report, the County's watershed restoration level is at 1,537.1 acres (22.9%).

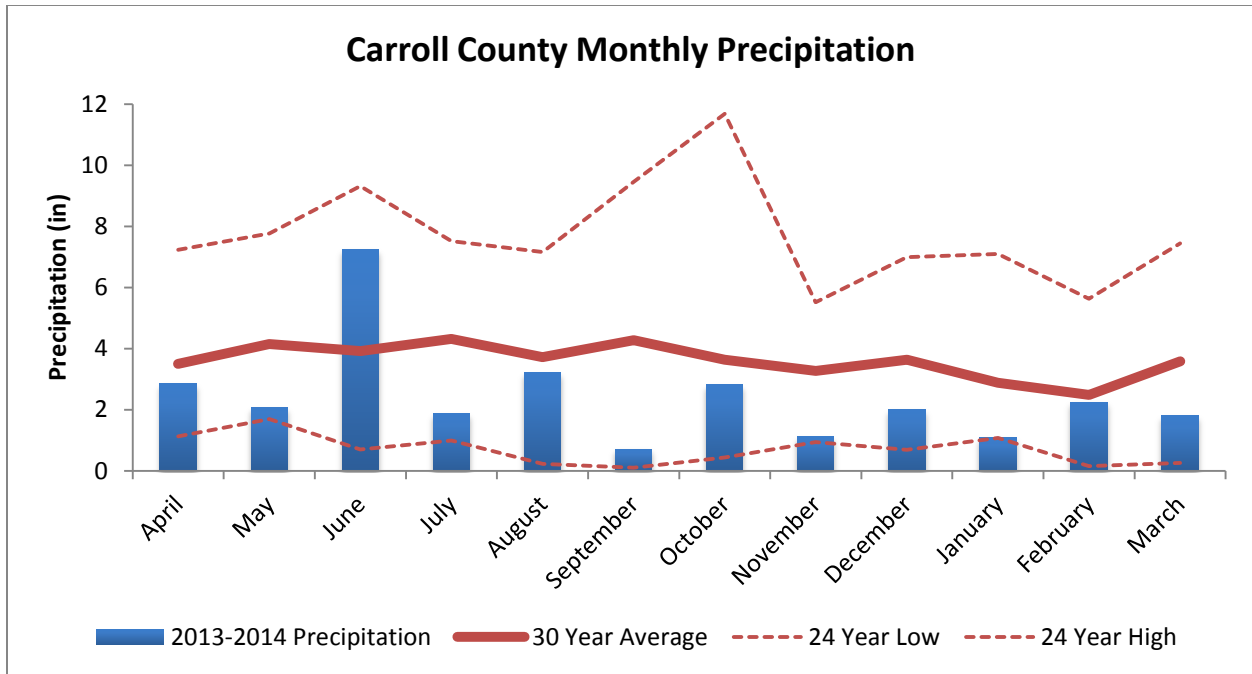
**Figure 5: Monthly Precipitation Summary for the Reporting Period**

Monthly precipitation data for the 2013 – 2014 reporting year are summarized in **Figure 5**. Also included for reference are 30-year monthly averages and monthly high and low extremes from the previous 24 years. Monthly average precipitation was below average in every month except June. The total precipitation for the reporting period was 29.12 inches, a 14.28 inch deficit from the normal yearly total. This reporting period was the driest since 2002, making this the second driest period since the monitoring stations were installed in 2000.

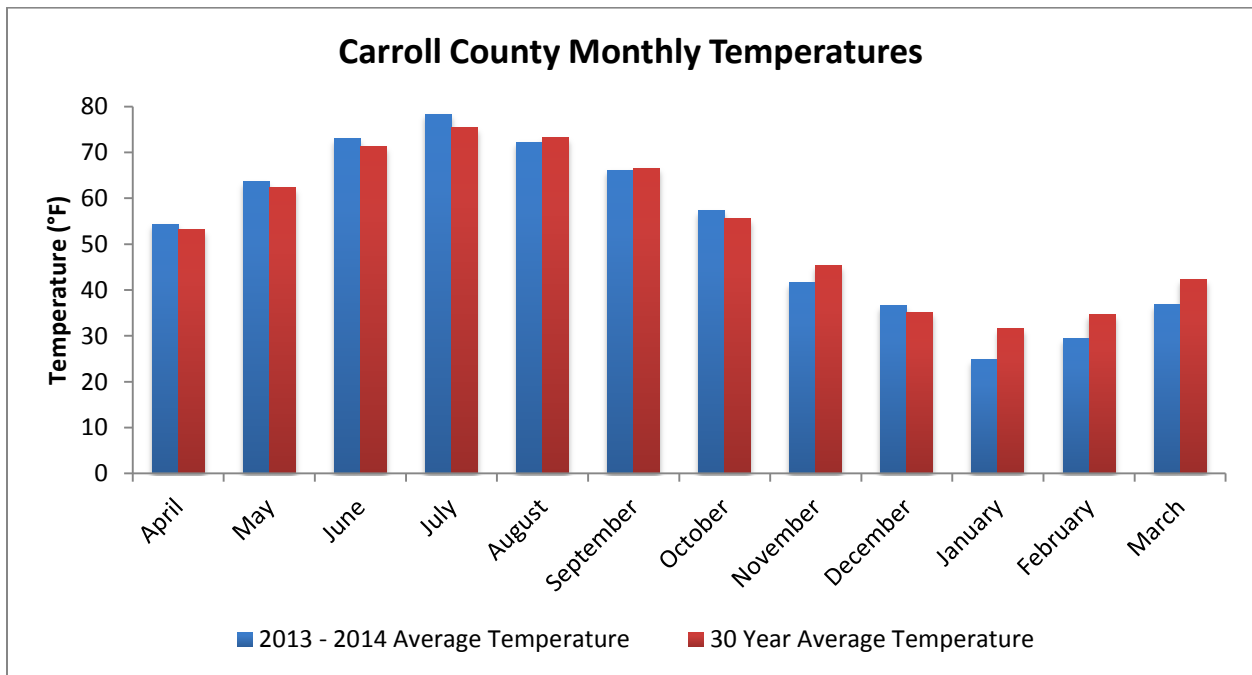
**Figure 6: Monthly Temperature Summary for the Reporting Period**

Monthly temperature data for the 2012 – 2013 reporting year are summarized in **Figure 6**. The 30-year monthly average temperatures are included for reference. Overall, the reporting period experienced an annual average temperature of 53°F, one degree cooler than the 30-year annual average. Temperatures during the spring and early summer of 2013 were consistently warmer

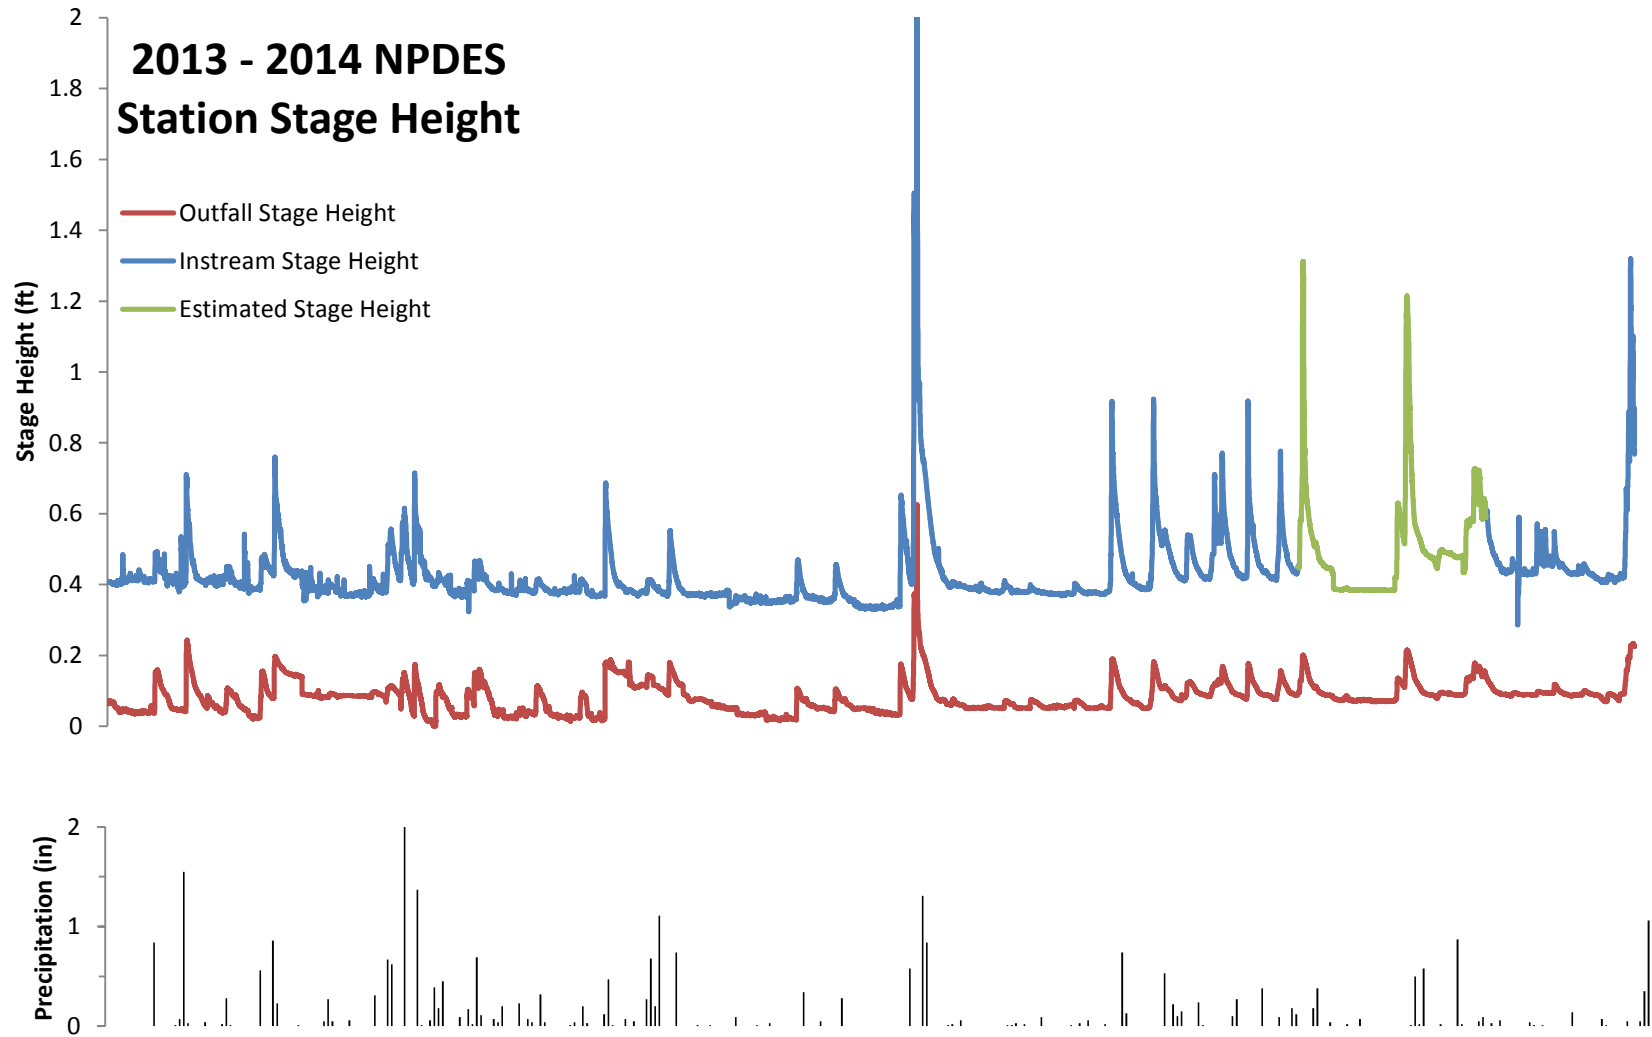
Figure 7: Stage Heights and Daily Precipitation for NPDES Monitoring Stations for the 2013 – 2014 Reporting Year

Typical stage heights observed for the in-stream monitoring station were approximately 0.4 feet, or 700 gpm. During the October 11, 2013 storm event, stage height reached the peak for the reporting year at 2.17 feet. The resulting discharge was 22,854 gpm. There were three other storm events during this time where stage heights above 1 foot (6,600 gpm) were observed. These occurred on January 11, 2014, February 5, 2014, and March 31, 2014 with stage heights of 1.31 feet, 1.22 feet, and 1.32 feet.

Please note that in-stream stage heights and discharges from January 10, 2014 through February 24, 2014 are estimated values. These data were lost due to equipment failure.

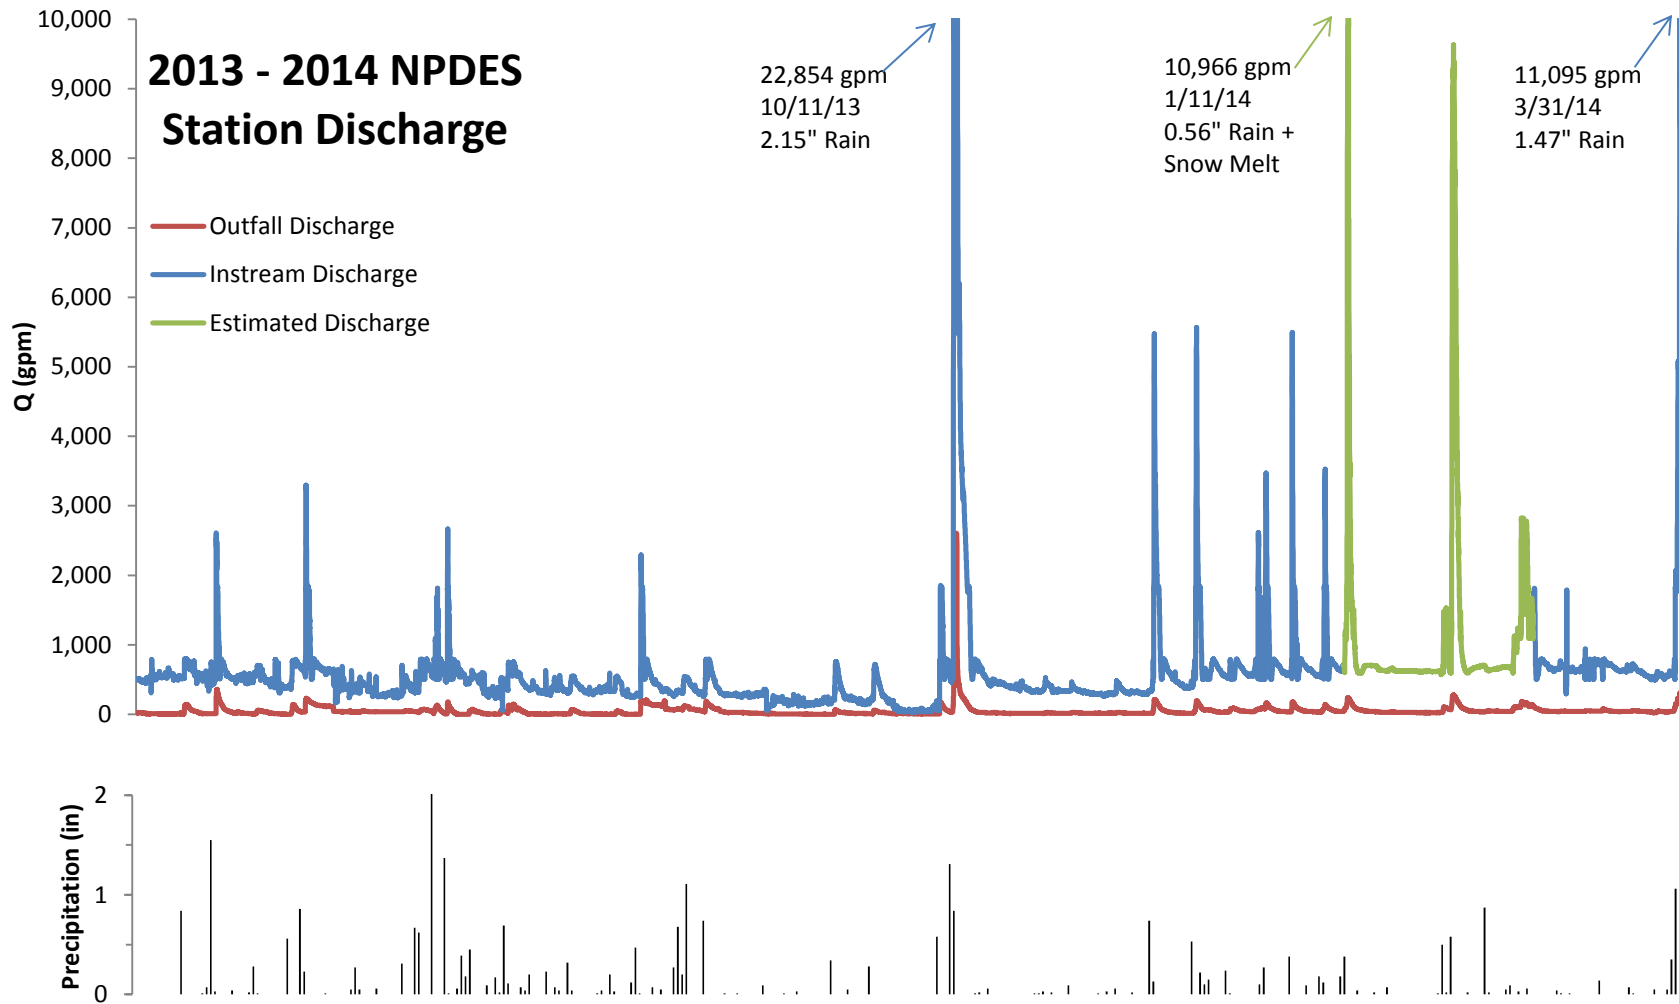
Figure 8: Discharge and Daily Precipitation for NPDES Monitoring Stations for the 2013 – 2014 Reporting Year

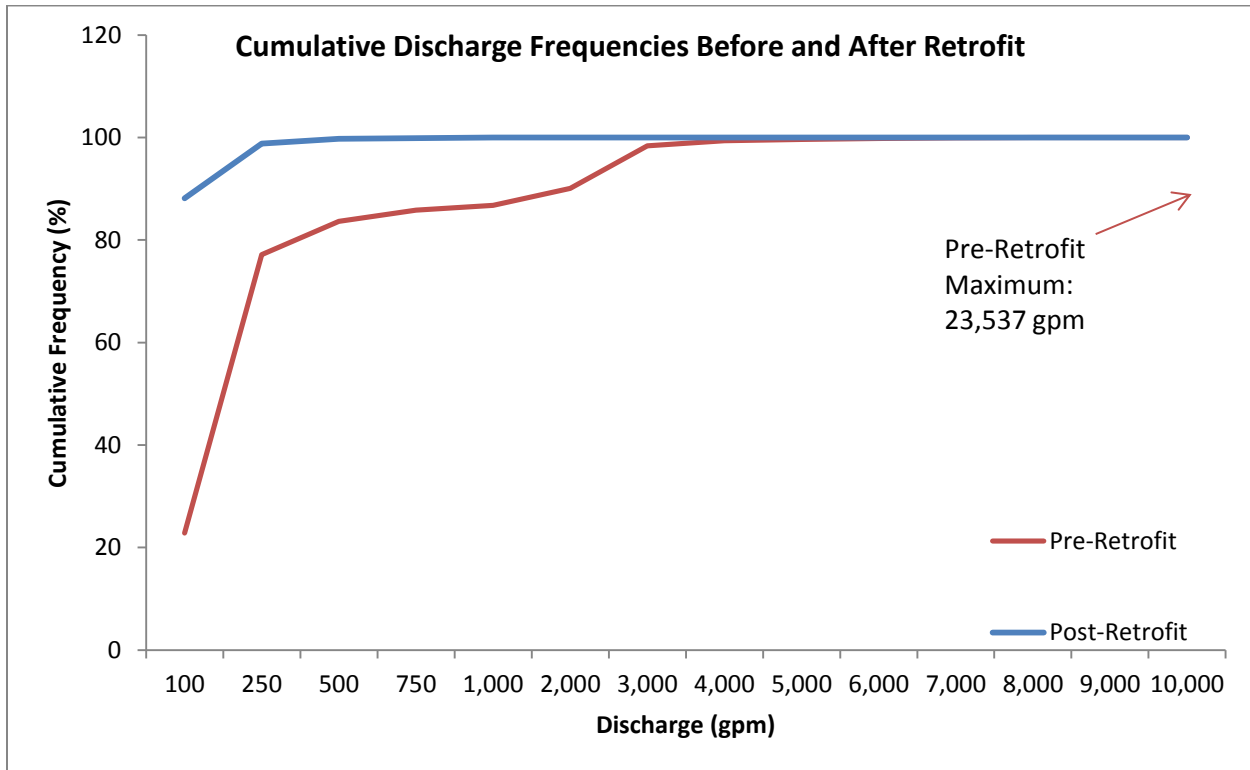
**Figure 9: Outfall Discharge Frequencies for 2007 and 2014**

To compare pre- and post-pond retrofit hydrology, cumulative discharge frequency was plotted in **Figure 9**. This figure compares the discharge frequencies from the outfall monitoring station for the 2006–2007 and 2013–2014 reporting years. The maximum discharge during the pre-retrofit period (2007) was an order of magnitude higher than the post-retrofit period (2014). The maximum discharge in 2007 was 23,537 gpm while the maximum in 2014 was only 2,608 gpm. Additionally, the frequency and magnitude of high discharge events was greater during the pre-retrofit period. Eighty-eight percent of all discharge measurements were below or equal to 100 gpm. This contrasts with the pre-retrofit measurements where only 23 percent of measurements were below 100 gpm. Ten percent of all measurements in 2007 were greater than 2000 gallons per minute, which are greater in magnitude than the highest discharges from 2014. It is difficult to determine how much of this variation is due to precipitation disparity between the two years as the 2006 – 2007 reporting period received significantly more precipitation. Discharge data from 2002, the only comparable year for precipitation, was lacking for a proper comparison.

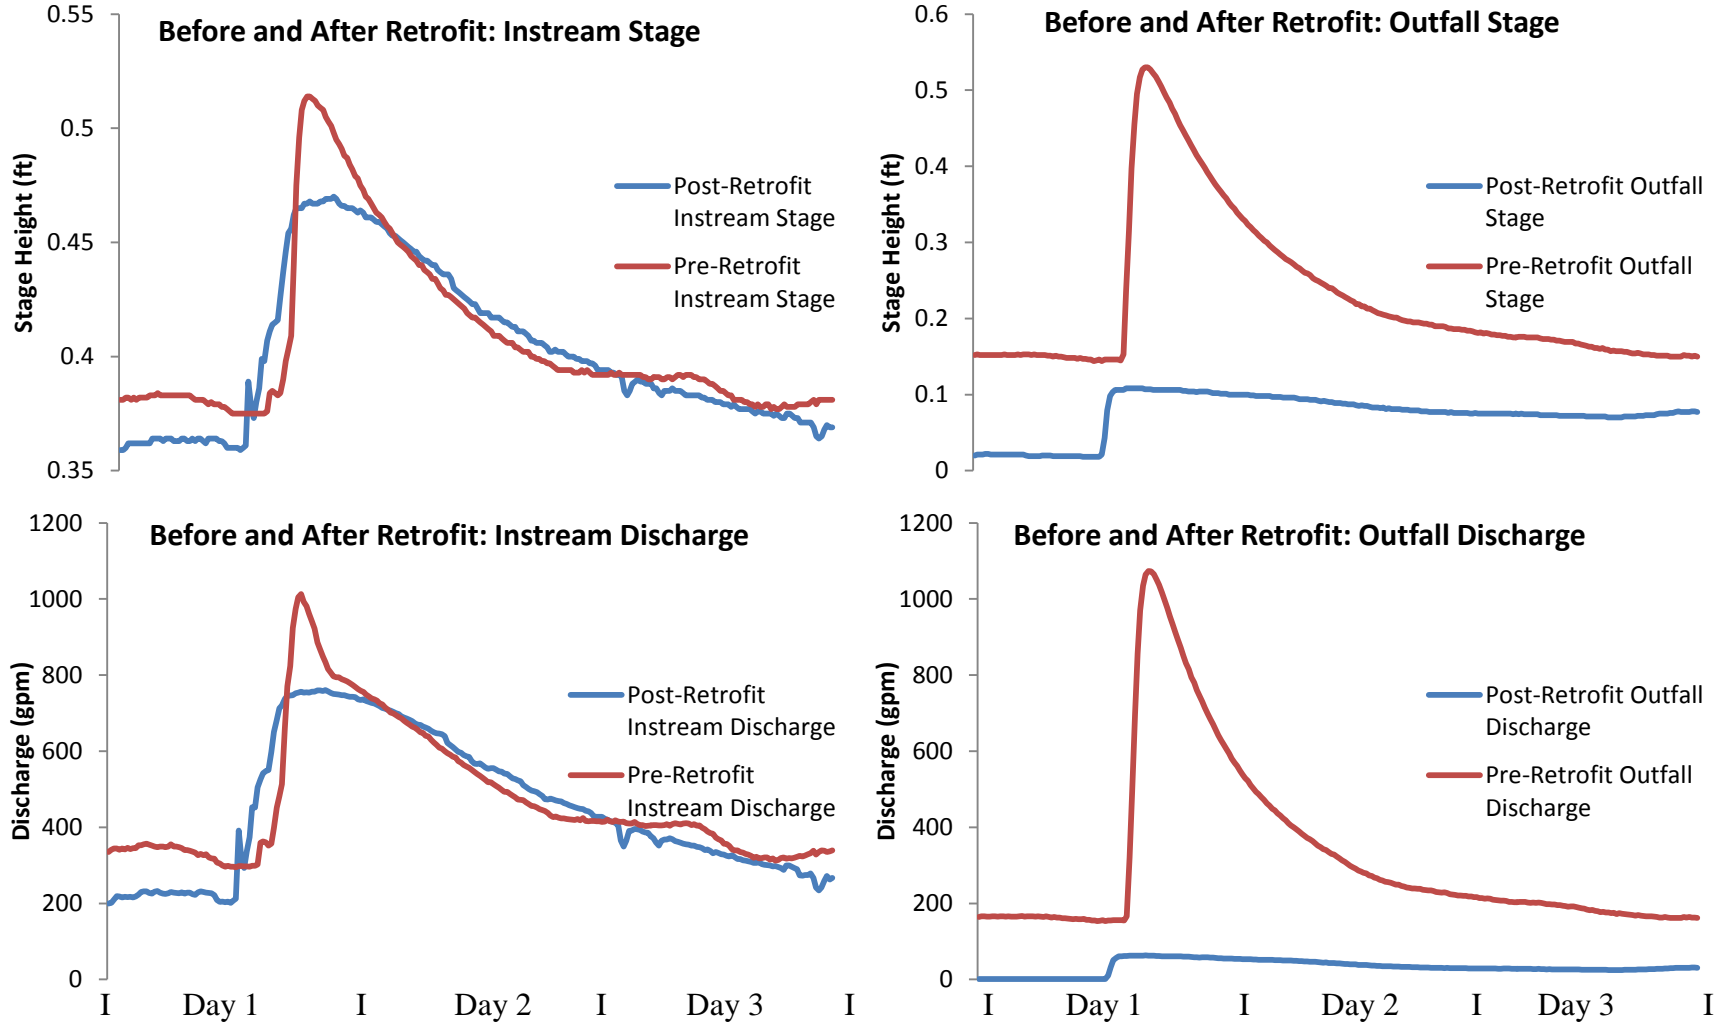
**Figure 10: Characteristics of Analogous Storms Pre-Retrofit (7/6/2006, 0.39") and Post-Retrofit (9/12/2013, 0.34")**

Individual components of the hydrograph below show the distinct mechanism behind any changes in cumulative frequencies throughout the year. **Figure 10** represents two analogous storm events, one before and one after the stormwater retrofit, and a hydrological comparison therein. This figure contains hydrographs before and after retrofit for in-stream and outfall stage heights and discharges. The pre-retrofit event had 0.39 inches of precipitation observed while the post-retrofit event had 0.34 inches of precipitation observed. All pre-retrofit hydrographs show a distinctly steeper slope for the ascending storm limb and greater maximum stage and discharge. This is particularly true at the outfall station where the slope and peak were even more distinct. The outfall to in-stream station discharge ratio for the post-retrofit storm event maintained the 7 percent contribution, as was the case for the overall discharge and separated stormflow for the reporting period. During the pre-retrofit storm, however, the outfall station contributed 70 percent of the total in-stream discharge. The period of baseflow recession after the storm event was much shorter during the pre-retrofit storm. Overall, longer baseflow recessions and lower peak discharges were observed with the current stormwater configuration.

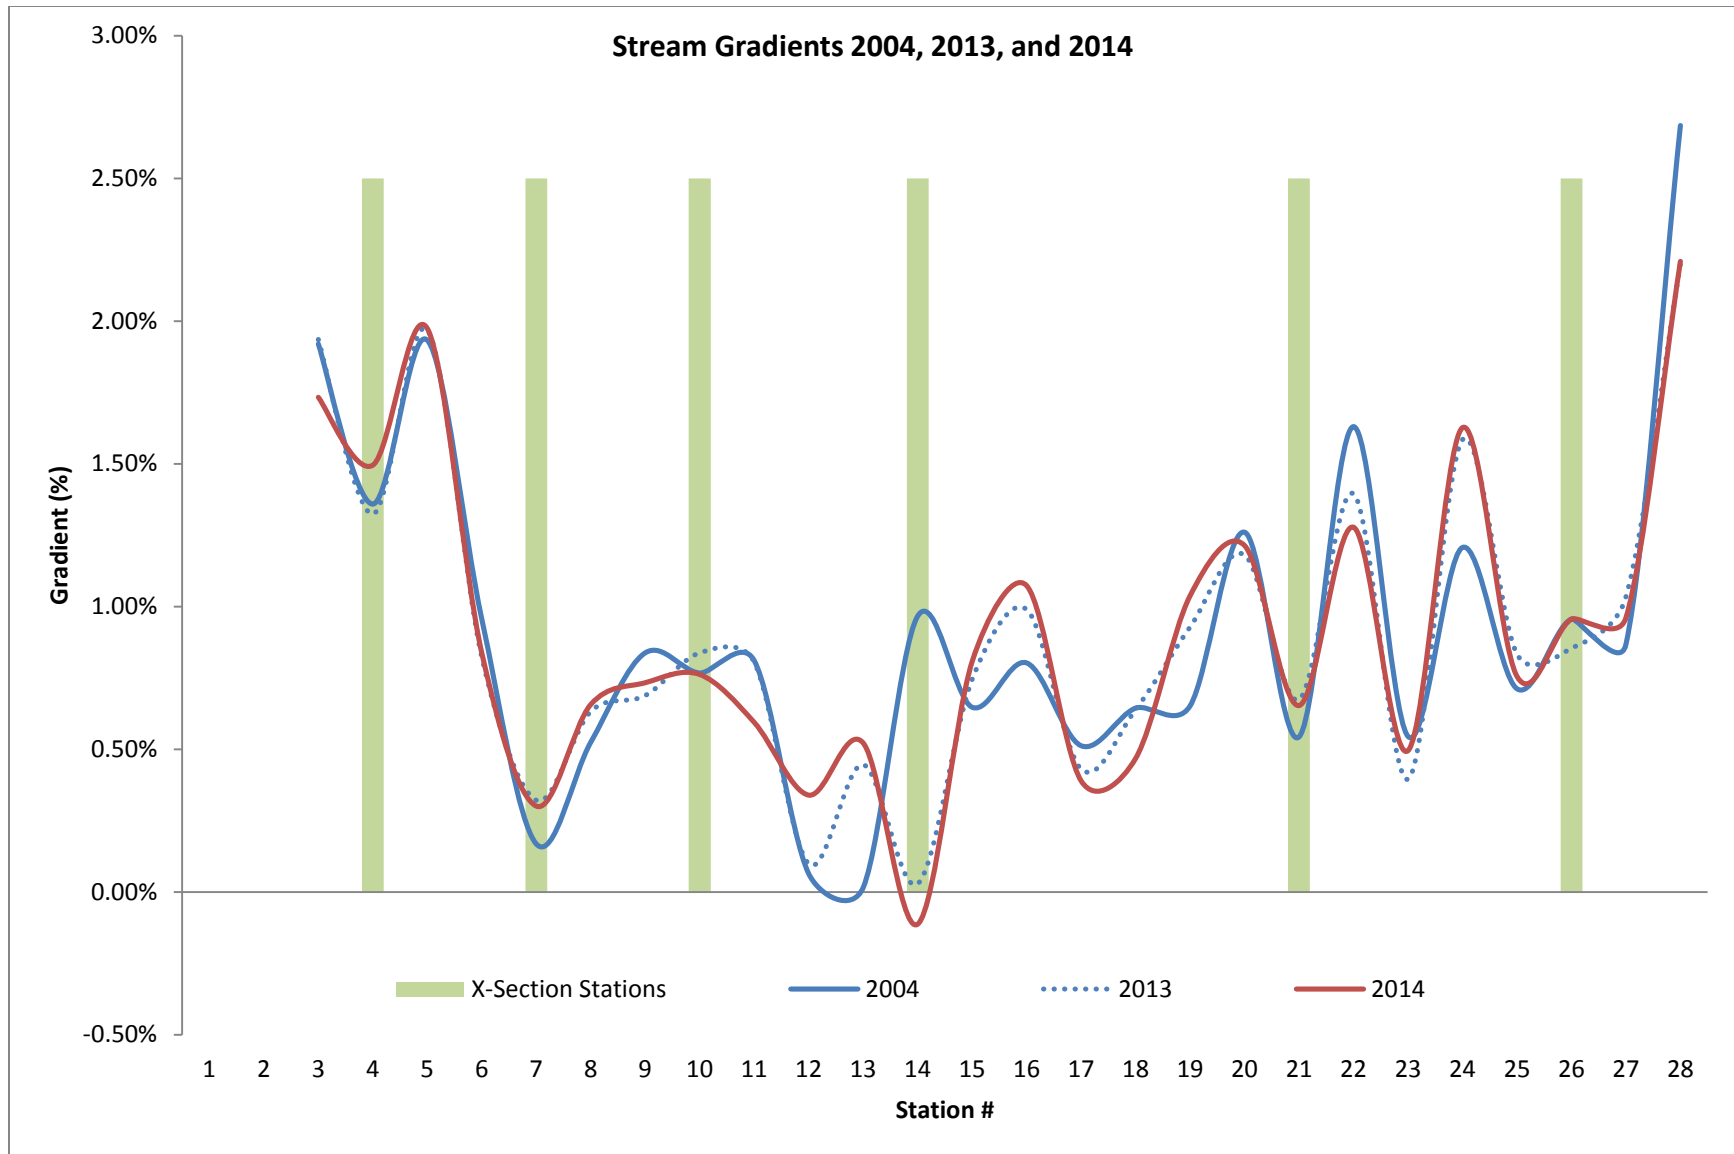
Figure 12: Stream Gradient Change from 2004 – 2014

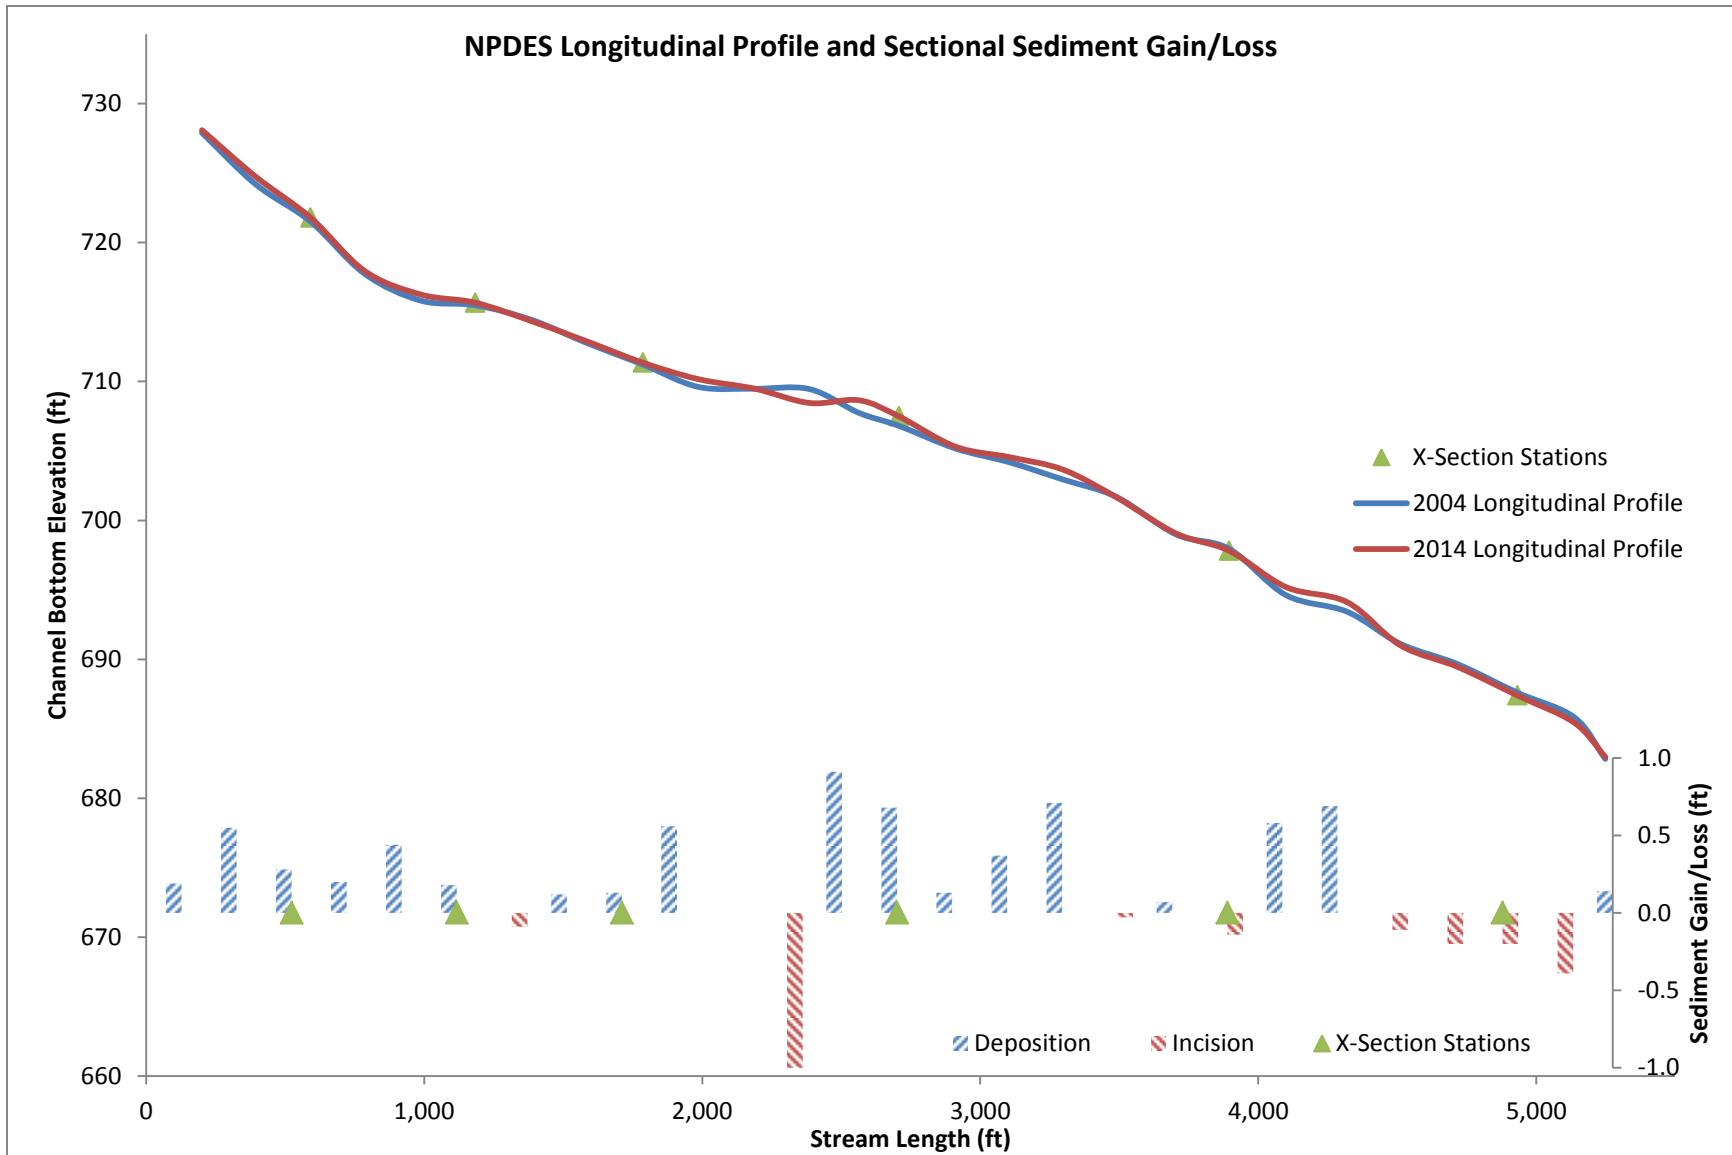
Figure 13: Comparison of Longitudinal Profile and Sectional Deposition/Incision from 2004 - 2014

**Figure 13** displays the longitudinal stream profile for elevation and depth of deposition or incision at each of the 28 sections along the profile. Included are the six monumented reaches for reference. The profile shows the low gradients in the center section of the stream and that the areas with lowest gradient have moved downstream, the cause of elevated deposition at monumented reach four. Aggradation and degradation is most significant in the center section of the stream. Elevation change during the past ten years has not exceeded one foot at channel bottom. However, since the stream has two small tributaries, varying bends and straight segments, as well as a number of soils series represented along the channel, it is important to monitor the physical characteristics of the stream channel over time.

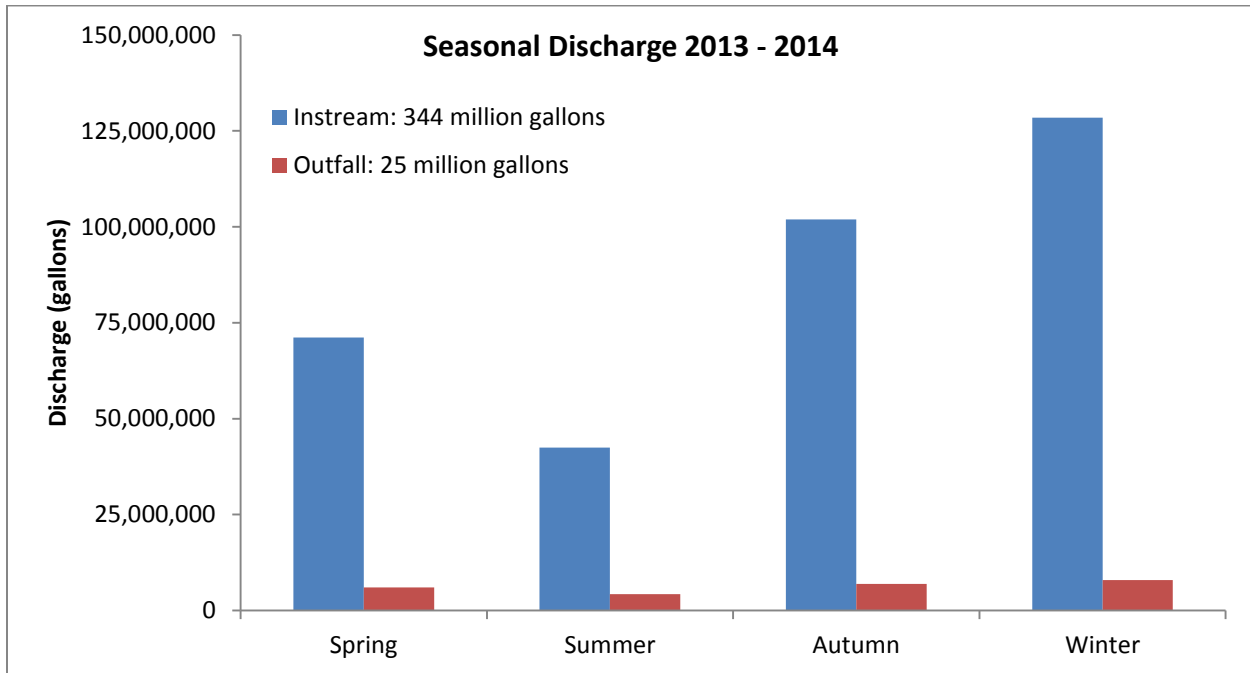
**Figure 16: Seasonal Discharge for the 2013 – 2014 Reporting Year**

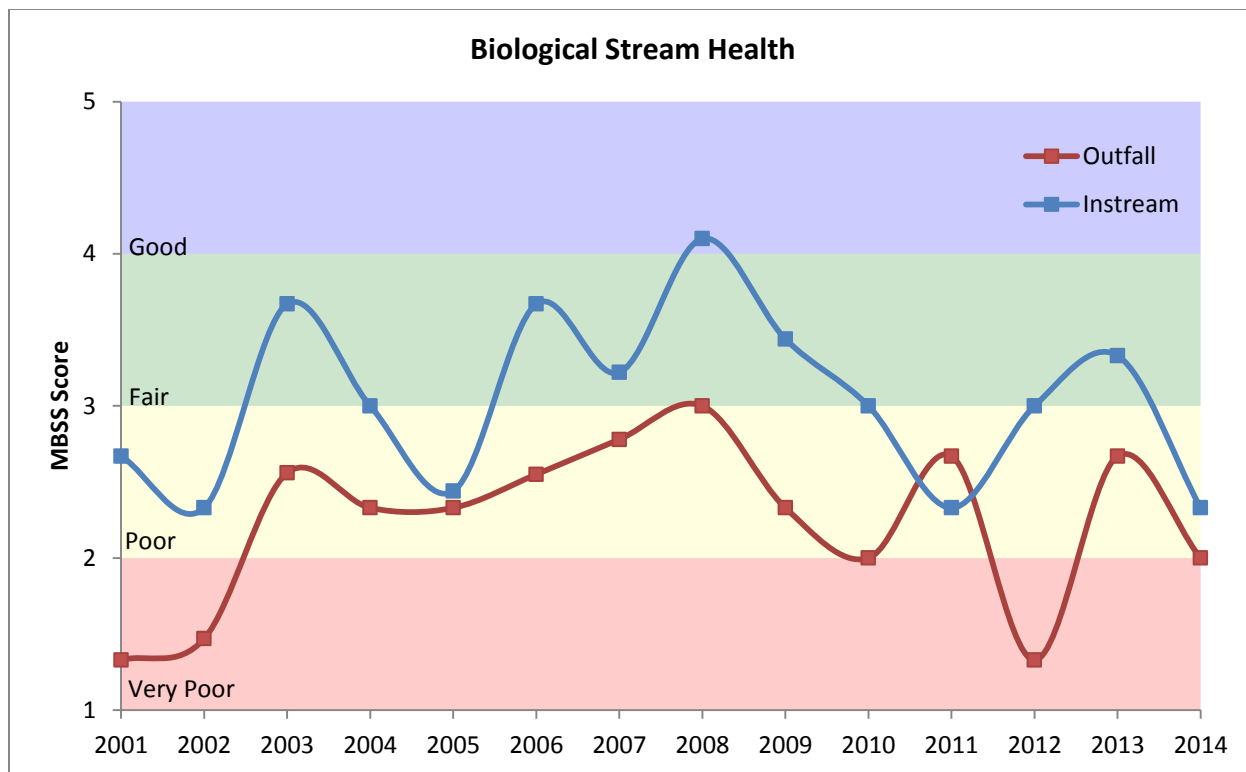
**Figure 17: Macroinvertebrate IBI Analysis 2001 – 2014**

**Figure 17** presents these scores annually from 2001 through 2014. The trends of both stations appear to be correlative throughout this time period. On average, the score for the in-stream station remains 0.8 greater than that of the outfall station. The average score for the outfall station is 2.2, which is rated as poor biological health according to MBSS protocols. The average score for the in-stream station is 3, which is on the boundary between poor and fair biological health according to MBSS protocols. The results from the biological survey were very similar with the exception of the presence of a large number of Ephemeroptera within the in-stream reach. This was the only scoring parameter that was different from the outfall stream reach. The outfall station appears to be relatively intolerable for most sensitive species as only 2 percent of the individuals recovered were considered sensitive with a large percentage of tolerant species present.

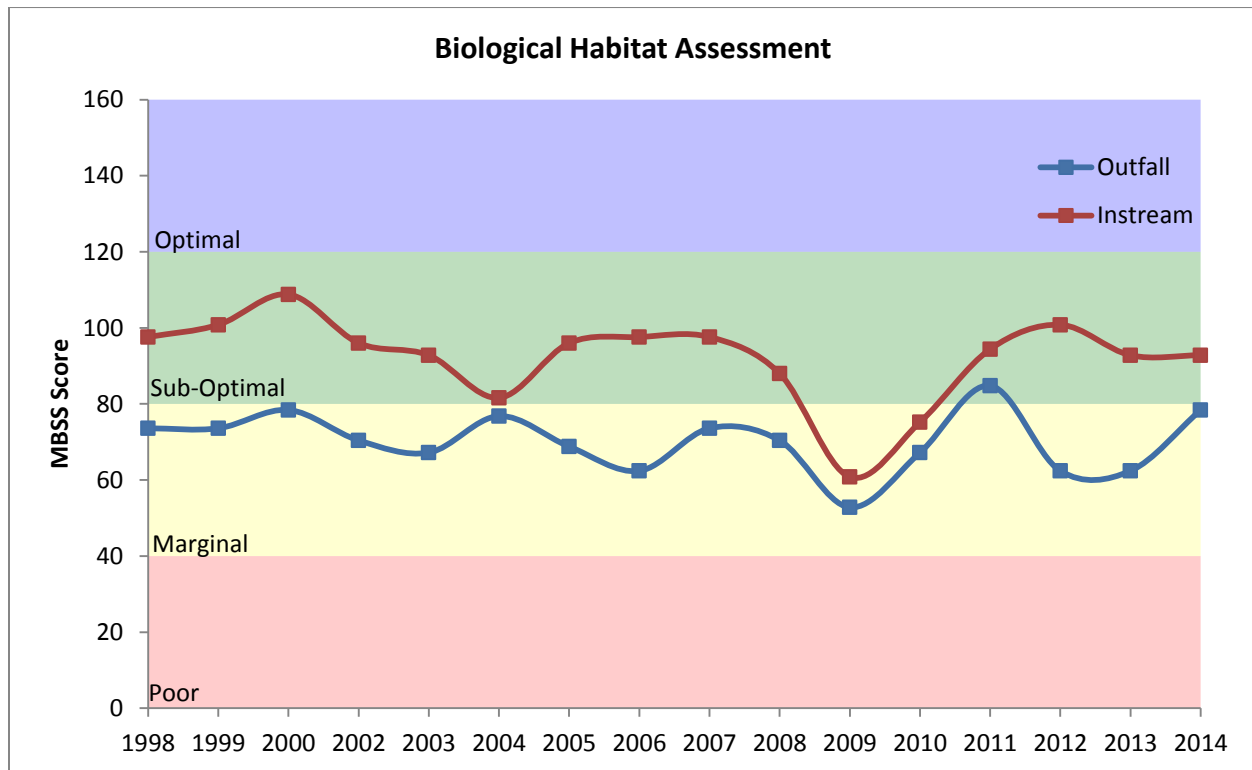
**Figure 18: Comparison of NPDES Station Habitat 1998 – 2014 (Excluding 2001)**

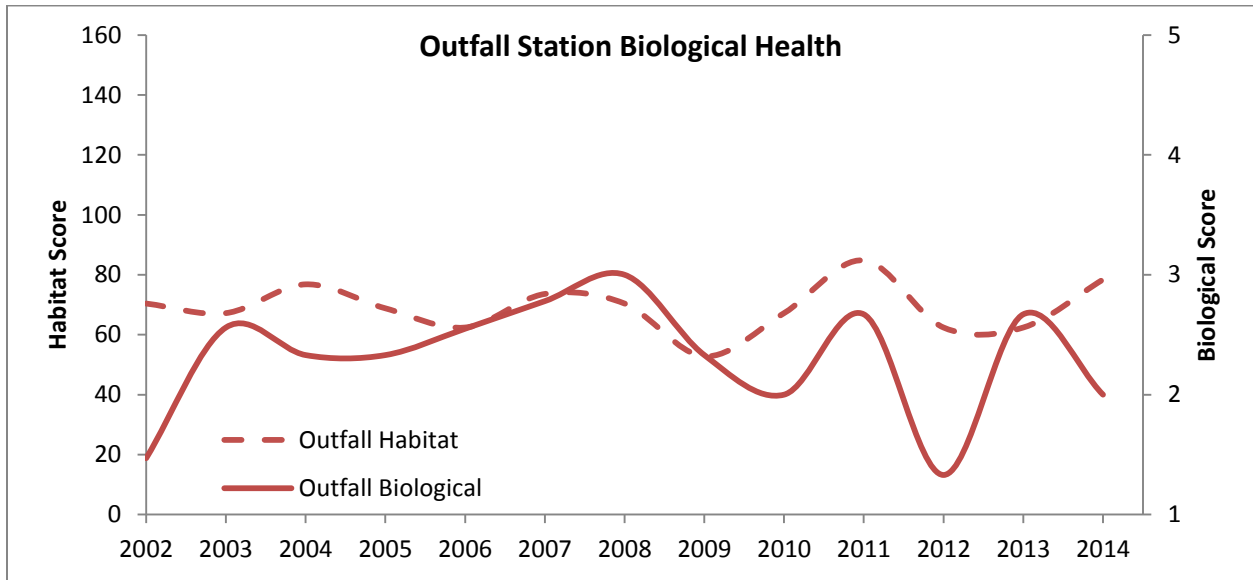
**Figure 19: Comparison of Outfall Station Habitat and Biological IBI Scores 2002 – 2014**

It should be noted that the habitat assessment is wholly subjective. Slight changes may be a result of inconsistencies in assessor(s) scoring methodology. To show a general relationship between the habitat and biological scores, these have been plotted for the outfall and in-stream stations in **Figures 19 and 20**. These are plotted on each assessment's overall scoring range. Though not unexpected, it is evident that the lower the quality of habitat in this case, the lower the biological quality found in the habitat. Both stations appear to have a one to two year period of latency between habitat and biological changes. The certainty of any evident relationship is low given the high degree of bias and chance that is probable in these assessments.

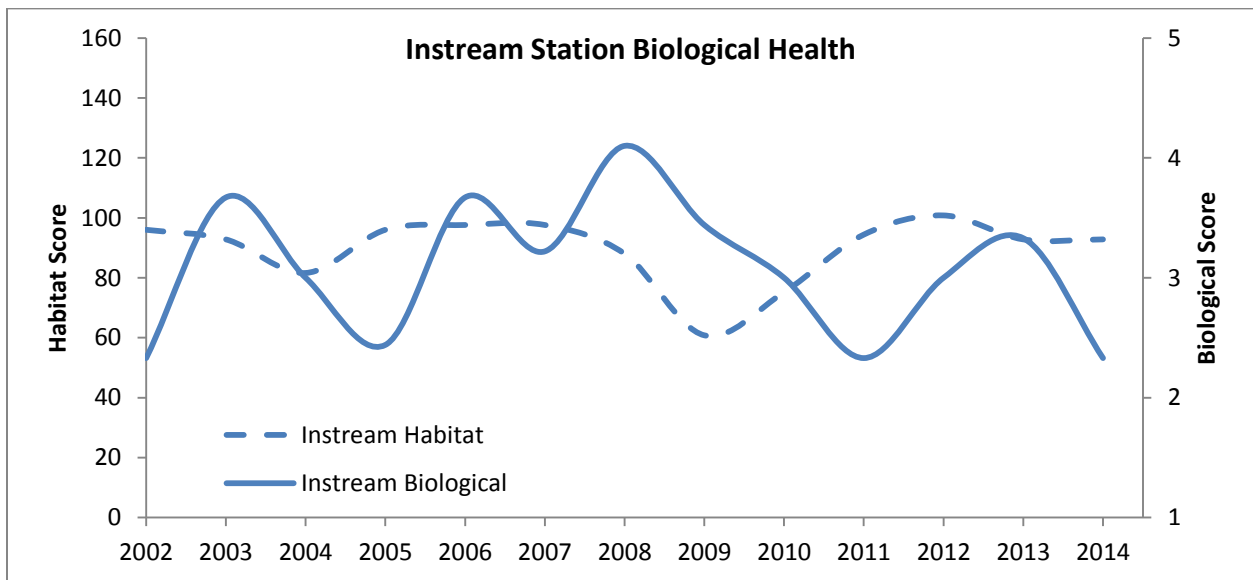
**Figure 20: Comparison of In-stream Station Habitat and Biological IBI Scores 2002 – 2014**

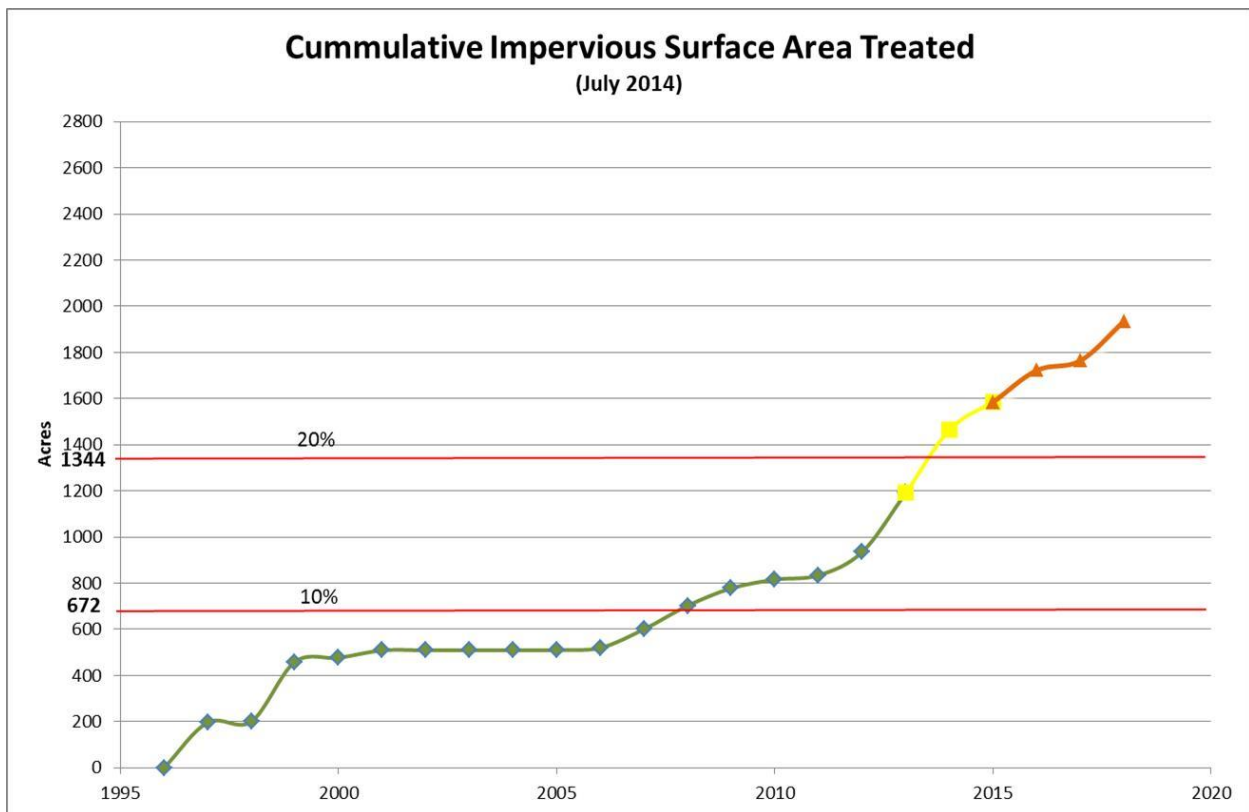
**Figure 22: Impervious Surface Acres Treated For Constructed, Designed, And Planned Projects**

During the permit year 2013 – 2014, the County completed a total of five (5) stormwater retrofit projects, equaling 123 acres of treated imperviousness and 486.57 acres of treated drainage area. In addition, two (2) tree plantings associated with stream buffer enhancement were implemented which resulted in 5.42 acres of impervious treated. Specific projects completed (green), in design (yellow), and planned (orange) can be found in **Table 22**. An estimate of pollutant load reductions associated with select completed projects can be found in **Table 23**.

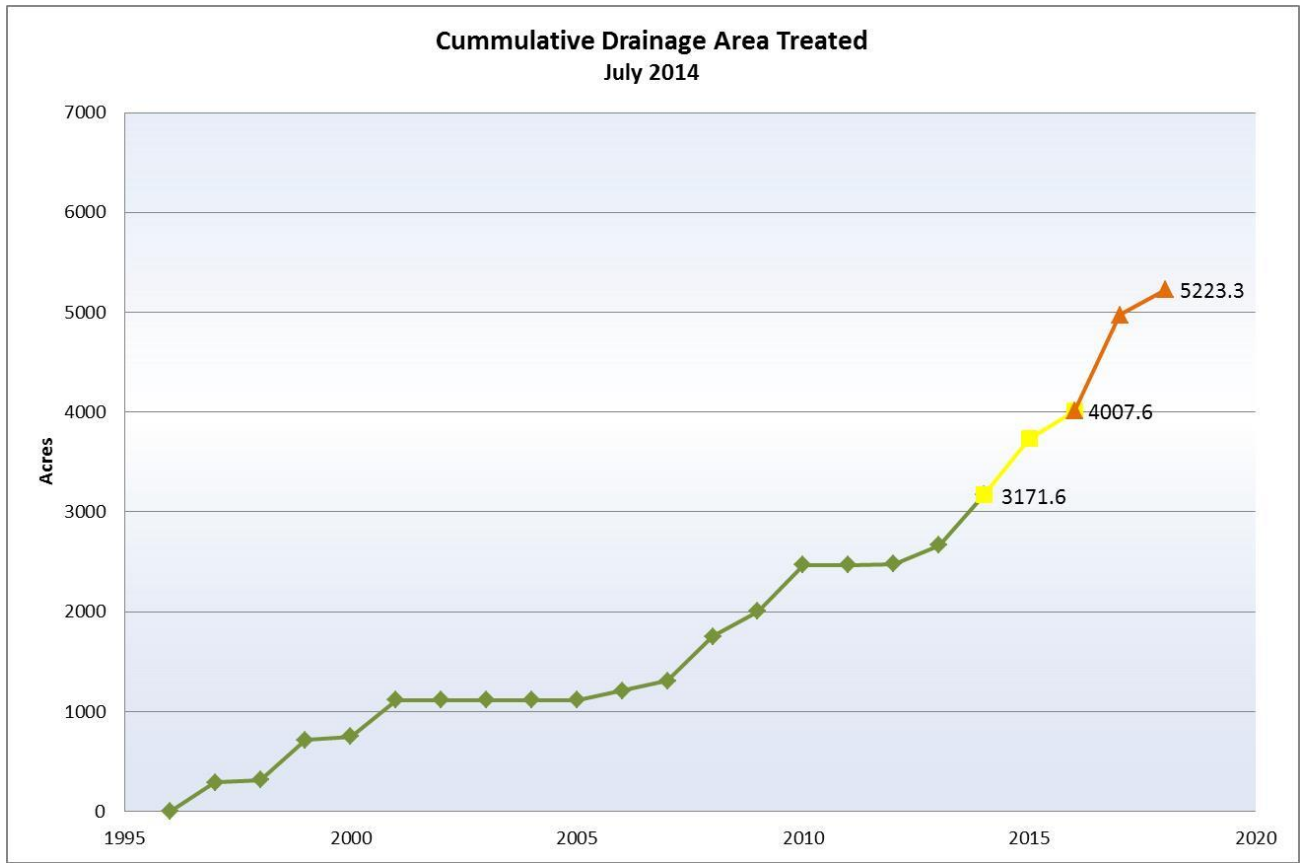
**Figure 23: Drainage Area In Acres Treated For Construction, Design, And Planned Projects.**
