## **NATIONAL POLLUTANT DISCHARGE ELIMINATION SYSTEM MUNICIPAL SEPARATE STORM SEWER SYSTEM DISCHARGE PERMIT**

### **2020 ANNUAL REPORT**

**CARROLL COUNTY, MARYLAND  
NATIONAL POLLUTANT DISCHARGE ELIMINATION SYSTEM (NPDES)  
MUNICIPAL SEPARATE STORM SEWER SYSTEM (MS4)  
PERMIT**

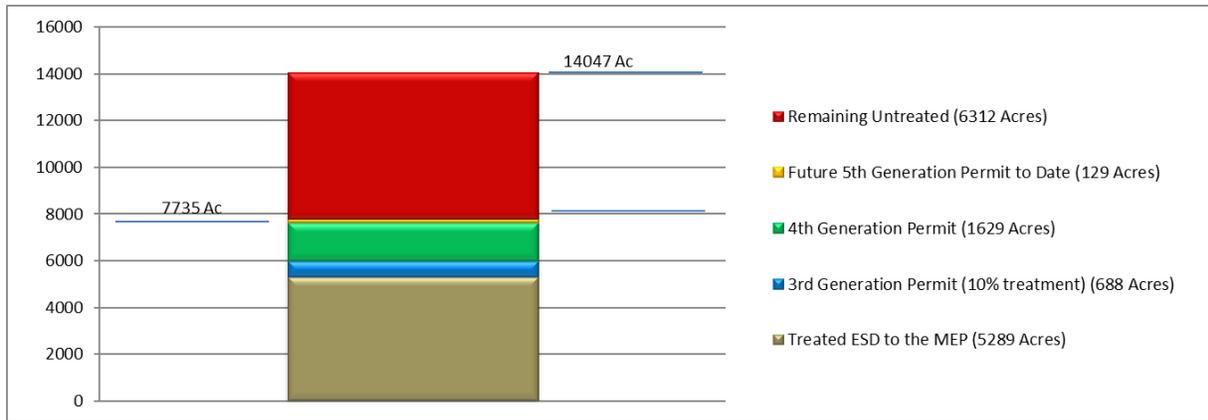
Figure 1: Carroll County Permit Impervious Surface Analysis

Activities associated with treatment efforts taken during each permit term are listed in **Table 10**. Impervious acres treated to date (July 2020) are 1,759. The County has met both the third- and fourth-generation permit requirements and has achieved 1.6% impervious area treatment toward the future requirement of the fifth-generation permit.

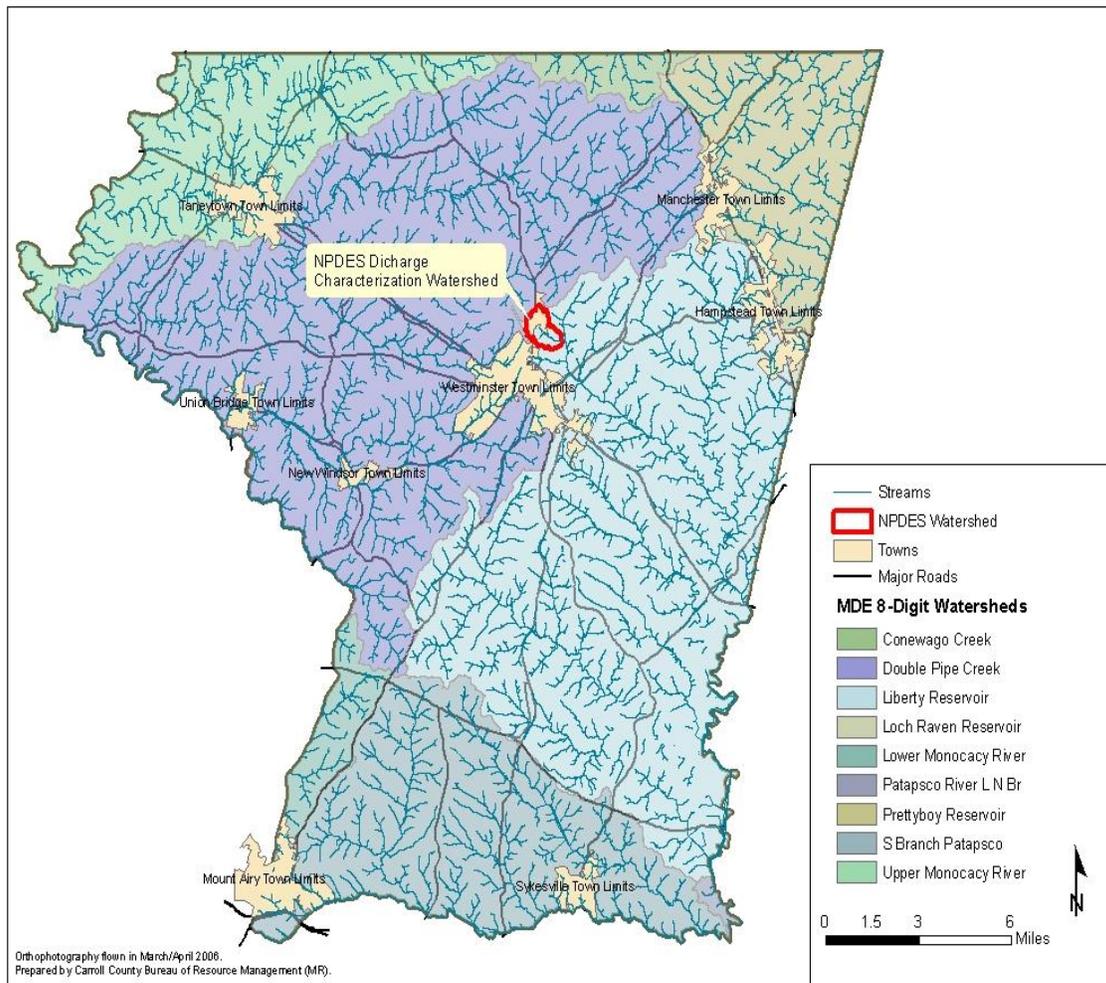
**Figure 7: Carroll County NPDES Discharge Characterization Location**

topographic divide separating the eastern and western piedmont physiographic provinces. As shown in **Figure 7**, this is a headwater stream draining the upper-most extent of the watershed.

The Air Business Center regional stormwater management facility discharges through a constructed outfall to a small stream that flows southeast to its confluence with the West Branch. The stream receives the majority of its flow from the pond's outfall, with additional contribution from overland flow from the drainage basin during precipitation events. A new stormwater management pond at the West Branch Trade Center has been constructed adjacent to and east of the Air Business Center stormwater management facility. This facility also drains to the stream, just below the outfall station.

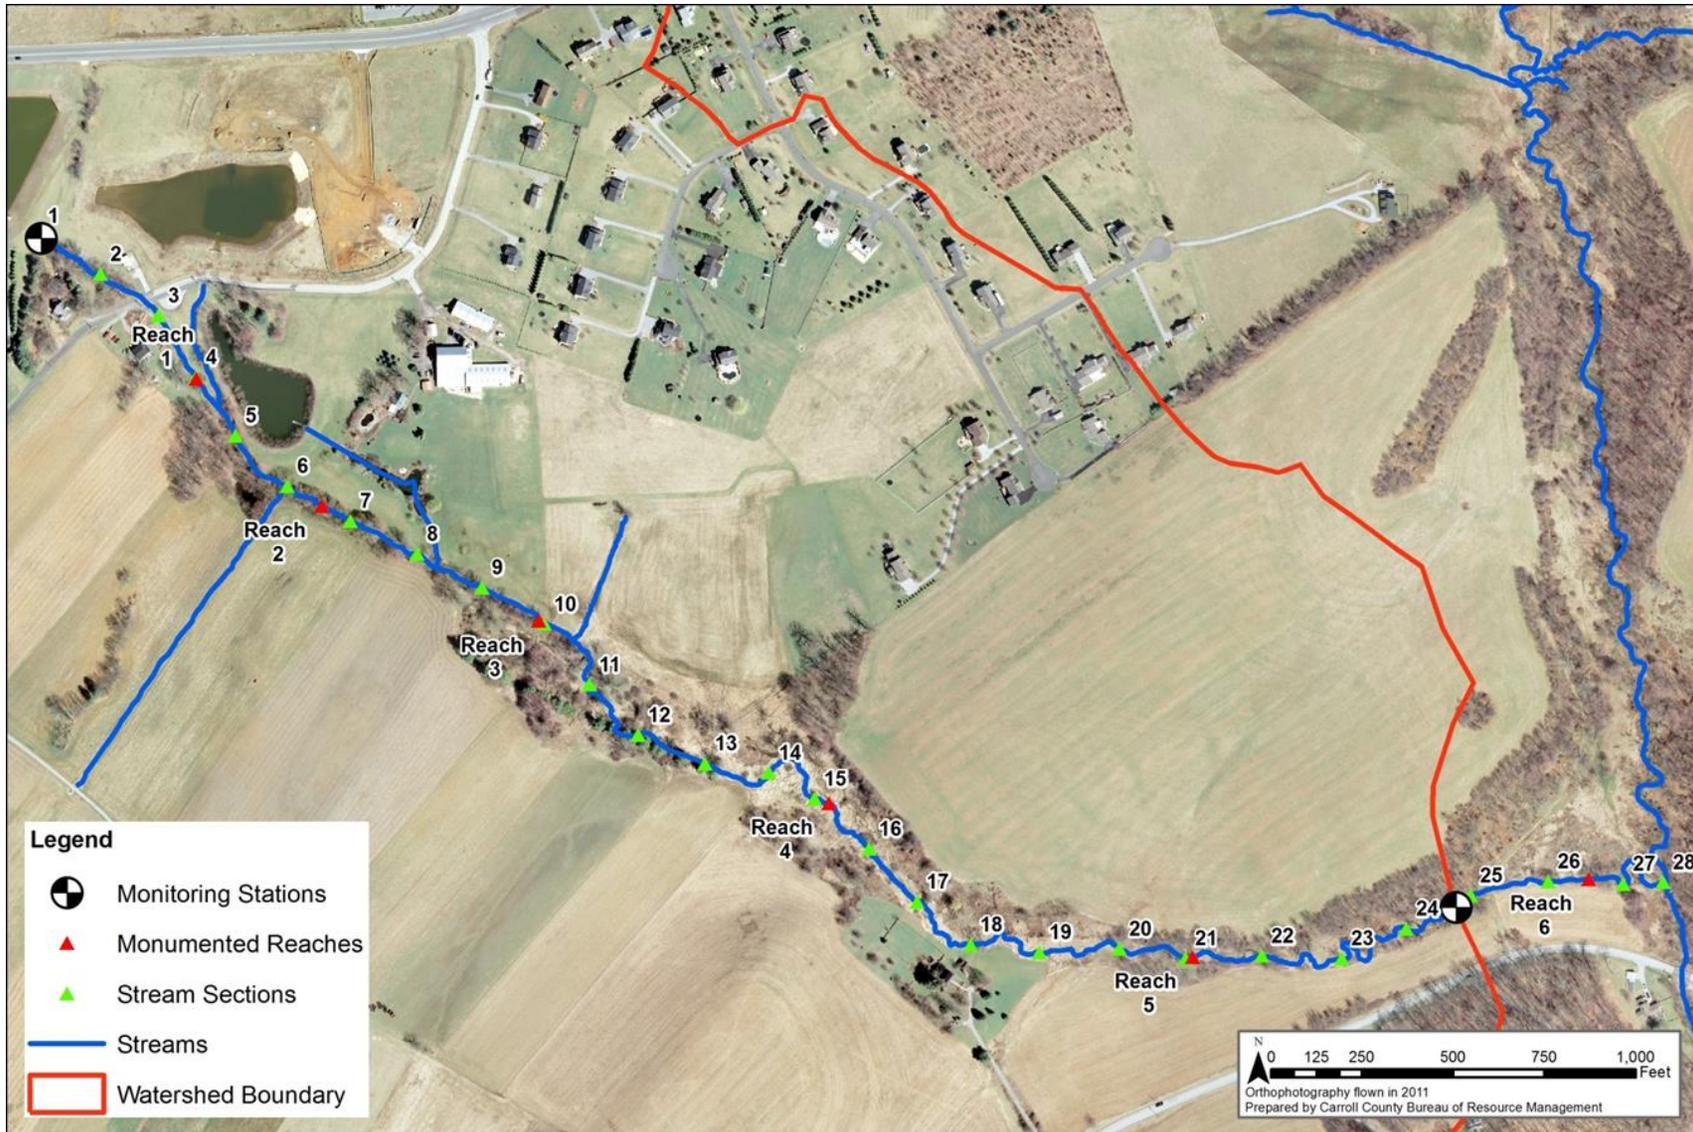
Figure 9: Physical Data Collection Stations

A Level 1 geomorphologic stream assessment has been conducted on the entire stream segment to assess potential geomorphologic changes to the stream. This assessment included a physical evaluation of stream channel changes and an interpretation of those changes. The physical evaluation involved determining channel segment characteristics and assessing dimensional changes. The results of the physical evaluation were then translated into a channel response by comparing changes in channel geometry (e.g. cross-sectional dimensions) in the context of the physical setting.

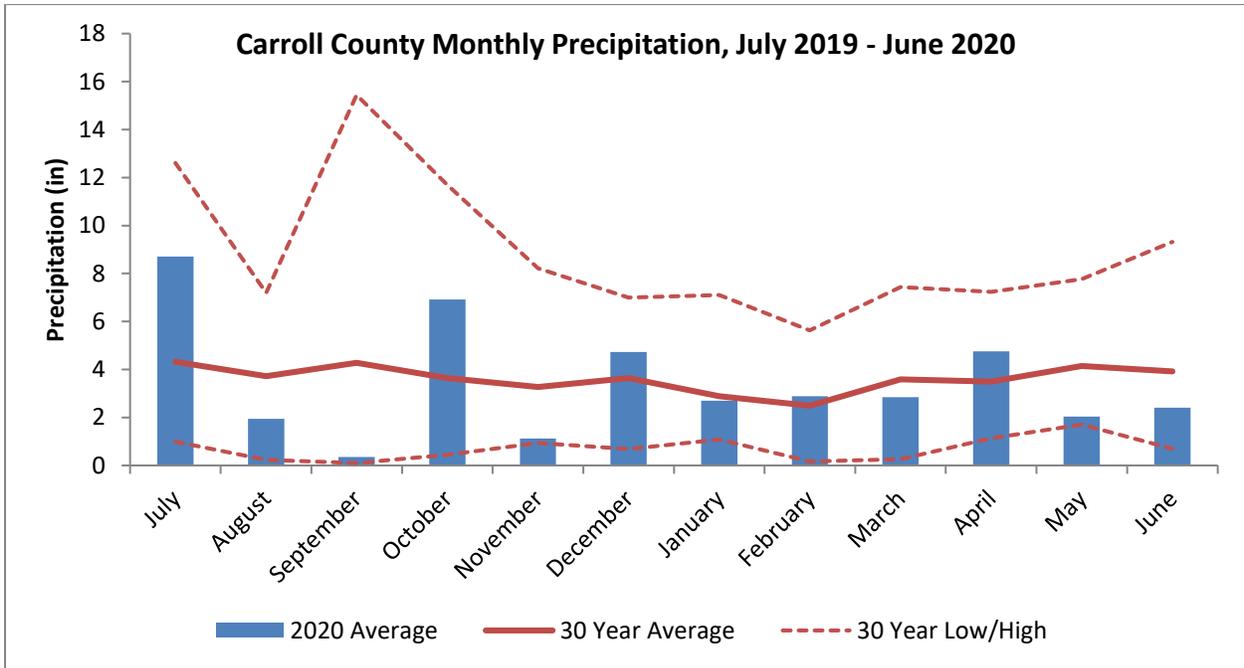
**Figure 11: Monthly Precipitation Summary for the 2020 Reporting Period**

This reporting year was the eighth driest year for total precipitation since reporting began at this station in 2000.

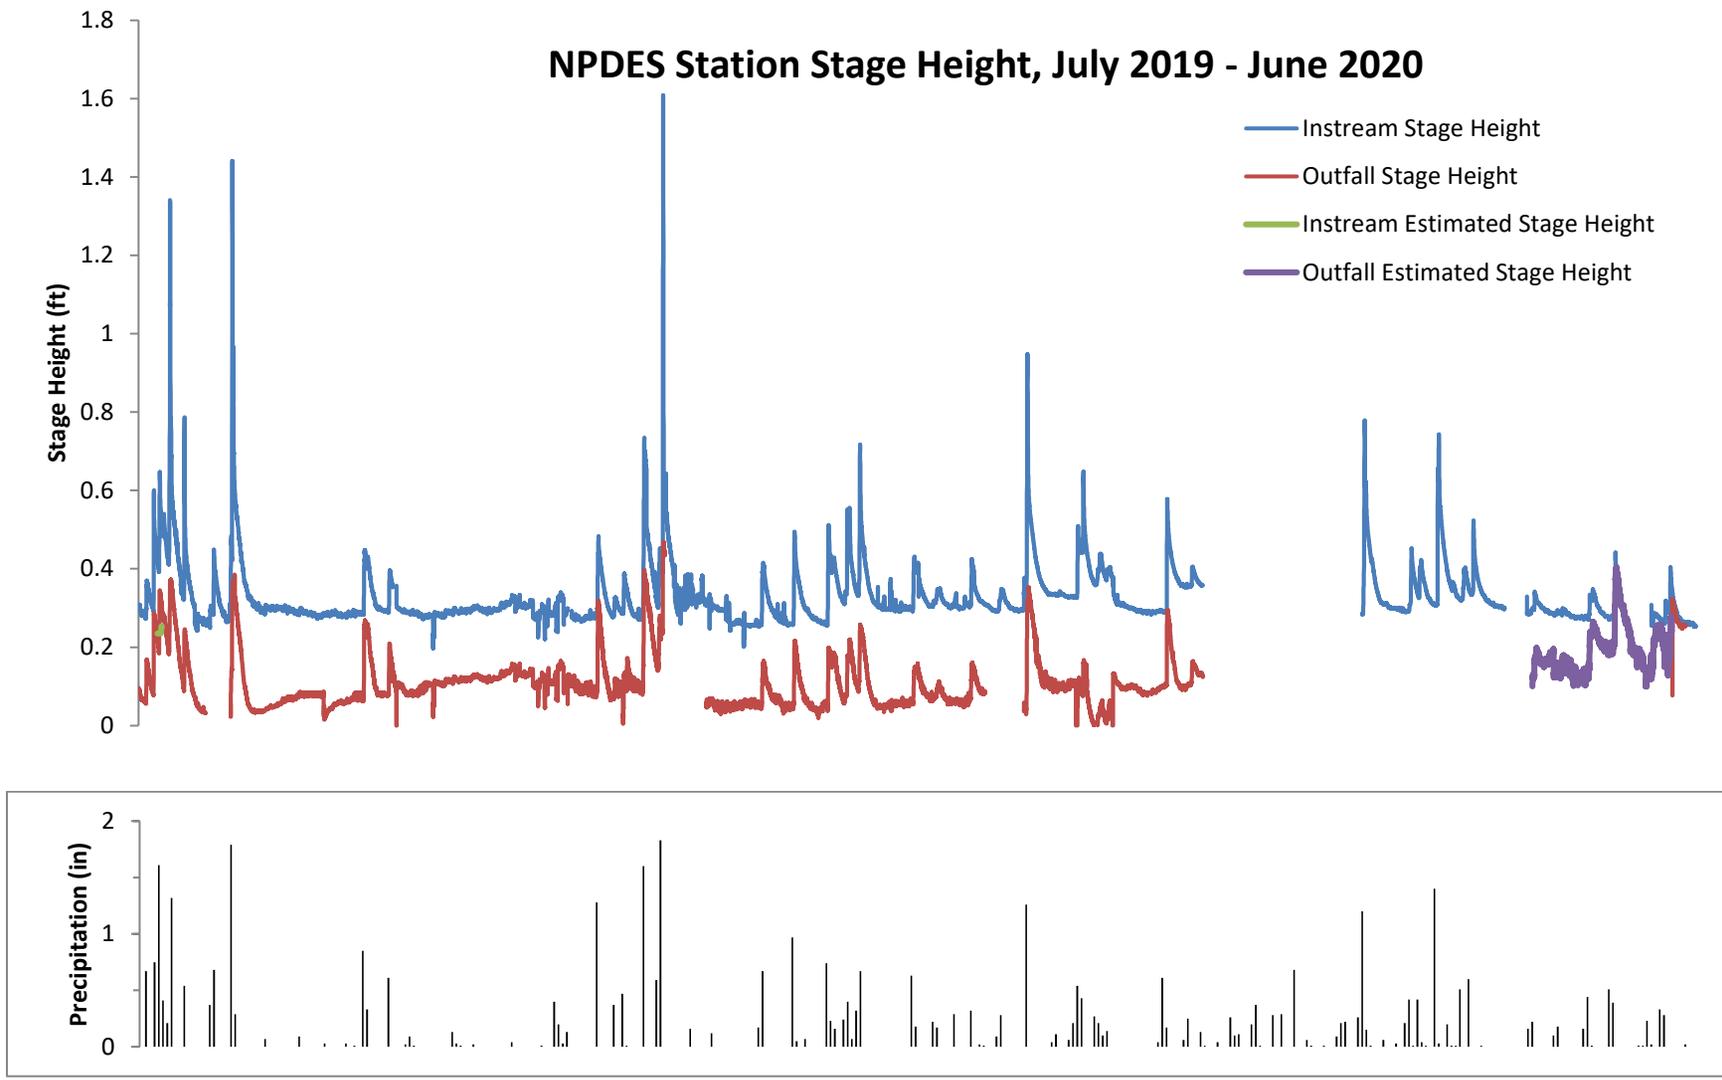
Figure 13: Stage Heights and Daily Precipitation for NPDES Monitoring Stations for the 2020 Reporting Year

Typical stage heights at the outfall monitoring station were approximately 0.1 feet, or 57 gpm. Peak discharge occurred on November 1, 2019 when a stage height of 0.47 feet was recorded. The resulting discharge was 1,432 gpm. Only one other storm event with a discharge greater than 1,000 gpm occurred during the reporting period.

Typical stage heights observed for the instream monitoring station were approximately 0.3 feet, or 275 gpm. Peak discharge at this monitoring station occurred during the same storm event as the outfall station. Peak observed stage height was 1.6 feet and peak discharge was 19,964 gpm. Peak observed discharge for most storm events at the instream station were less than 5,000 gpm; only three storm events had peak discharge measurements greater than 5,000 gpm.

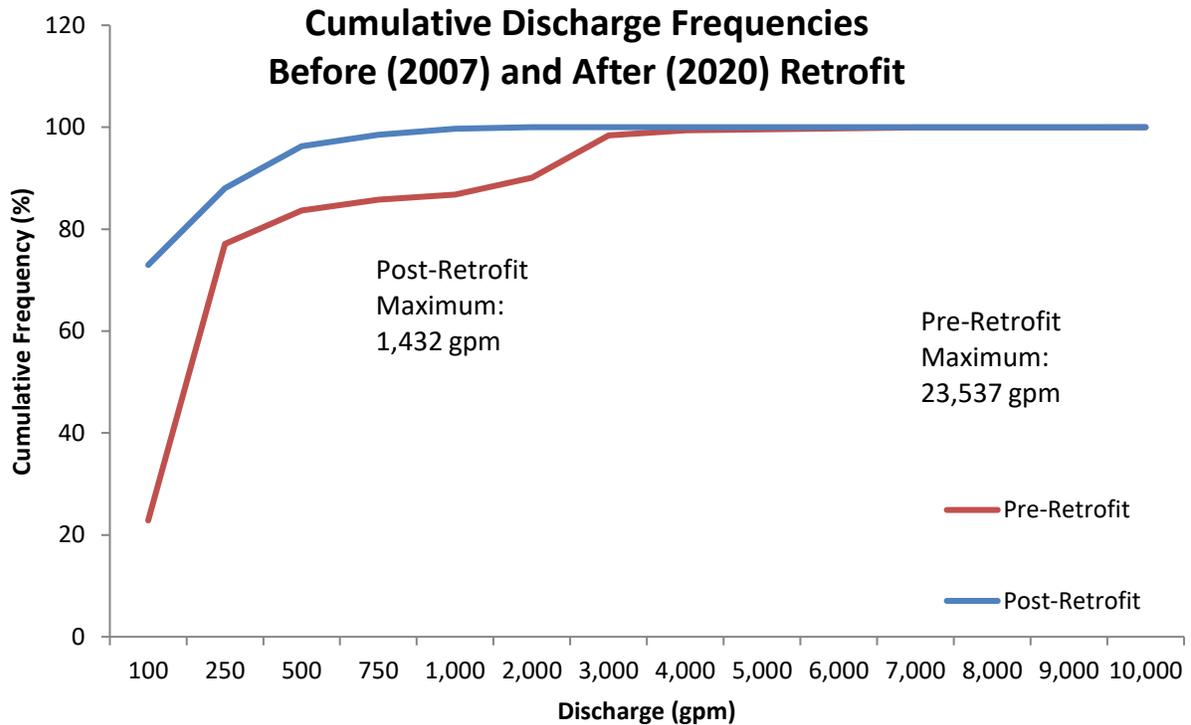
**Figure 15: Outfall Discharge Frequencies for FY2007 and FY2020**

discharge measurements were below or equal to 100 gpm. This contrasts with the pre-retrofit measurements where only 23% of measurements were below 100 gpm. 10% of all measurements in 2007 were greater than 2,000 gallons per minute, which are greater in magnitude than most of the highest discharges from post-retrofit years. It should also be noted that only 71% of the yearly discharge measurements were recorded due to the previously stated equipment problems at the outfall station.

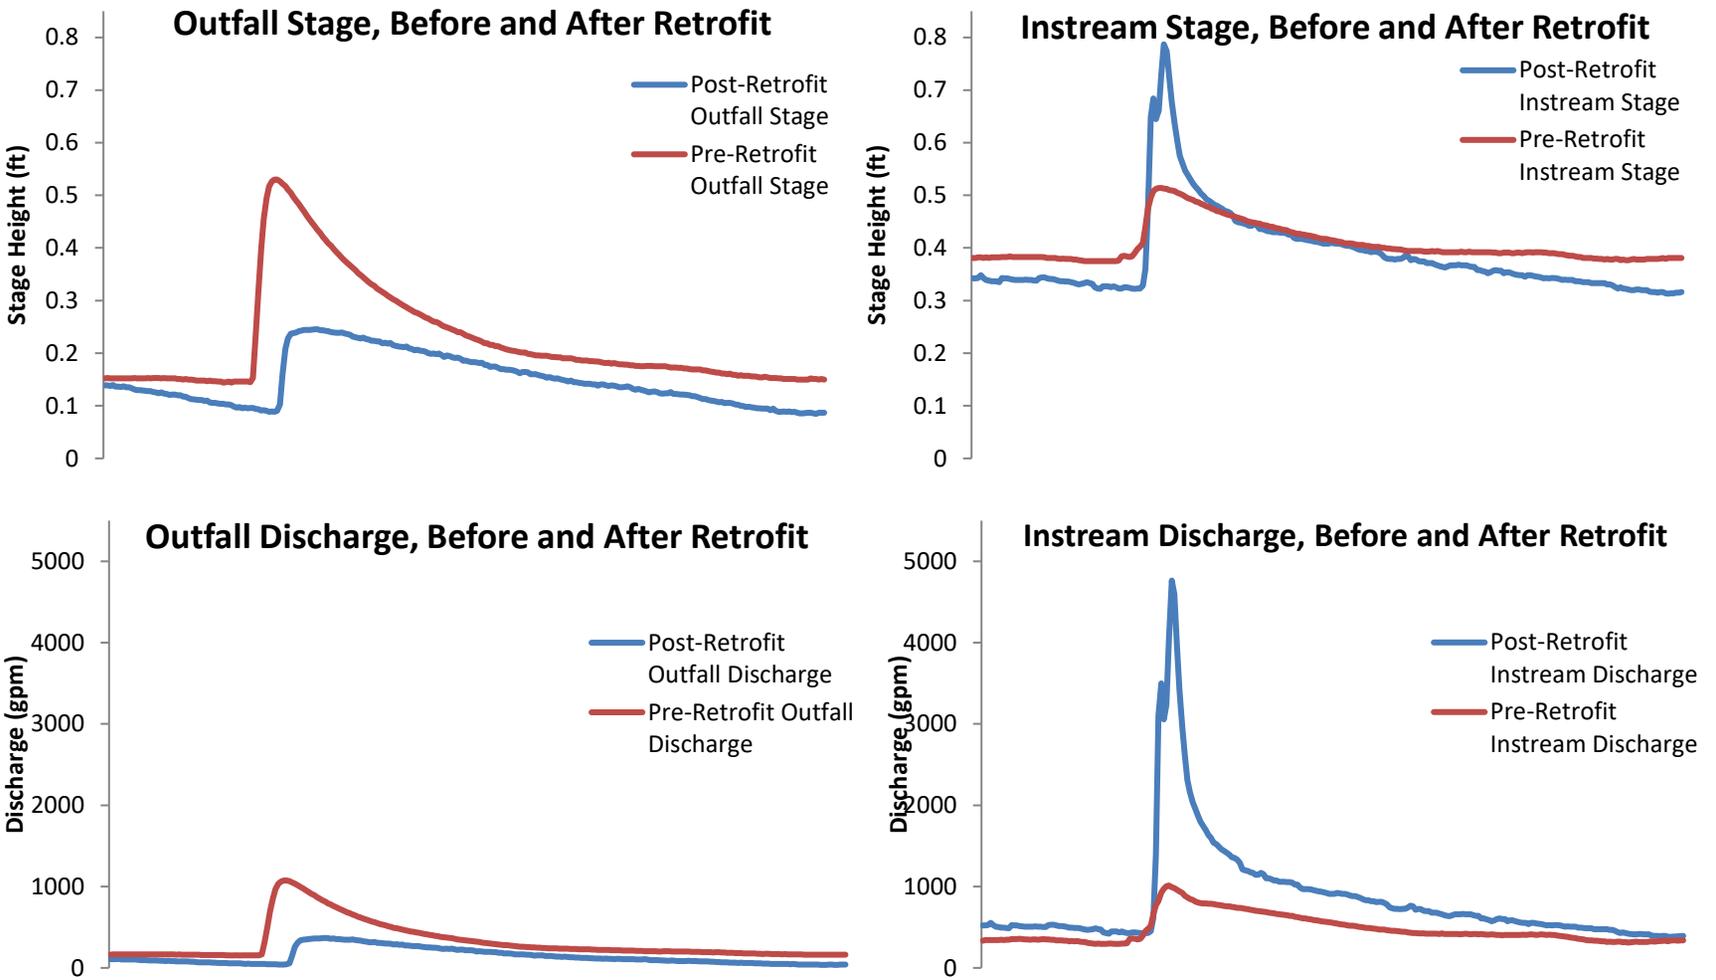
Figure 16: Characteristics of Analogous Storms Pre-Retrofit (7/23/2006, 0.39") and Post-Retrofit (7/11/2019, 0.54")

An examination of individual events on the hydrograph demonstrates the distinct mechanisms driving changes in cumulative frequencies. **Figure 16** represents two analogous storm events, one before and one after the stormwater retrofit, and a hydrological comparison therein. This figure contains hydrographs before and after retrofit for instream and outfall stage heights and discharges. Unlike previous years, which compared storm events with nearly identical precipitation totals, this comparison is of a slightly larger storm event to the same pre-retrofit storm. The pre-retrofit event had 0.39 inches of precipitation observed, while the post-retrofit event had 0.54 inches of precipitation observed. Despite the higher precipitation intensity and total, the ascending limb for the post-retrofit outfall station still had a lower slope and peak discharge than the hydrograph of the pre-retrofit outfall station. The outfall-to-instream station discharge ratio for the post-retrofit storm event averaged a 17% contribution, peaking at 25%, as was roughly the case for the overall discharge and separated stormflow for the reporting period. During the pre-retrofit storm, however, the outfall station contributed about 70% of the total instream discharge. The lesser contribution during the post-retrofit storm event is evident in the instream station hydrographs. Overall, longer baseflow recessions and lower peak discharges were observed with the current stormwater configuration.

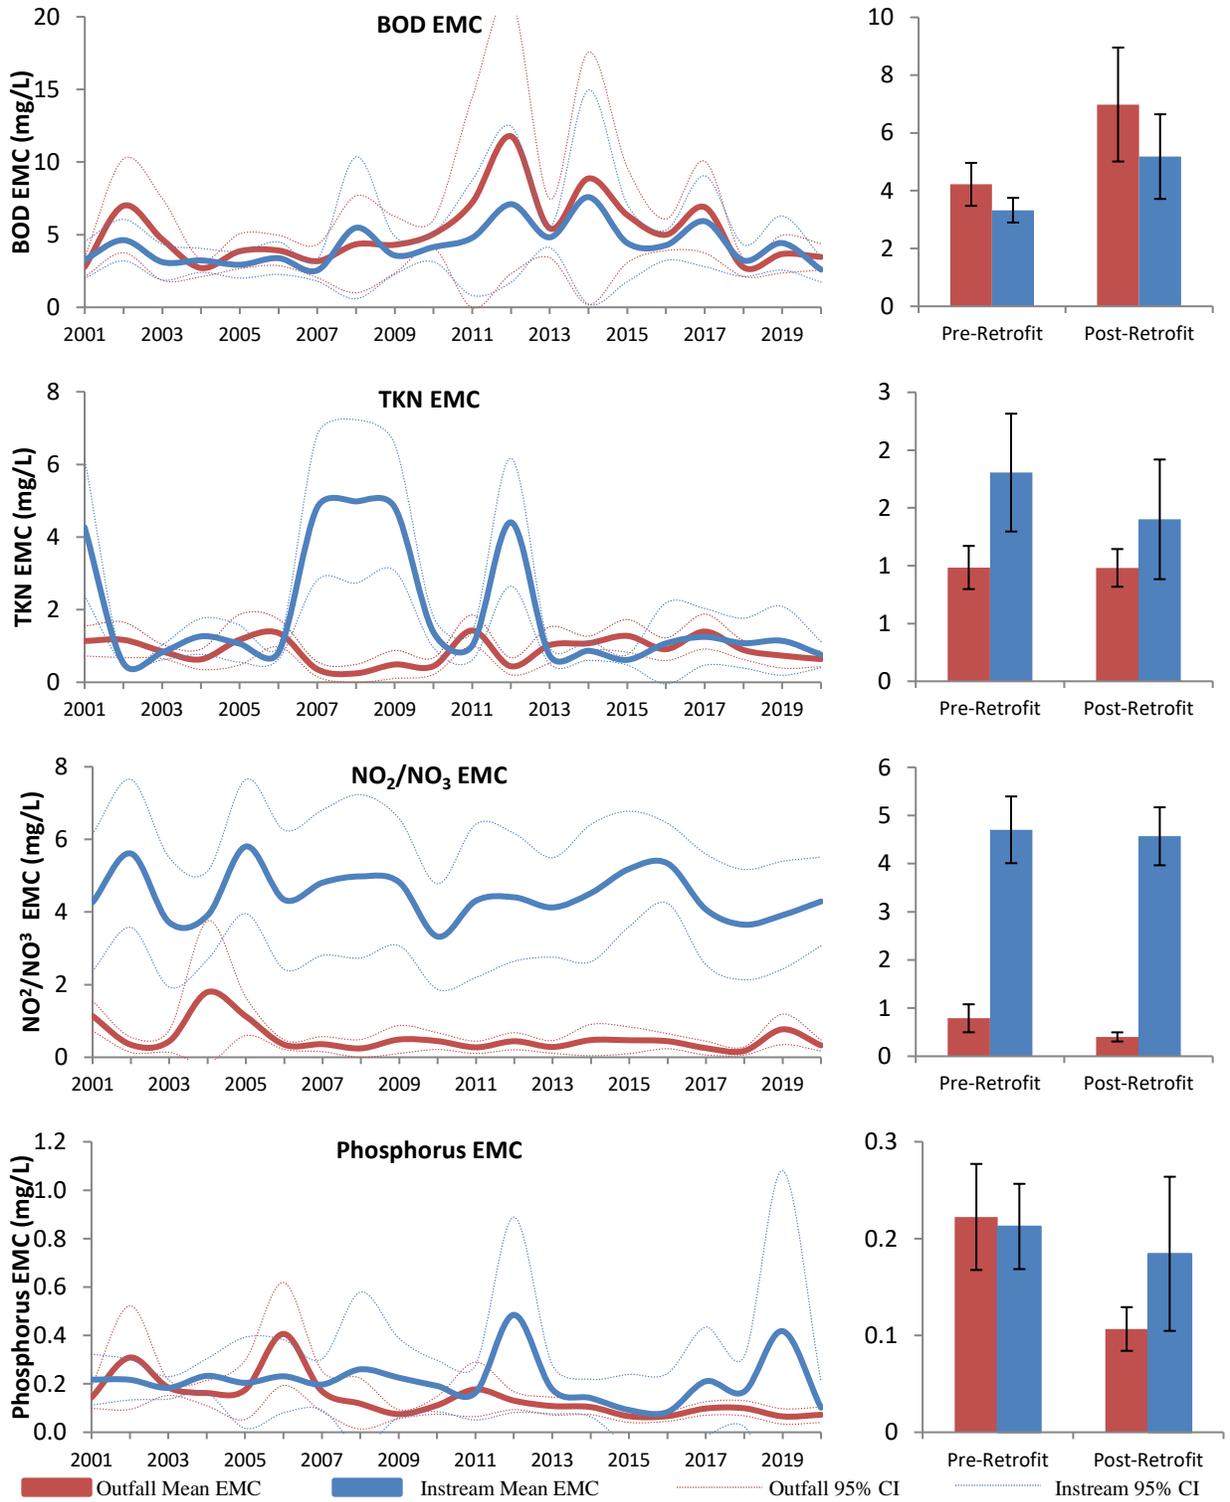
**Figure 19: EMC Values from 2001 – 2020 for BOD, TKN, NO<sub>2</sub>/NO<sub>3</sub>, and Phosphorus**

**Figures 19 and 20** present annual mean EMC values for eight analytes from reporting years 2001 through 2020. Also presented are mean EMC values before and after the stormwater retrofit. The only analyte with a significant observed difference between the outfall and instream stations consistently from 2001 to 2020 was nitrate/nitrite. The pre- and post-retrofit graph reinforces this difference. Though not all mean EMC values were significantly different for the three metals at the instream station, all EMC values for copper, lead, and zinc decreased at the outfall station after the retrofit. This is not unexpected, given the increased residence within the stormwater facility. Please note that a single outlying measurement in July 2014 caused a large increase in average zinc for that reporting year. The instream concentration increases over outfall for 2019 are due to the non-paired analysis. Seven storm events were measured for the instream station as opposed to only one for the outfall station.

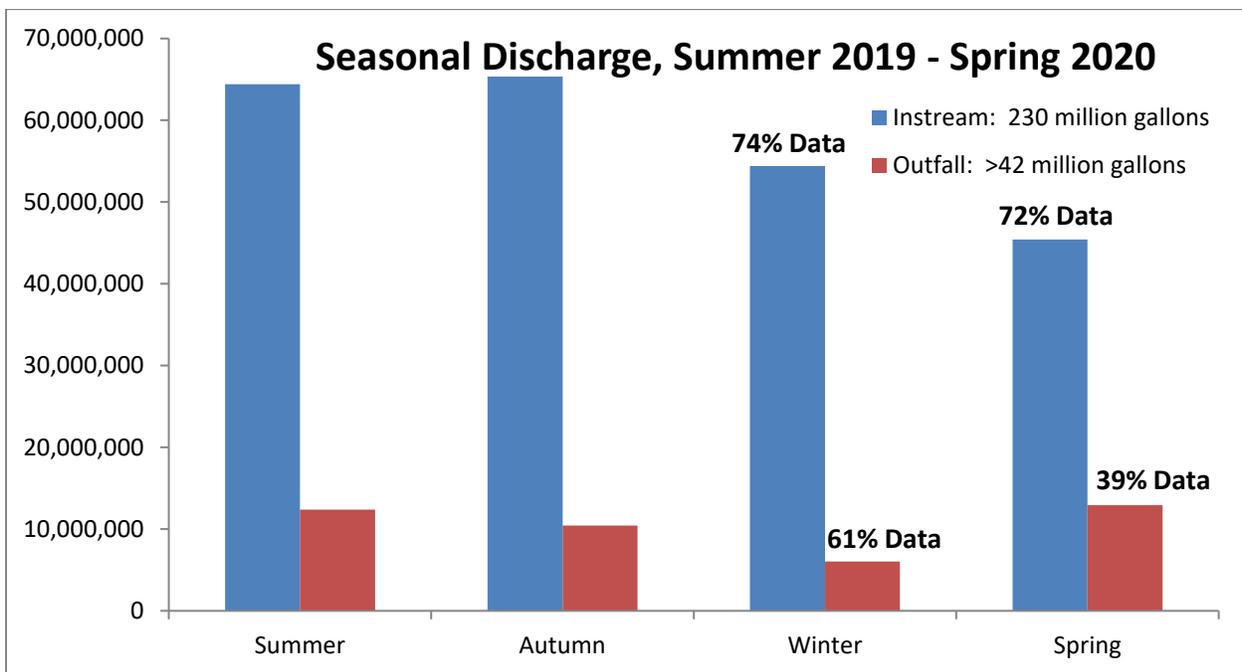
Figure 21: Seasonal Discharge for the 2020 Reporting Year

Apart from nitrates/nitrites at the outfall station, the largest loadings for all analytes were observed in either summer or autumn. This is expected, as the summer and autumn seasons had the greatest total discharge and precipitation of the reporting period. Unlike many years, seasonal loadings were relatively even, with only one loading (Autumn TSS) accounting for a majority (56%) of the annual loading across the four seasons. Additionally, unlike most years, several TPH samples at the outfall station were above detection limits, accounting for slightly elevated TPH loadings. Elevated (above detection) instantaneous TPH measurements were observed in samples at the outfall station from November 2019 through January 2020; this is unusual considering only very sporadic elevated measurements have been observed since 2000. The previous two reporting periods had at least one elevated sample for TPH also. It should be noted that a gas station and an agricultural equipment business are both adjacent to the outfall station. The agricultural equipment business was issued a Class I Exterior Washwater Permit in 2017, which allows exterior-only equipment washwater to be discharged at a rate of less than 500 gallons per week. Typically, the outfall station correlates to values estimated for the instream station. It should be noted that for loading calculations, the detection limit concentrations were used instead of zero values with samples below detection. Therefore, actual loadings are likely less than values provided below.

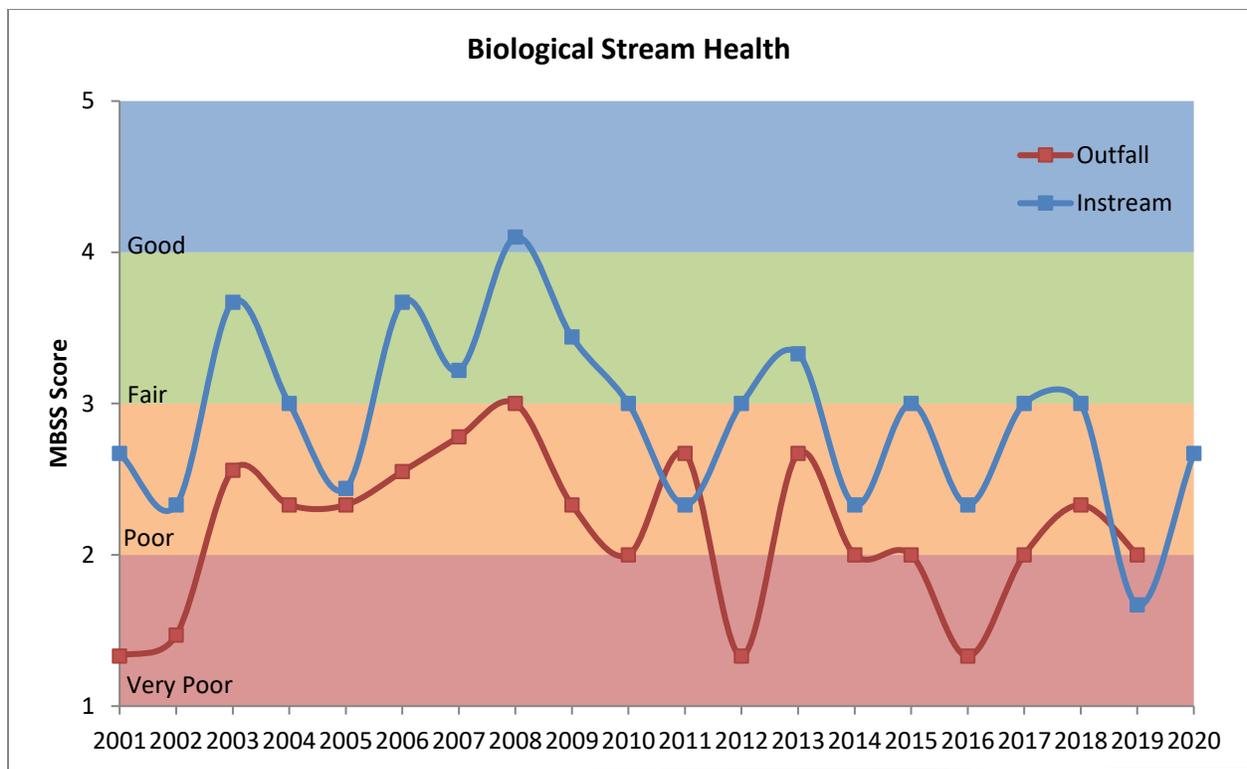
**Figure 22: Macro-Invertebrate IBI Analysis 2001 – 2020**

**Figure 22** presents these scores annually from 2001 through 2020. The trends of both stations appear to be correlative throughout this time period. On average, the score for the instream station remains 0.8 higher than that of the outfall station. The average score for the outfall station is 2.2, which is rated as poor biological health according to MBSS guidelines. The average score for the instream station is 2.9, which is just below the boundary between poor and fair biological health according to MBSS guidelines. The outfall station was not sampled this reporting year due to delays because of COVID-19 and nesting geese. Historically, the outfall station has never received any score that was not poor or very poor. This is usually due to a lack of any intolerant taxa and a large percentage of Chironomidae. The instream reach score increased from the previous year. While the total number of taxa was only slightly higher than the previous year, the percentage of Chironomidae in the sample decreased while the number of EPT taxa, particularly Ephemeroptera, increased, resulting in a higher score than the previous year. Both stations appear to be relatively intolerable for sensitive species.

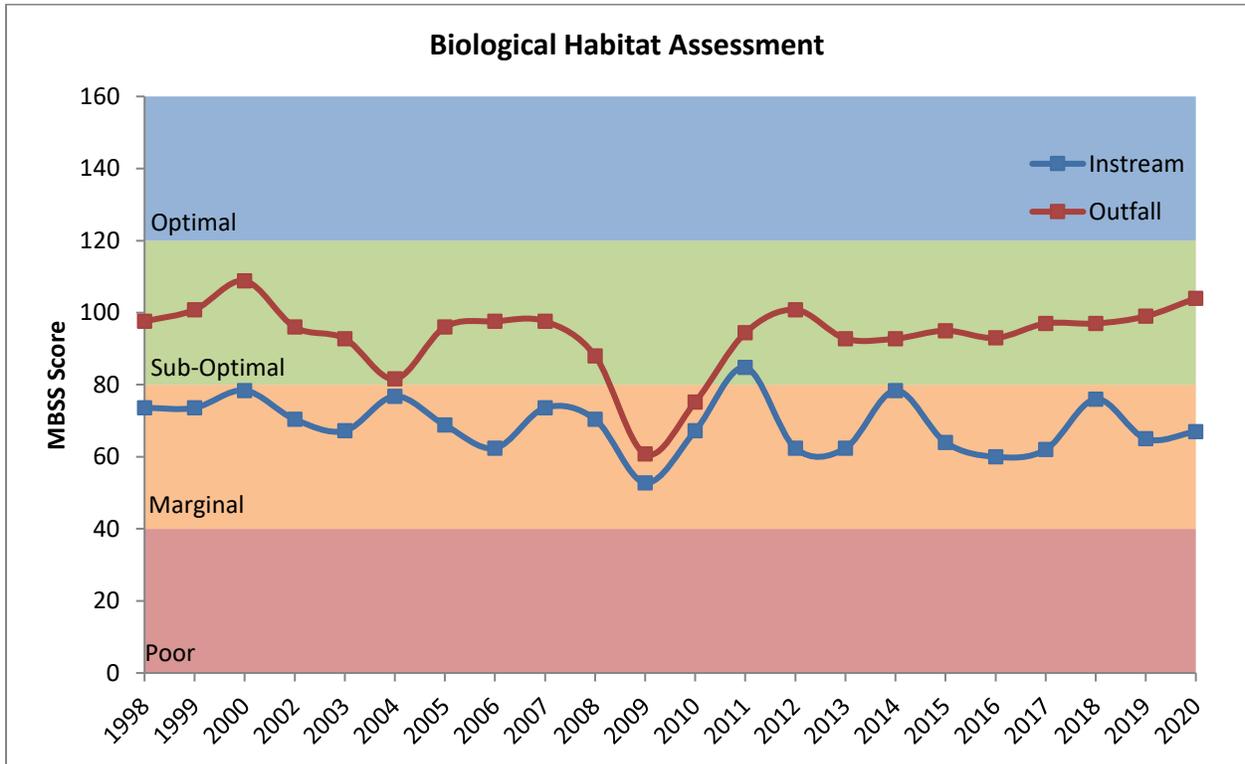
**Figure 23: Comparison of NPDES Station Habitat 1998 – 2020 (Excluding 2001)**

The biological habitat assessment results for each station are summarized in **Table 23**. The scores are out of a maximum 160 points, based on the eight parameters in **Table 15**. Overall, the quality of biological habitat at the instream station remains higher than at the outfall station, with overall habitat scores of 104 and 67, respectively. From 1998 through 2020 (excluding 2001), as shown in **Figure 23**, the mean habitat scores of the instream station and outfall station were 94 and 69, respectively. The 2020 reporting year was a typical year for both stations; the instream station scored 10 points higher, but the outfall station scored two points below average, with a considerable decrease in the embeddedness metric. The weakest parameters for both stations are embeddedness, particularly for the outfall station, at which almost the complete stream segment was embedded with silt. Both stations however, improved their ratings for shading and trash.

It should be noted that the habitat assessment is a qualitative assessment only. Variations in scores may be a result of inconsistencies in assessor scoring methodology, among other factors. To show a general relationship between the habitat and biological scores, these data have been plotted for the outfall and instream stations in **Figures 24 and 25**, respectively. These are plotted on each assessment’s overall scoring range. As is typical, lower habitat quality is correlated with lower instream biological integrity. Both stations appear to have a one- to two-year period of latency between habitat and biological changes. These relationships, however, are impacted by a small sample size and the subjectivity of the habitat assessment. The certainty of
