# Lower North Branch Patapsco River Watershed Characterization Plan

Spring 2016

Prepared by  
Carroll County Bureau of Resource Management

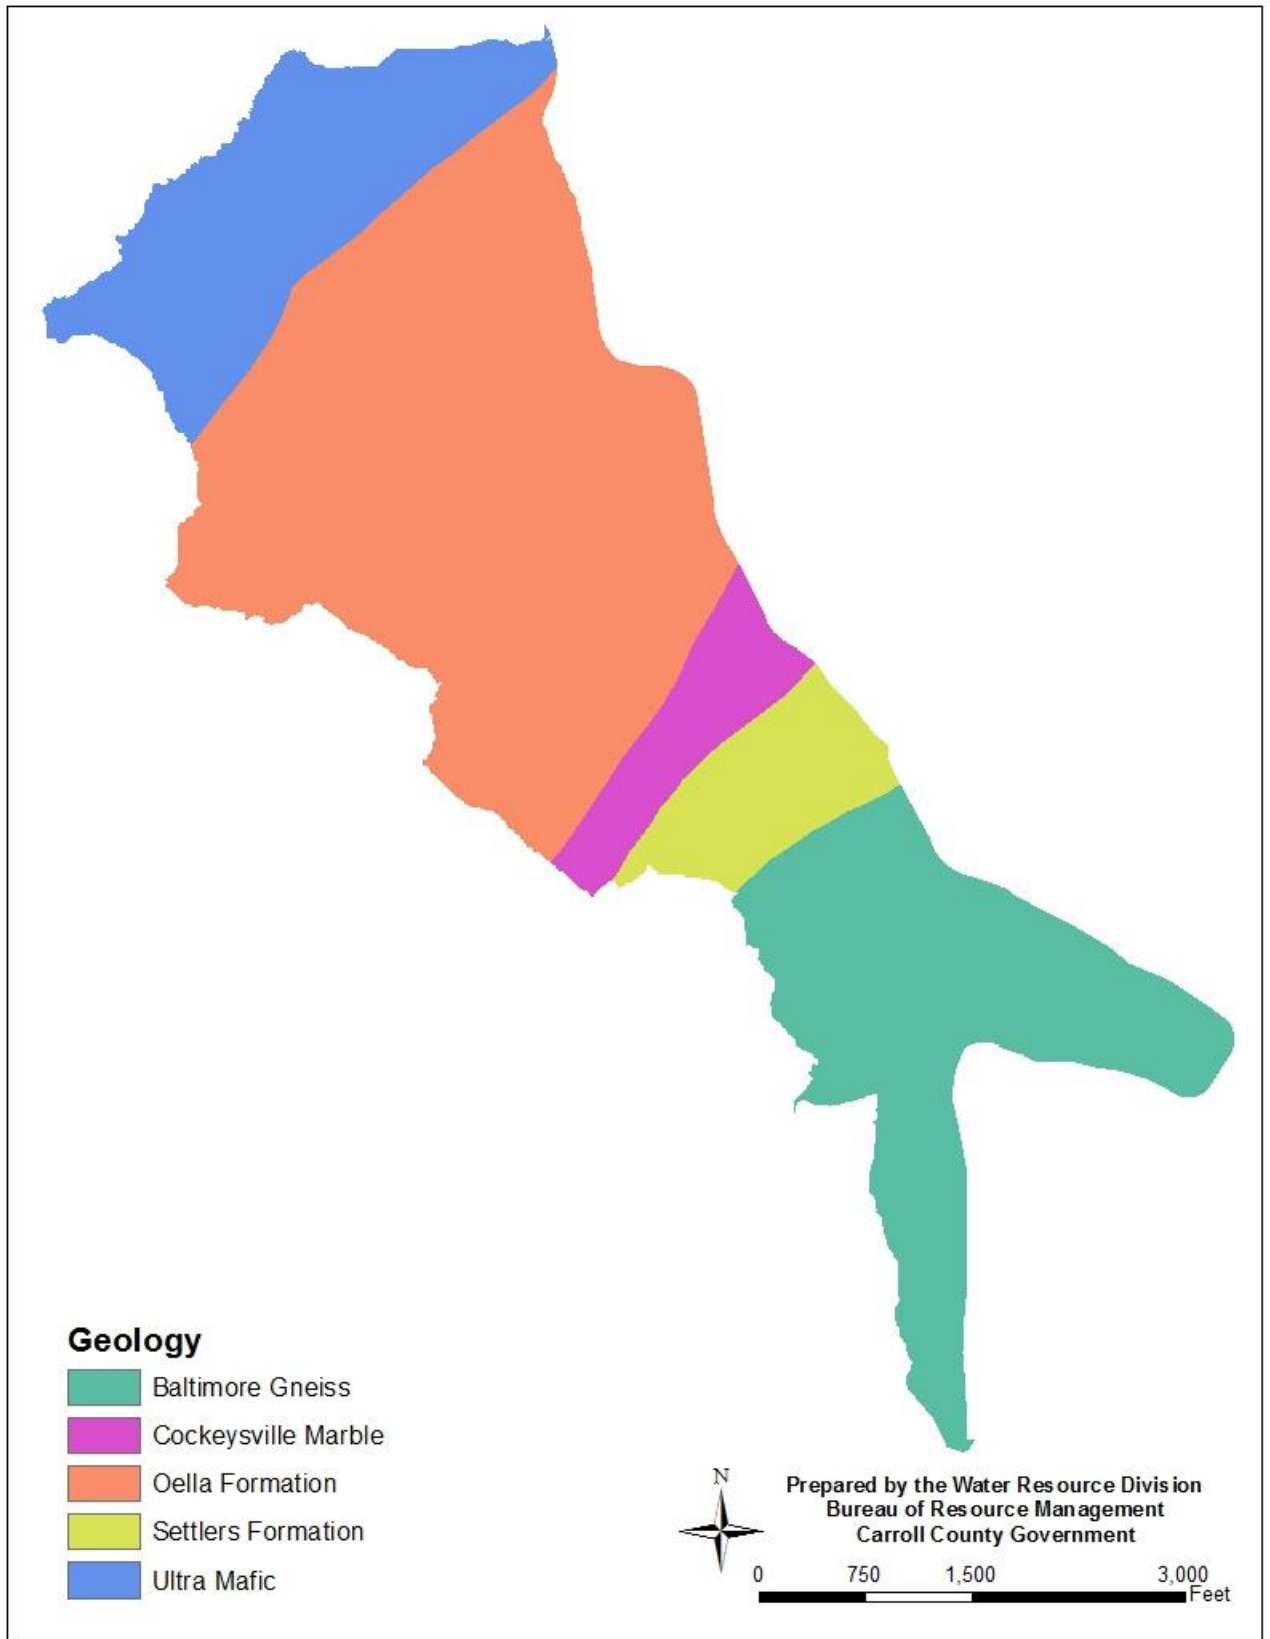
Figure 2-3: LNB Patapsco Watershed Geology

A simplified map of the geologic units within the LNB Patapsco Watershed is shown in Figure 2-3. The types of geological formations within a watershed can impact and alter the chemical composition of surface and groundwater as well as the rate of recharge to groundwater. The underlying geology also determines soil formation. Intrinsically, the underlying geology can be closely correlated to the water quality within that system by affecting the buffering capacity.

The LNB Patapsco Watershed, like most of the Piedmont, consists of metamorphic rock—mainly crystalline schists. These formations have moderate infiltration rates with average recharge to groundwater.
