LANGDON STORMWATER FACILITY

2022 ANNUAL REPORT

**CARROLL COUNTY, MARYLAND
NATIONAL POLLUTANT DISCHARGE ELIMINATION SYSTEM (NPDES)
MUNICIPAL SEPARATE STORM SEWER SYSTEM (MS4)
PERMIT**

2022 NPDES MS4 Permit Annual Report

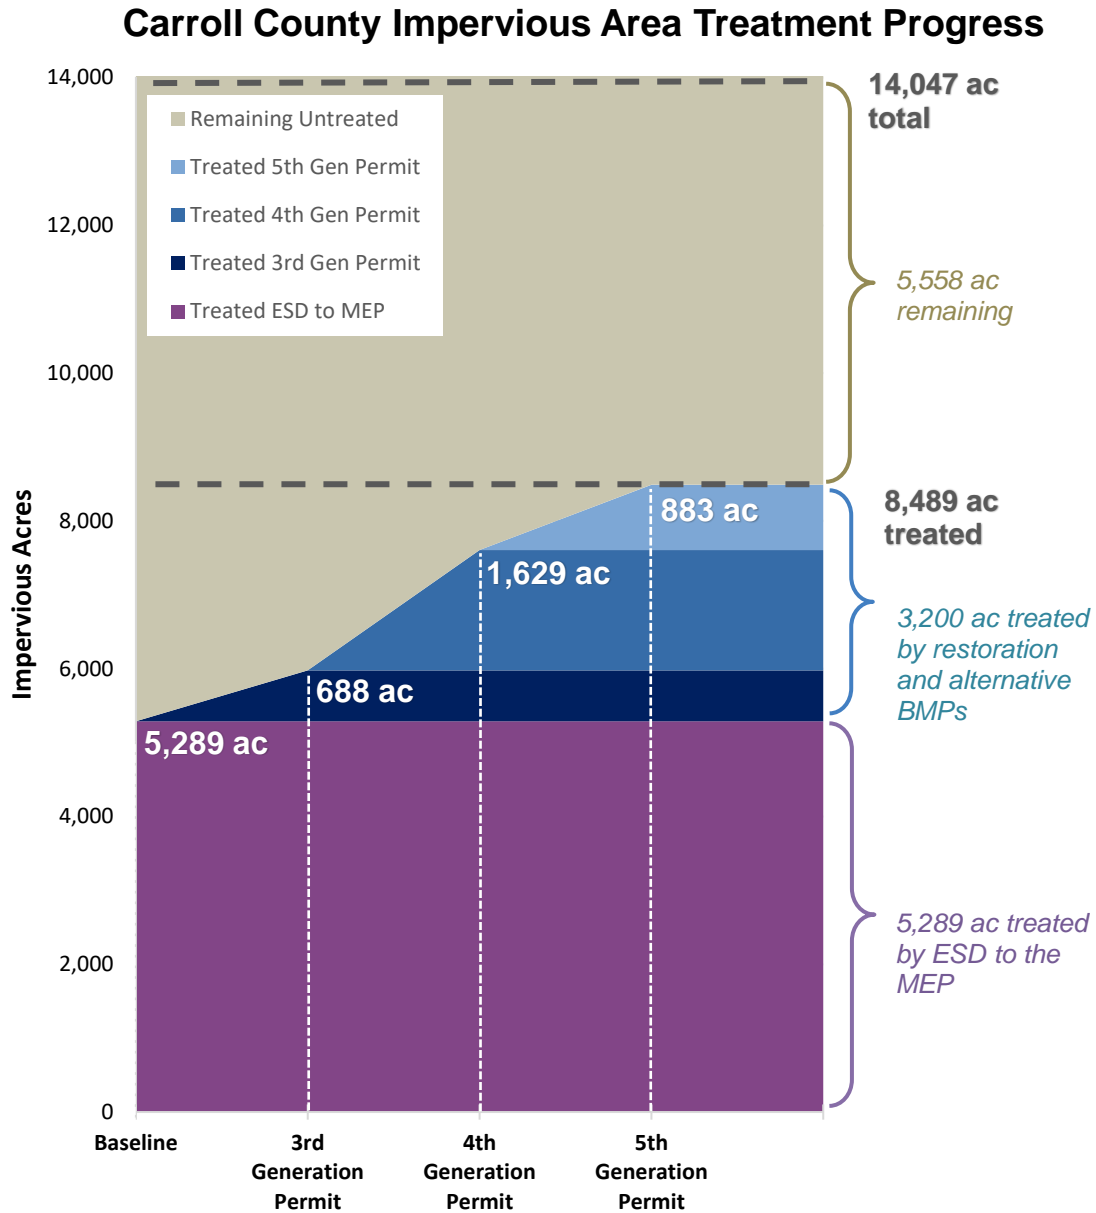
Figure 1: Carroll County Permit Impervious Surface Analysis

Activities associated with treatment efforts taken during each permit term are listed in **Table 10**. Total impervious acres treated as of June 30, 2022, are 3,200. The County has met both the third- and fourth-generation permit requirements and has achieved 10.9% impervious area treatment toward the future requirement of the fifth-generation permit.

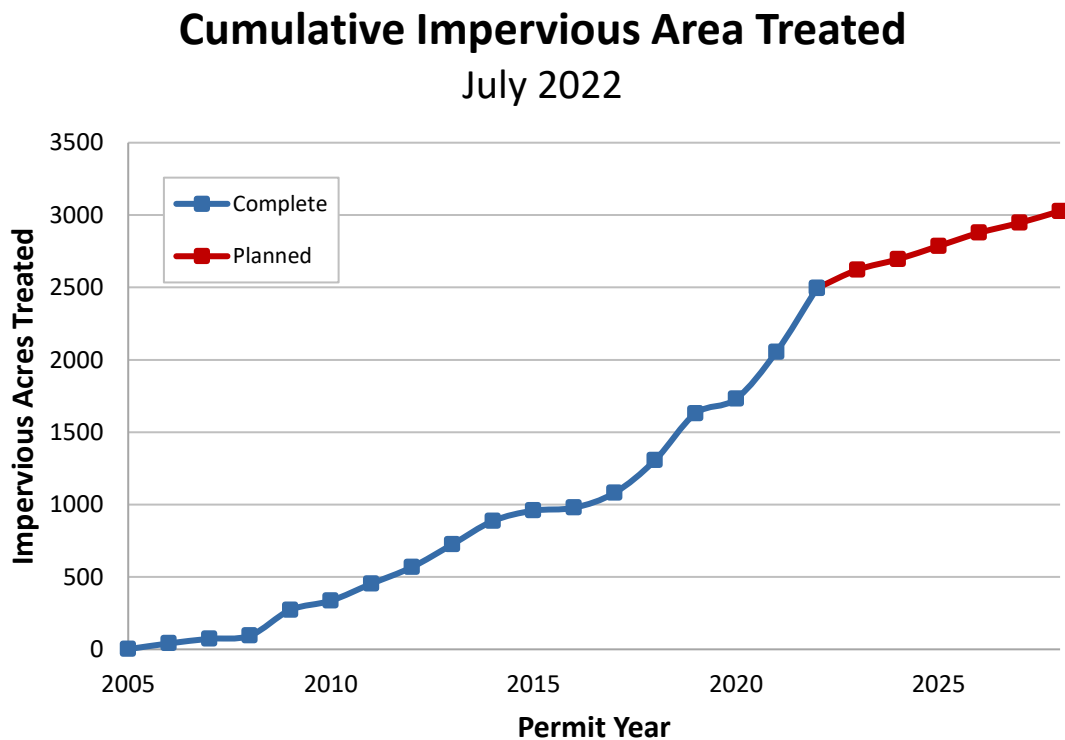
Figure 5: Impervious Surface Acres Treated: Projects Completed and Planned for Current (4th Generation) and Future (5th Generation) Permits

Figure 5 depicts the number of acres restored (blue) and acres in planning and design phases (red) for projects to restore impervious surfaces to the mitigation projects. This graph provides an excellent representation of the level of true watershed restoration accomplished through the County's restoration efforts.

Projects planned or in design that are scheduled for completion between 2023 and 2028 are shown in red and will address future impervious acre and nutrient reduction requirements anticipated in the fifth-generation permit. To date, these projects reflect approximately 531 acres of restoration. These acres keep the County moving in a positive direction for addressing both untreated impervious acreage and local and Chesapeake Bay nutrient reduction requirements.

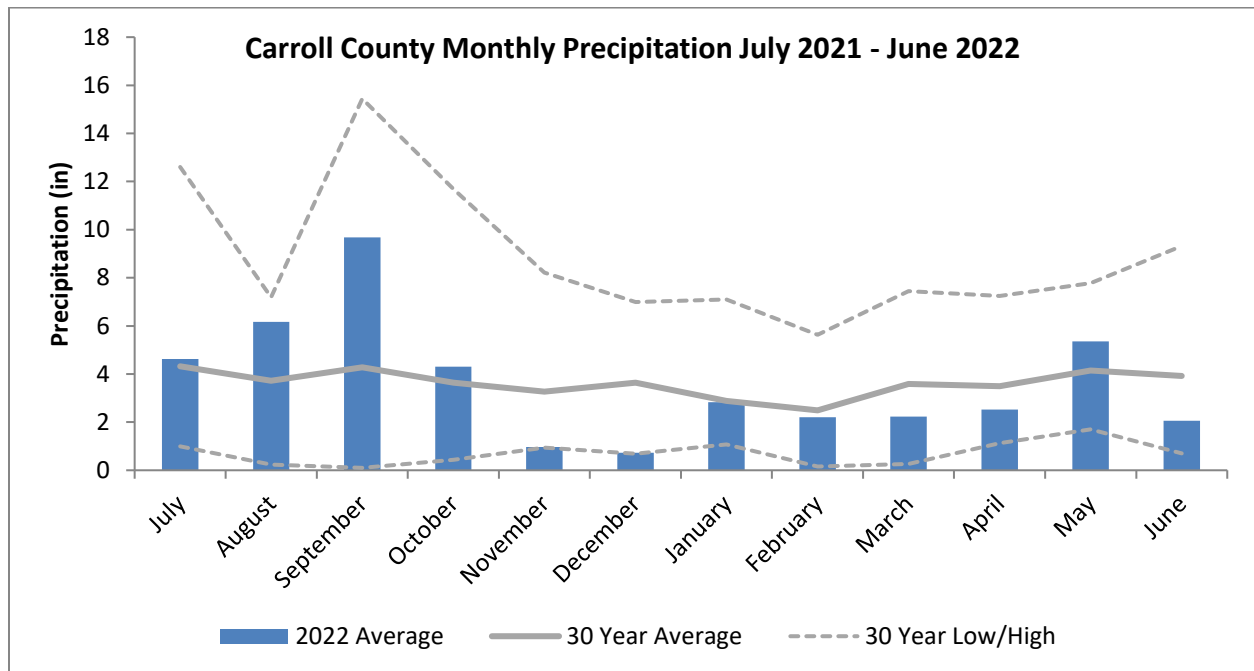
Figure 10: Monthly Precipitation Summary for the 2022 Reporting Period

Monthly precipitation data for the 2022 reporting year are summarized in **Figure 10**. The 30-year monthly precipitation average and high/low extremes are also included. The total precipitation for the reporting period was 43.69 inches, a 0.29-inch surplus from the mean yearly total. Relative to mean monthly precipitation totals, September 2021 was the wettest month, with a surplus of 5.4 inches, while December 2021 was the driest month, with a deficit of 2.91 inches. This reporting year was the tenth driest year for total precipitation since reporting began at this station in 2000.

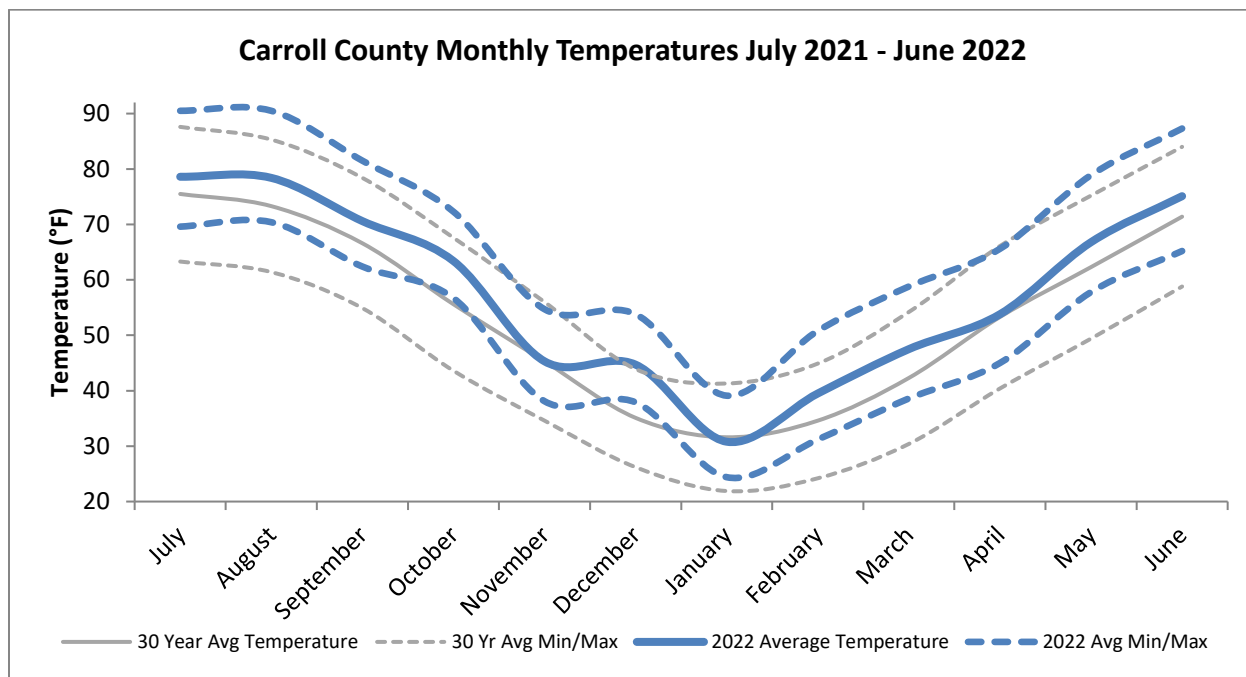
Figure 11: Monthly Temperature Summary for the 2022 Reporting Period

Monthly temperature data for the 2022 reporting year are summarized in **Figure 11**. The 30-year monthly average temperatures and high/low temperature extremes are included for reference. Overall, the reporting period experienced an annual average temperature of 57.9°F, which was 4.0°F warmer than the 30-year annual average. One month was cooler than average, which was 0.8°F cooler than normal. Eleven months were warmer than or equal to average temperatures, with a mean of 4.4°F warmer than normal. October 2021 and December 2021 were the warmest relative to each month's respective average temperatures with a 7.8°F and 9.6°F increase above normal temperatures. It should be noted that warmer-than-average daily minimum temperatures were observed for every month; the mean for this reporting period was 7.4°F above average.

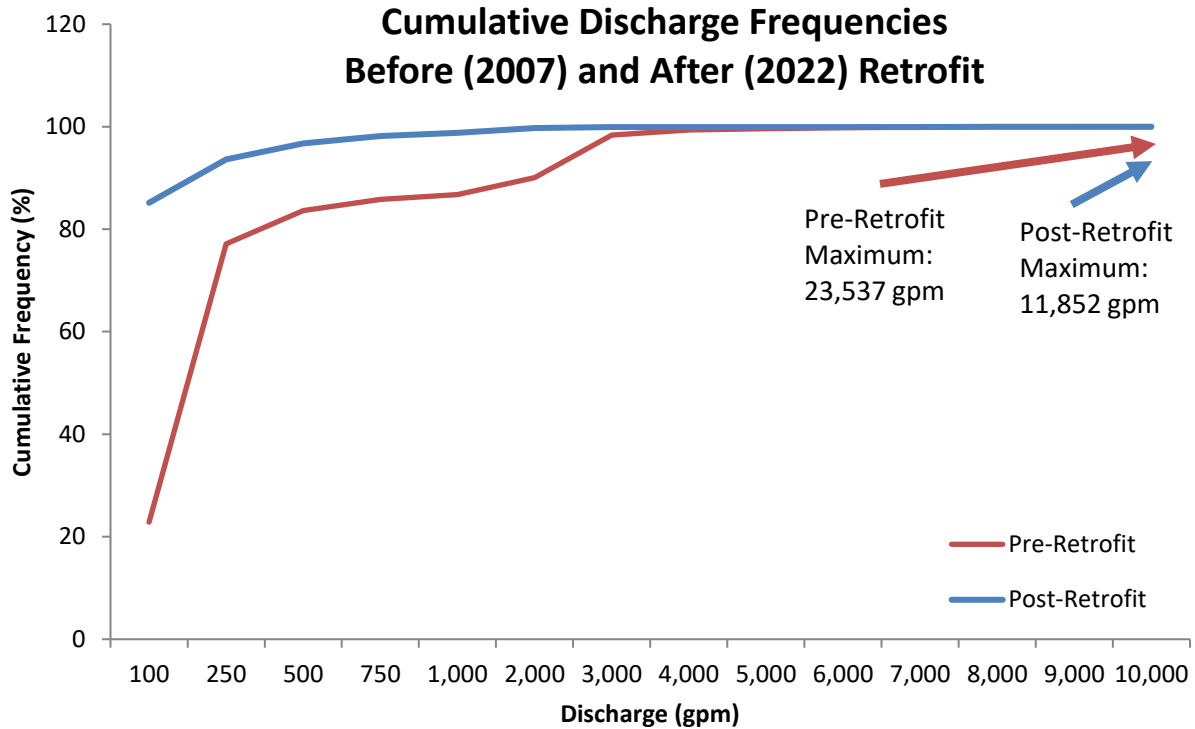
Figure 14: Outfall Discharge Frequencies for FY2007 and FY2022

To assess the impact of the retrofit on hydrology, cumulative discharge frequencies at the outfall monitoring station were compared for the 2007 (pre-retrofit) and 2022 (post-retrofit) reporting years (**Figure 14**). The maximum discharge during the pre-retrofit period is typically an order of magnitude higher than that of the post-retrofit period. The maximum discharge in 2007 was 23,537 gpm, while the maximum in 2022 was 11,852 gpm. The 2022 maximum was the result of a storm event where 3.64 inches of precipitation was observed over 18.5 hours. The next highest peak discharge for any other storm event was 3,470 gpm. In many reporting years, the maximum recorded discharge at the outfall station is less than 2,000 gpm. During this reporting period, 85% of all discharge measurements were below or equal to 100 gpm, similar to most post-retrofit years. This contrasts with the pre-retrofit measurements where only 23% of measurements were below 100 gpm. In 2007, 10% of all measurements were greater than 2,000 gpm, which was greater in magnitude than most of the highest discharges from post-retrofit years.

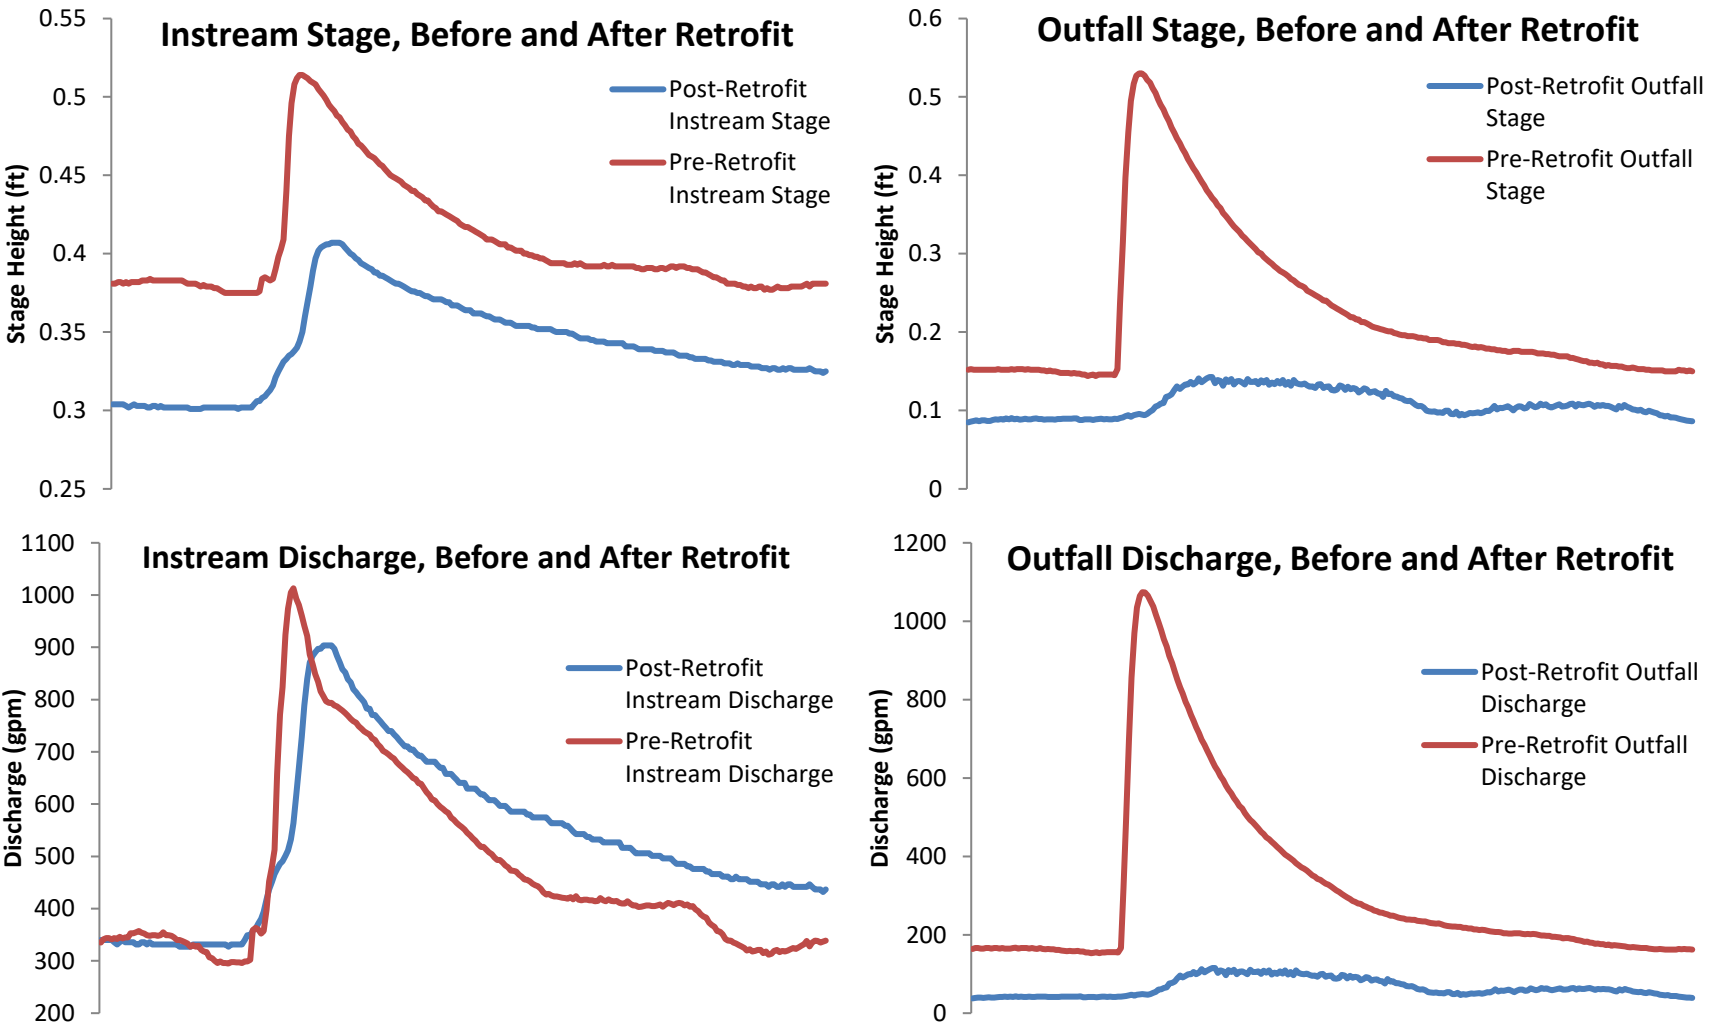
Figure 15: Characteristics of Analogous Storms Pre-Retrofit (7/23/2006, 0.39") and Post-Retrofit (3/9/2022, 0.46")

An examination of individual events on the hydrograph demonstrates the distinct mechanisms driving changes in cumulative frequencies. **Figure 15** represents two analogous storm events, one before and one after the stormwater retrofit, and a hydrological comparison therein. This figure contains hydrographs before and after retrofit for instream and outfall stage heights and discharges. The pre-retrofit event had 0.39 inches of precipitation observed, while the post-retrofit event had 0.46 inches of precipitation observed. The ascending limb for the post-retrofit outfall station had a lower slope and peak discharge than the hydrograph of the pre-retrofit outfall station. The outfall-to-instream station discharge ratio for the post-retrofit storm event averaged a 12% contribution, peaking at 16%. This was slightly less than the overall discharge and separated stormflow for the reporting period; however, this was a very small storm event. During the pre-retrofit storm, however, the outfall station contributed about 70% of the total instream discharge. The lesser contribution during the post-retrofit storm event is evident in the instream station hydrographs. Overall, longer baseflow recessions and lower peak discharges were observed with the current stormwater configuration.

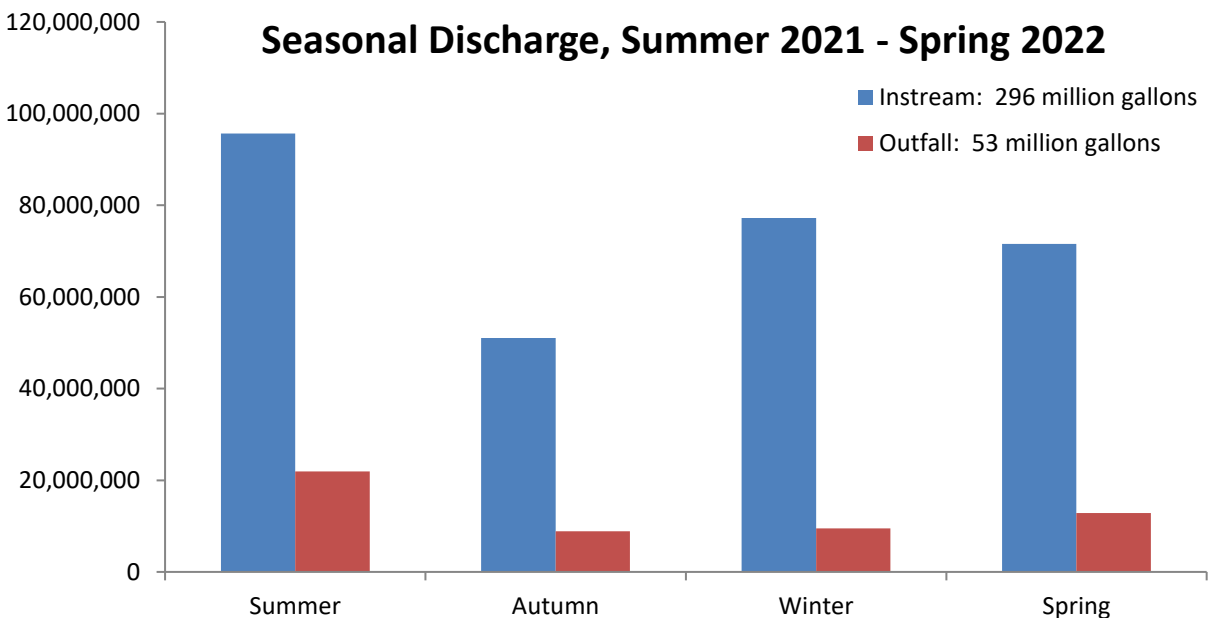
Figure 20: Seasonal Discharge for the 2022 Reporting Year

The largest loadings for most analytes were observed in summer 2021. This is expected as the summer 2021 season had the largest observed total discharge for both stations during the reporting period. At the instream station, TKN and zinc loadings during spring 2022 were slightly higher than summer 2021. Unexpectedly, the summer 2021 nitrate-nitrite loading was the lowest of all four seasons during this reporting year. This can be attributed to the uncharacteristically low observed EMC values for both storm events during that season. At the outfall station, the largest seasonal loadings were in summer 2021 for all analytes except nitrate-nitrite and copper. Nitrate-nitrite loadings for autumn 2021 were three pounds higher than those observed in summer 2021. For copper, spring 2022 had the largest observed loading. A single outlying storm event had an elevated EMC during that season. Seasonal loadings, while fairly typical, were spready bimodally with generally the lowest loadings occurring in autumn 2021 and winter 2022; autumn 2021 accounted for the smallest loadings with only around 10% of the total yearly loading being observed during this period for most analytes. No samples were observed above detection limits for TPH during this reporting period. Only very sporadic elevated measurements have been observed since 2000. It should be noted that a gas station and an agricultural equipment business are both adjacent to the outfall station. The agricultural equipment business was issued a Class I Exterior Washwater Permit in 2017, which allows exterior-only equipment washwater to be discharged at a rate of less than 500 gallons per week. Typically, the outfall station correlates to values estimated for the instream station. It should be noted that for loading calculations, the detection/reporting limit concentrations were used instead of zero values with samples below detection. Therefore, actual loadings are likely less than values provided below.

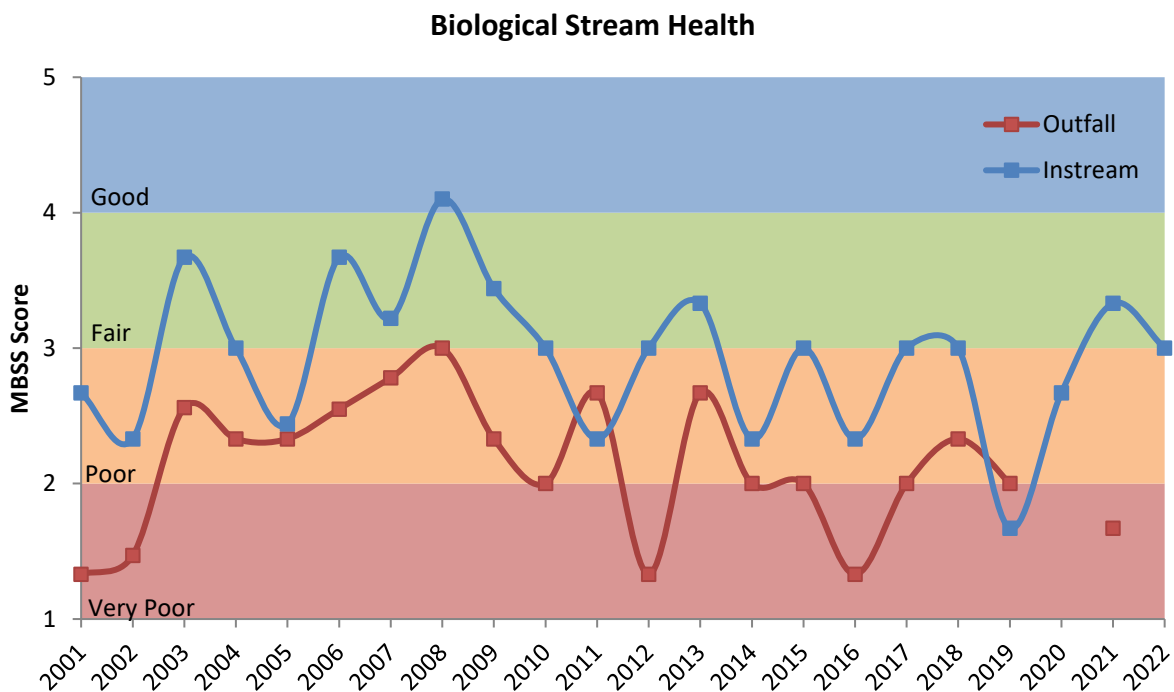
Figure 21: Macro-Invertebrate IBI Analysis 2001 – 2022

station in a typical year is 2.1, which is rated as poor biological health according to MBSS guidelines. The average score for the instream station is 2.9, which is just below the boundary between poor and fair biological health according to MBSS guidelines. Historically, the outfall station has never received any score that was not poor or very poor. This is usually due to a lack of any intolerant taxa and a large percentage of Chironomidae. The instream reach score had increased over the previous two years but decreased slightly this year. Two metrics decreased from the previous year. The total number of taxa identified dropped from 26 to 21, decreasing the score from a 5 to a 3 for that metric. Additionally, the percentage of intolerant taxa decreased from 15% to 11%, decreasing the score from a 3 to a 1. The only metric that increased this year was percent clingers, which increased from 55% to 82%. Both stations appear to still be relatively intolerable for sensitive species.

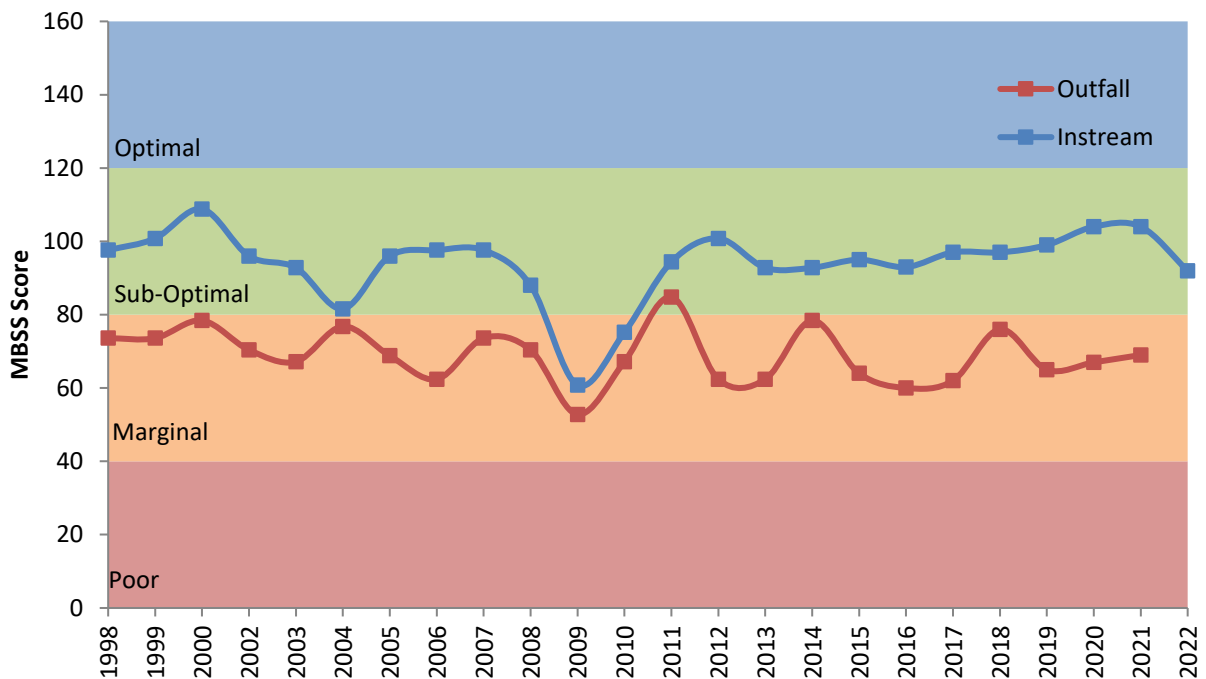
Figure 22: Comparison of NPDES Station Habitat 1998 – 2022 (Excluding 2001)

The biological habitat assessment results for the instream station are summarized in **Table 22**. The scores are out of a maximum 160 points, based on the eight parameters in **Table 15**. Overall, the quality of biological habitat at the instream station has been higher than at the outfall station in the past. From 1998 through 2022 (excluding 2001), as shown in **Figure 22**, the mean habitat scores of the instream station and outfall station were 94 and 69, respectively. For the 2022 reporting year, the instream station scored 2 points below average. The weakest parameters for the instream station were velocity/depth diversity, pool/glide/eddy quality, and riffle/run quality, resulting in marginal scoring for this year. For this reporting year, more trash was observed at the instream station than in recent years, resulting in a sub-optimal score. Over the last several years for both stations, improvements in the shading and trash ratings have offset the decreasing habitat and embeddedness scores resulting in relatively stable overall habitat scores.

It should be noted that the habitat assessment is a qualitative assessment only. Variations in scores may be a result of inconsistencies in assessor scoring methodology, among other factors. To show a general relationship between the habitat and biological scores, these data have been plotted for the outfall and instream stations in **Figures 23 and 24**, respectively. These are plotted on each assessment’s overall scoring range. As is typical, lower habitat quality is correlated with lower instream biological integrity. Both stations appear to have a one-to-two-year period of latency between habitat and biological changes. These relationships, however, are impacted by a small sample size and the subjectivity of the habitat assessment. The certainty of
