**SUPPLEMENTAL WATERSHED PLAN No. 2
and Environmental Assessment for
Rehabilitation of Piney Run Dam
Piney Run Watershed
Carroll County, Maryland**

Prepared By:
U.S. Department of Agriculture - Natural Resources Conservation Service

April 2025

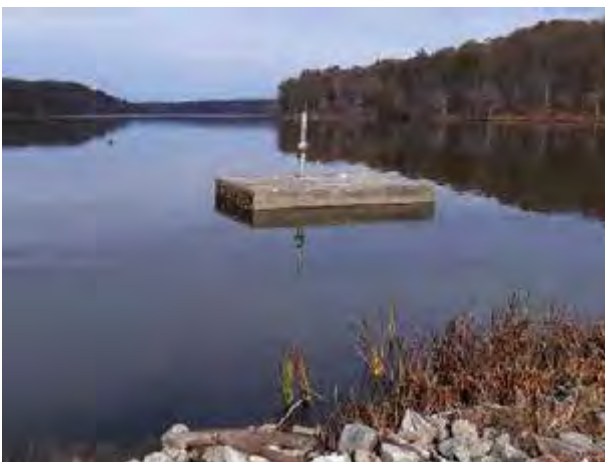
The spillway conduit, inlet structure, and impact basin were inspected visually and via camera in 2019 and are generally in good condition. The fall protection safety rail for the inlet structure ladder should be either re-secured to the ladder or replaced and the bottom six-foot section of the ladder which was missing should also be re-installed. Woody debris was present on one of the weirs of the inlet structure and was removed by the Sponsor. Photographs of the existing principal spillway system are provided in **Figure 3-2**.

Above-water portion of riser

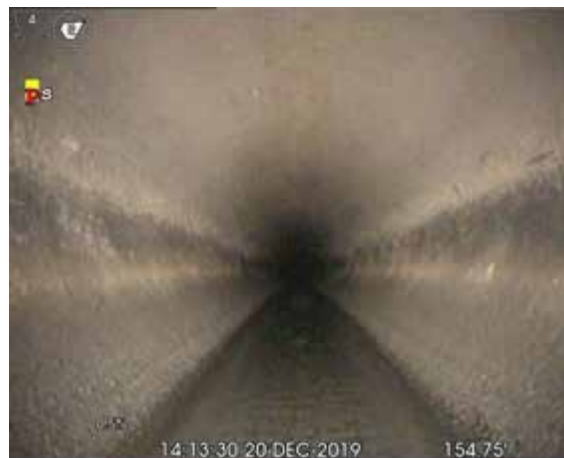
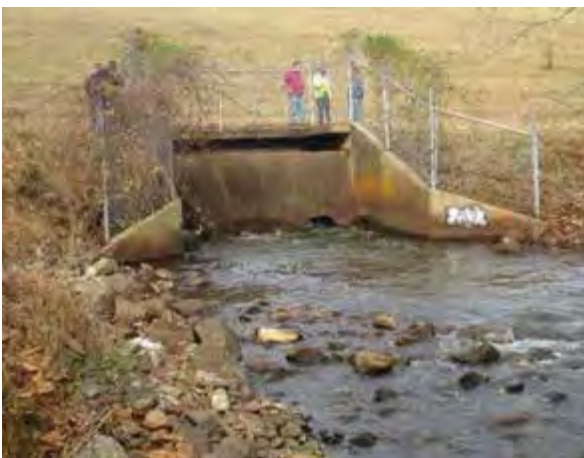
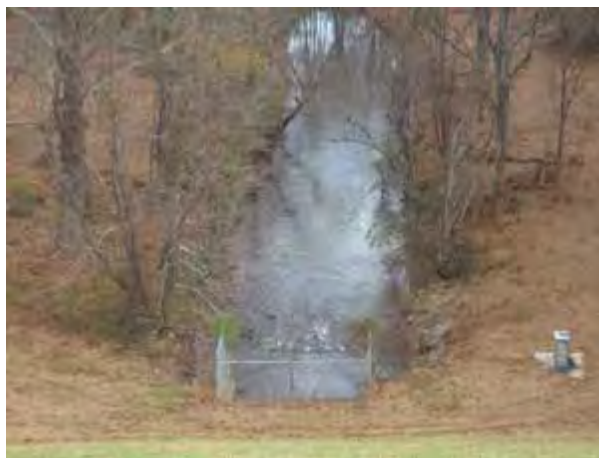
Figure 3-2. Principal spillway inlet, conduit, and outlet.

Conduit interior (typical)

Impact basin

Receiving stream

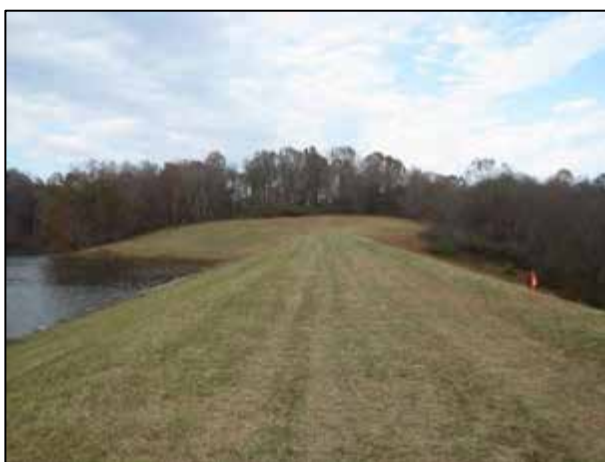
The upstream and downstream embankments were found to be in good condition, respectively, during the 2019 and 2020 inspections. The upstream embankment has good grass coverage and no visible signs of distress. There is wave erosion along the upstream slope water line that needs to be monitored and repaired as needed. The downstream slope has good grass coverage and no visible signs of distress. Wet areas have historically been observed at downstream toe of slope but concerns over underlying seepage have abated since the late 1990s. This area should continue to be monitored for seepage. Embankment photos are provided in **Figure 3-3**.

Embankment crest looking toward left abutment.

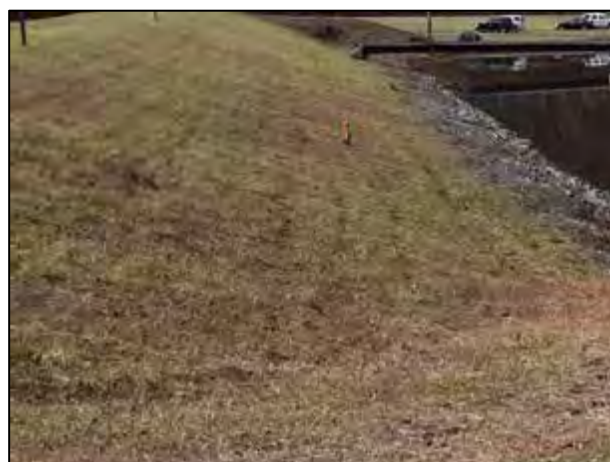
Upstream embankment slope and wave protection.

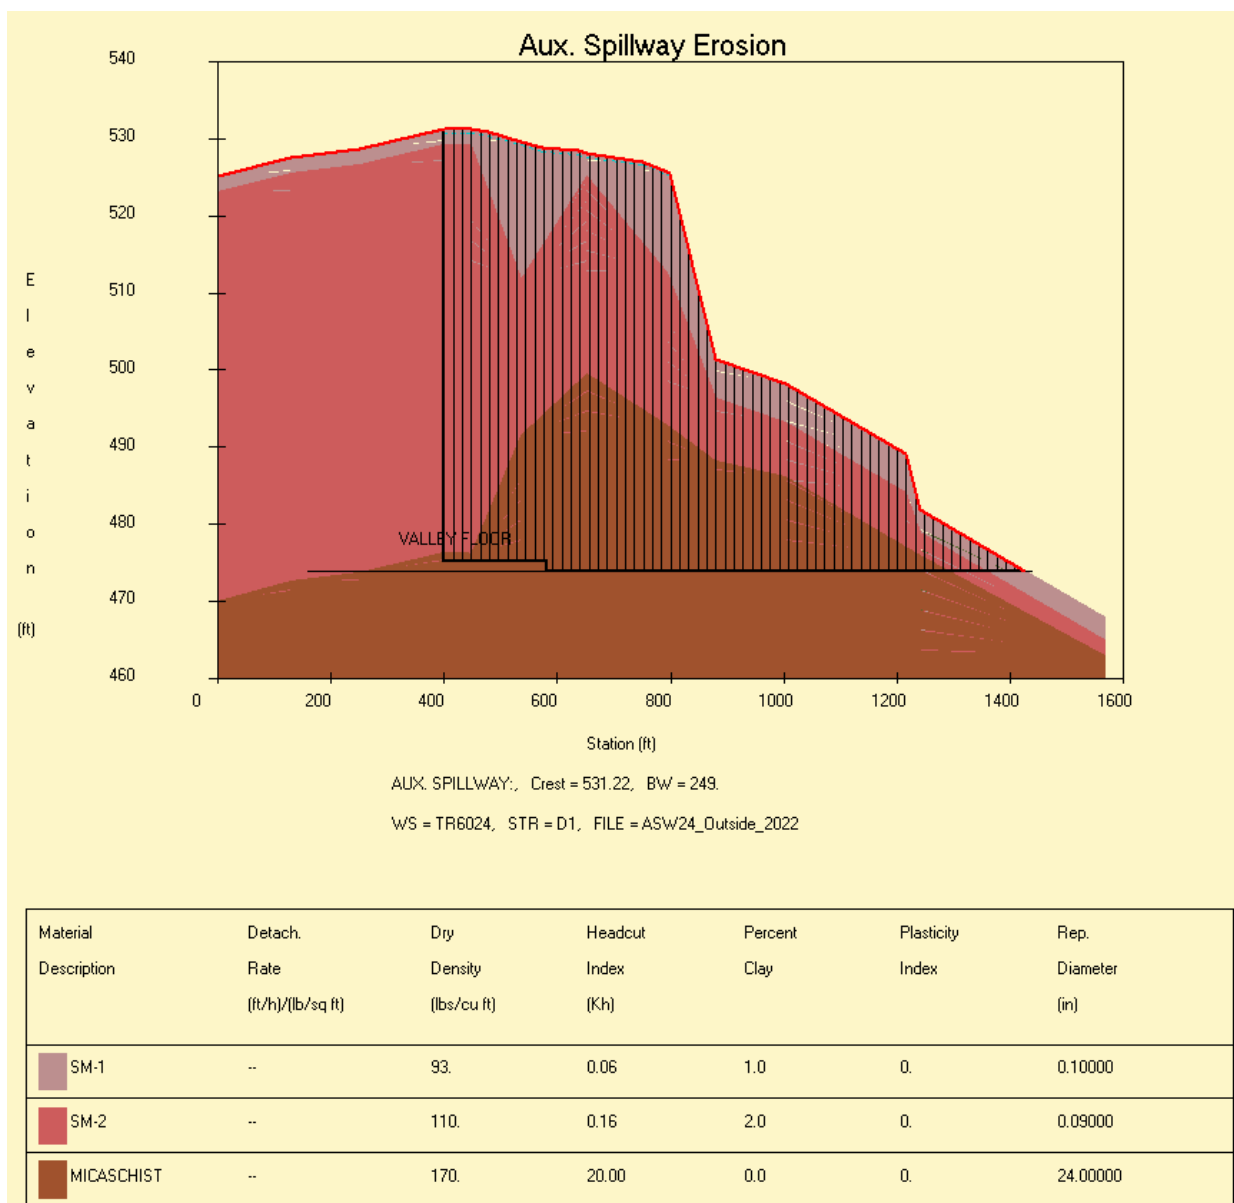
Figure 3-6. Plot of auxiliary spillway outside edge profile and extent of erosion from integrity analysis for existing conditions 24-hour PMF obtained from SITES model output.

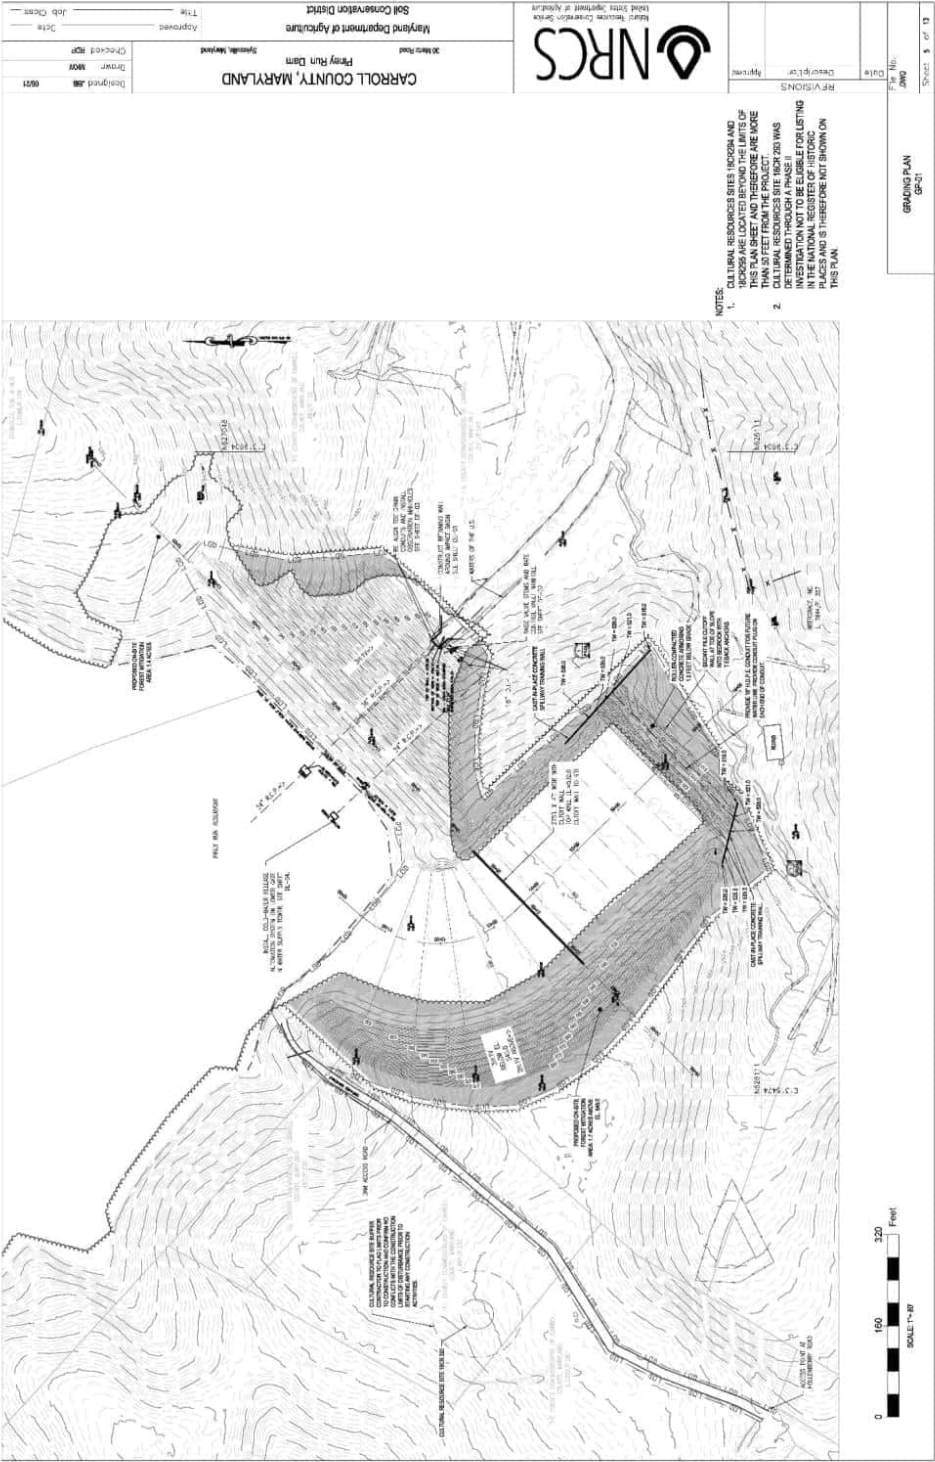
Figure 4. Piney Run Watershed Study plan showing the planned grading and Limit of Disturbance (LOD).

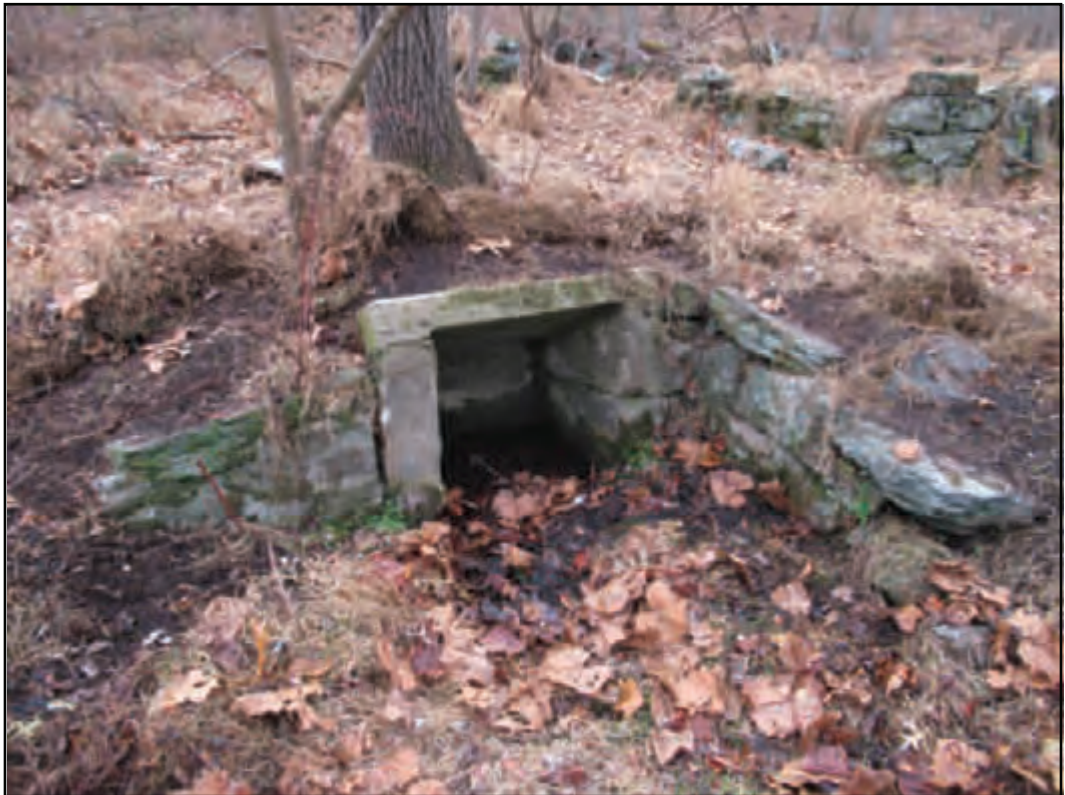
Figure 6-29. 18CR293, Feature 3, Facing Southwest

that appears to have been set in highly degraded lime/sand mortar. The stone spring box has been resurfaced with the same kind of concrete used to build Feature 1. No artifacts were found in association with Feature 3, though stone construction similarities shared with Feature 2 suggest a nineteenth century origin. The concrete surfacing presumably indicates twentieth century maintenance. No historic or modern mapping depicts Feature 3.

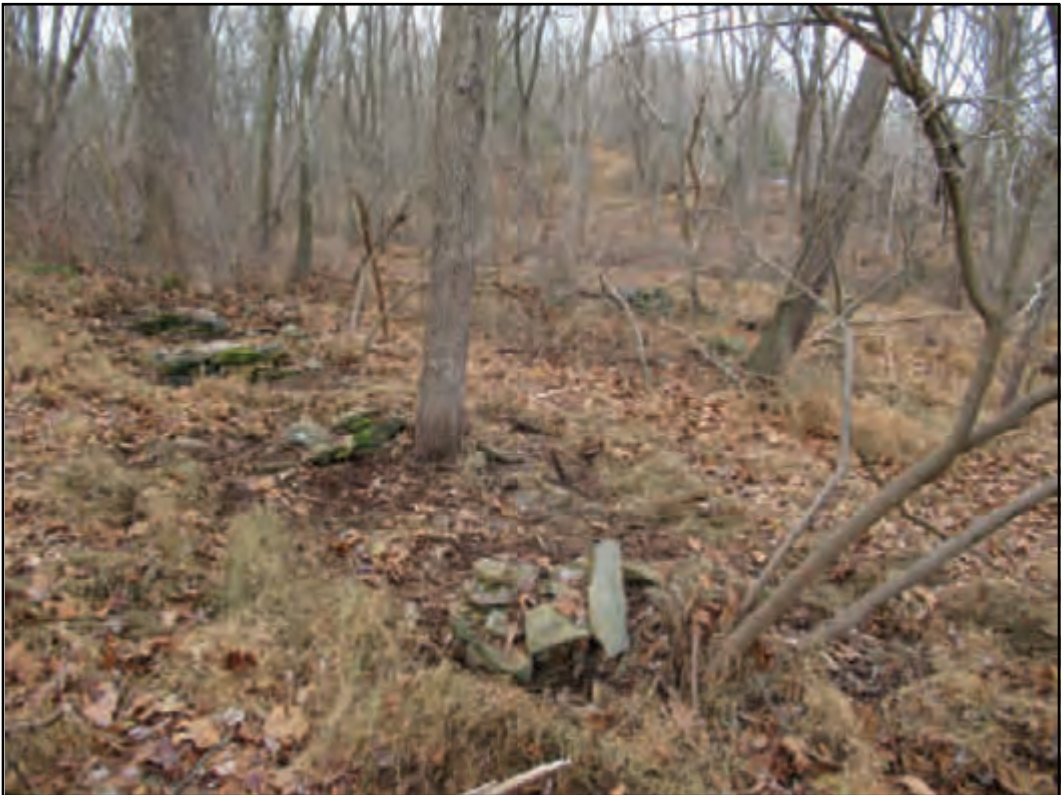
Figure 6-31. 18CR293, Feature 4, Facing Northwest

Feature 4 represents the second building identified in Locus A (Figures 6-31 and 6-32). Built onto a modified terrace above the unnamed tributary's floodplain, Feature 4 is located approximately 10 m (33 ft) southeast of Feature 2 on a slightly different orientation that fronts the southern edge of Road Trace 3. Parallel rows of four stone piers each define the building's footprint. The piers survive in varying states of completeness, with the intact ones each measuring 2.1 m (6.9 ft) north-south by 0.6 m (2 ft) east-west. The pier columns are spaced slightly more than 2 m (6.5 ft) apart and the rows are 4.8 m (15.75 ft) apart, producing a nearly square footprint measuring approximately 9.2 m (30.2 ft) east-west by 9 m (29.5 ft) north-south. Each pier is less than 0.5 m (1.6 ft) tall, built predominantly of phyllite and/or schist fieldstone that was once set in a lime/sand mortar that has heavily decayed.

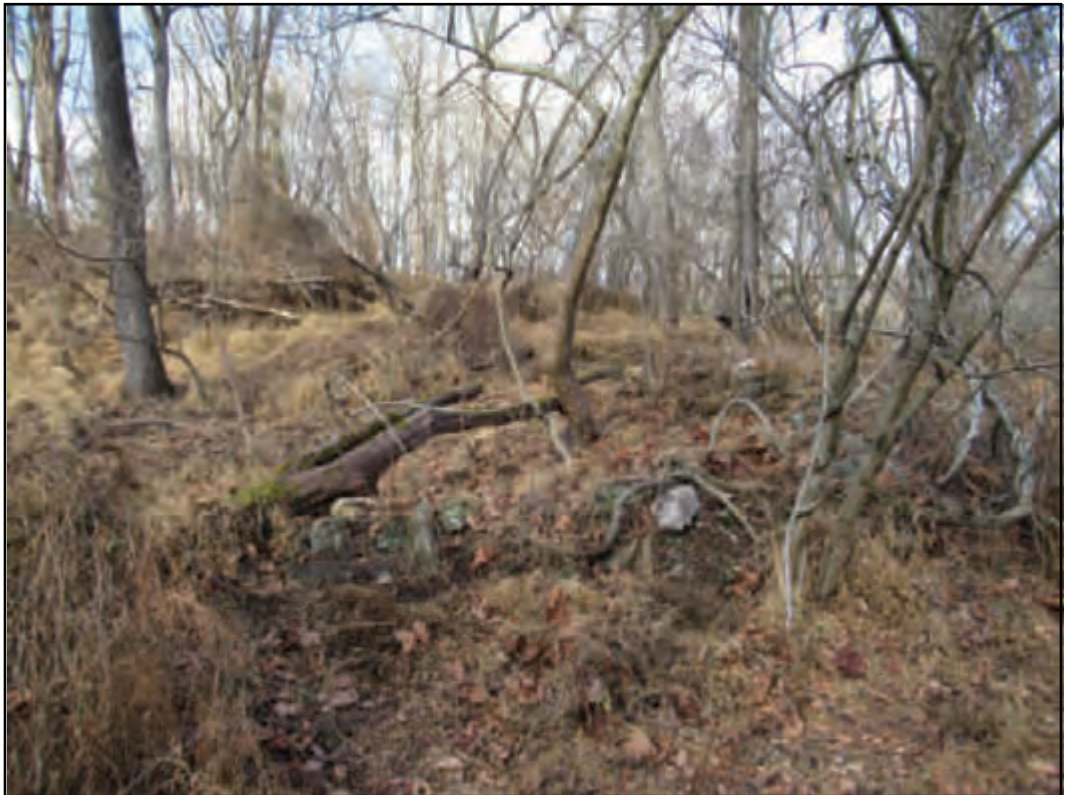
Figure 6-33. 18CR293, Feature 5, Facing North

Feature 5 is a largely collapsed stone foundation for a dwelling situated in Locus B approximately 70 m (230 ft) northeast of Feature 4 (Figures 6-33 and 6-34). The building was sited on a highly constrained, artificially leveled terrace approximately midway up a moderately inclined hillslope rising north above the unnamed tributary. Remnants of the building's foundation were only visible along its east and west sides, with each wall measuring approximately 7.5 m (24.6 ft) long and consisting of disarticulated phyllite/schist rubble. No evidence of the building's west foundation wall was observed, while the north side of the foundation appears to have partially banked into the hillslope. No clearly defined stone structure was visible on the north side, but a linear earthen berm suggests where the north foundation may have been. Approximately midway along this berm, a small concentration of disarticulated bricks may signify the location of a hearth/chimney. A contorted pile of standing seam metal roofing is located 10 m (33 ft) to the north.

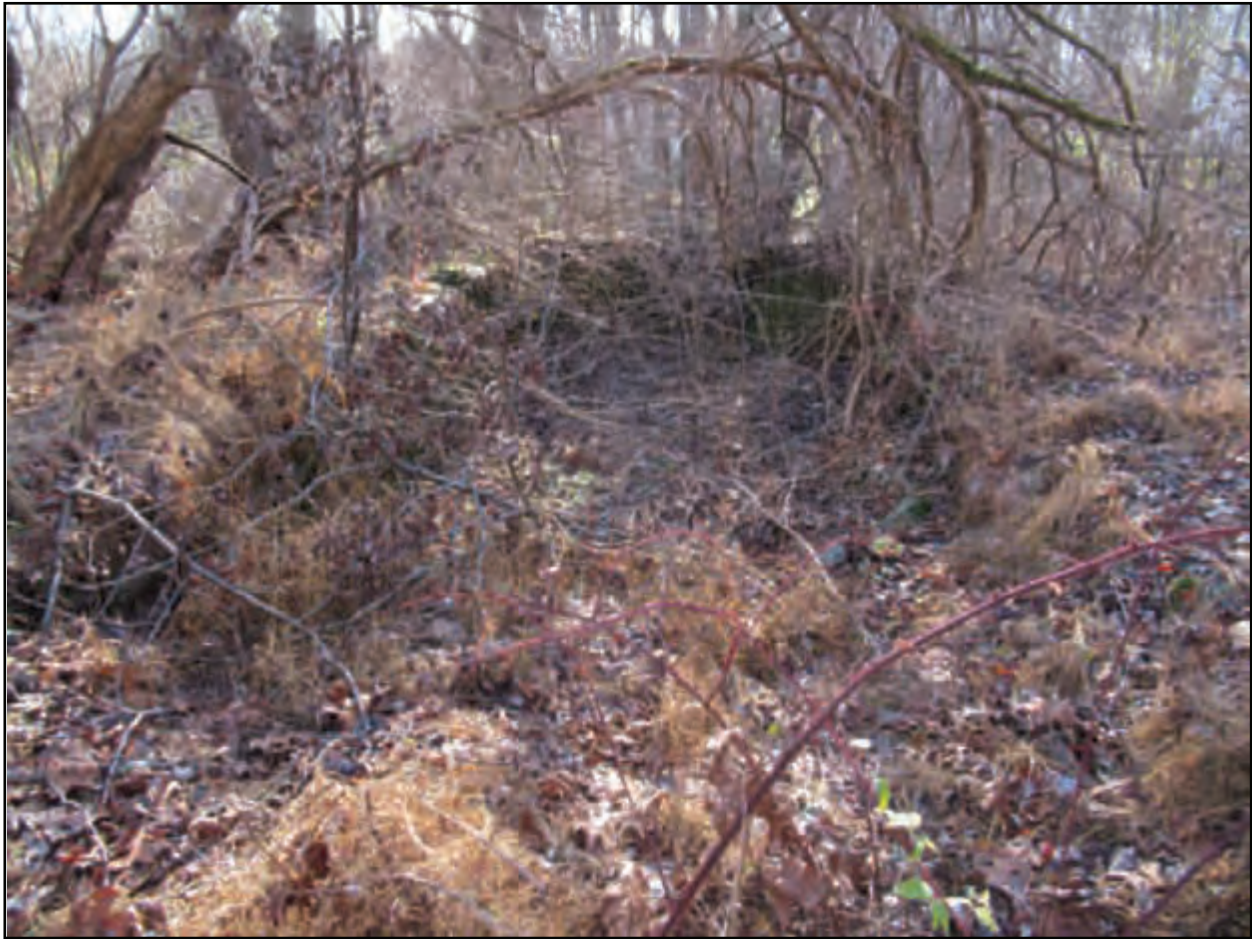
The site is defined by positive STP B-7 as well as Feature 1, a nearby and heavily overgrown stone foundation located beyond the APE boundaries (Figure 6-41). Feature 1 was photographed, but was not measured, drawn, or subjected to any pedestrian/subsurface investigation since it was not located within the APE. The rectilinear foundation is oriented roughly east-west along its long axis and appears to measure approximately 5 by 10 m (16.4 by 33 ft). Its west, north, and south walls were clearly visible, extending up to approximately 1 m (3.3 ft) above the forest floor. The west wall appears to include a doorway, but this could not be confirmed. No evidence for an east wall was observed, though it could be obscured by vegetation. The walls appear to be constructed of randomly coursed phyllite rubble with one entry piercing the west wall. Disarticulated sheet and piped metal objects could be seen within the foundation, but they could not be identified without closer inspection. The historically rural character of the local area suggests this may be

the foundation of a dwelling, barn, or other agricultural outbuilding. If the opening in the west wall represents a cellar access door, Feature 1 may represent a dwelling foundation

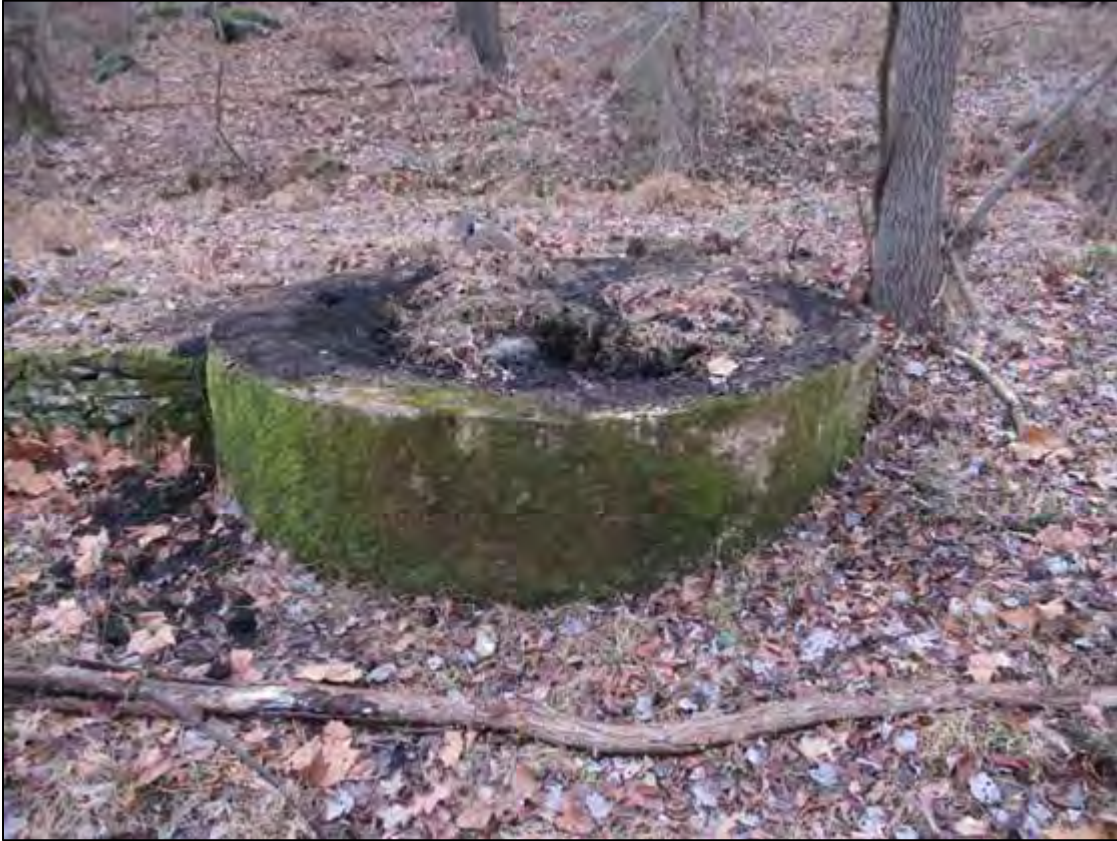
Figure 6-4. Feature 1 Facing South

Feature 1 is a cylindrical concrete foundation at the edge of the unnamed tributary's floodplain (Figure 6-4). The feature is short, rising less than 1 m (3.3 ft) above the floodplain to an elevation nearly level with the grade of the road trace. Measuring approximately 2.5 m (8.2 ft) in diameter, the feature's upper surface is shallowly dished, forming a broad bowl shape less than 0.15 m (0.5 ft) deep and filled with leaf litter. While the concrete itself is not diagnostic, it features small, rounded pebbles in a medium-hard cement matrix which is likely of more recent construction (perhaps early twentieth century) than the stone-built features nearby. The 1972 Piney Run Dam and Reservoir site plan (Figure 3-13) identifies this feature as a capped well, although it is more likely a silo foundation. A small concrete-over-stone pad joins Feature 1 to the southwest corner of Feature 2, a large barn foundation.

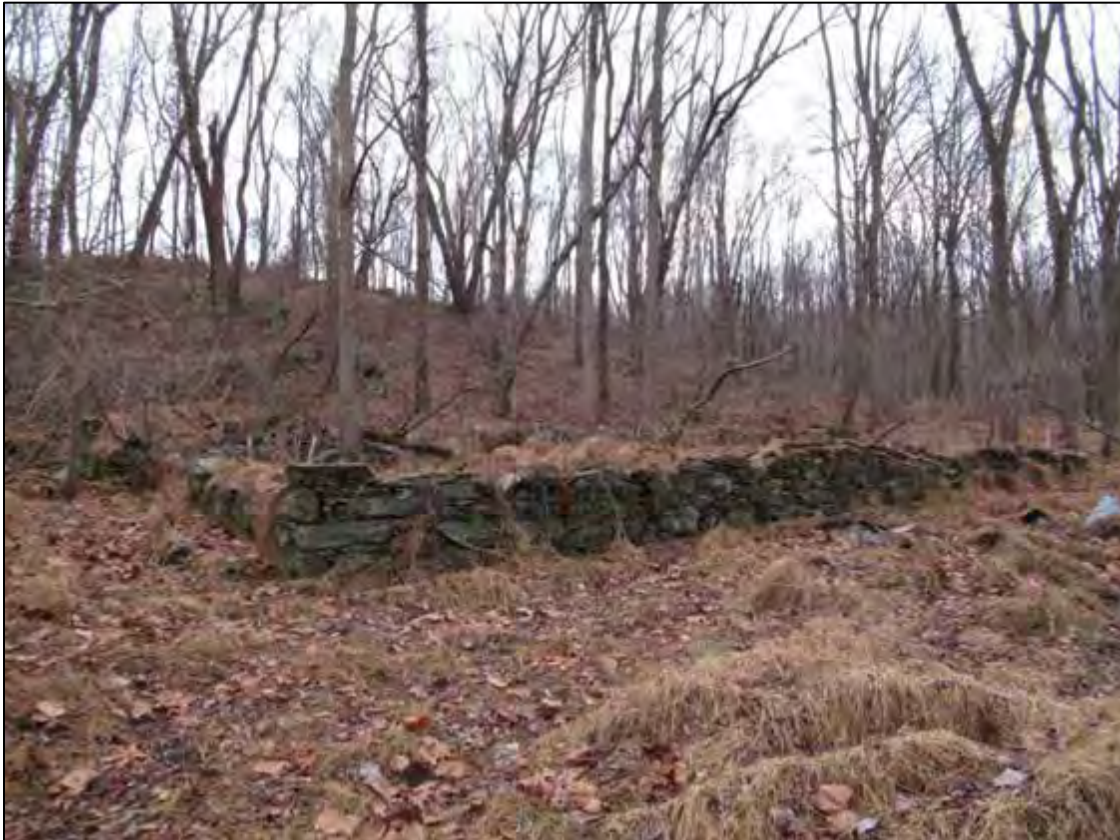
Figure 6-5. Feature 2 Facing Southwest

Feature 2 is a large, rectilinear stone barn foundation in Locus A (Figure 6-5). Measuring 18.25 m (60 ft) east-west by 9.3 m (30.5 ft) north-south, Feature 2 exhibits mirrored 3-m (10-ft) wide openings on its east and west walls and directly abuts a road trace along its south wall. The foundation is composed of randomly coursed phyllite and/or schist rubble with several of the individual stones measuring more than 1 m (3.28 ft) in length. Small pockets of lime/sand mortar are still evident in the stonework, though much of it has disintegrated. While the wall fabric generally exhibits few modified stones, each of the exterior corners exhibit massive cut quoins. Large remnants of sawn lumber representing beams or rafters are strewn about Feature 2. In some locations, the remains of a timber sill plate survives intact on the uppermost course of stonework. This detail indicates that the feature's superstructure was of frame construction and possibly sheathed in timber siding (e.g., board and batten, lapboard). A large, nearby pile of standing-seam metal panels represents the building's roofing. The feature's size, dimensions, and wide parallel openings indicate that it almost certainly served as a barn, likely built in the style of a small transverse crib/frame barn (Mroszczyk 2007).

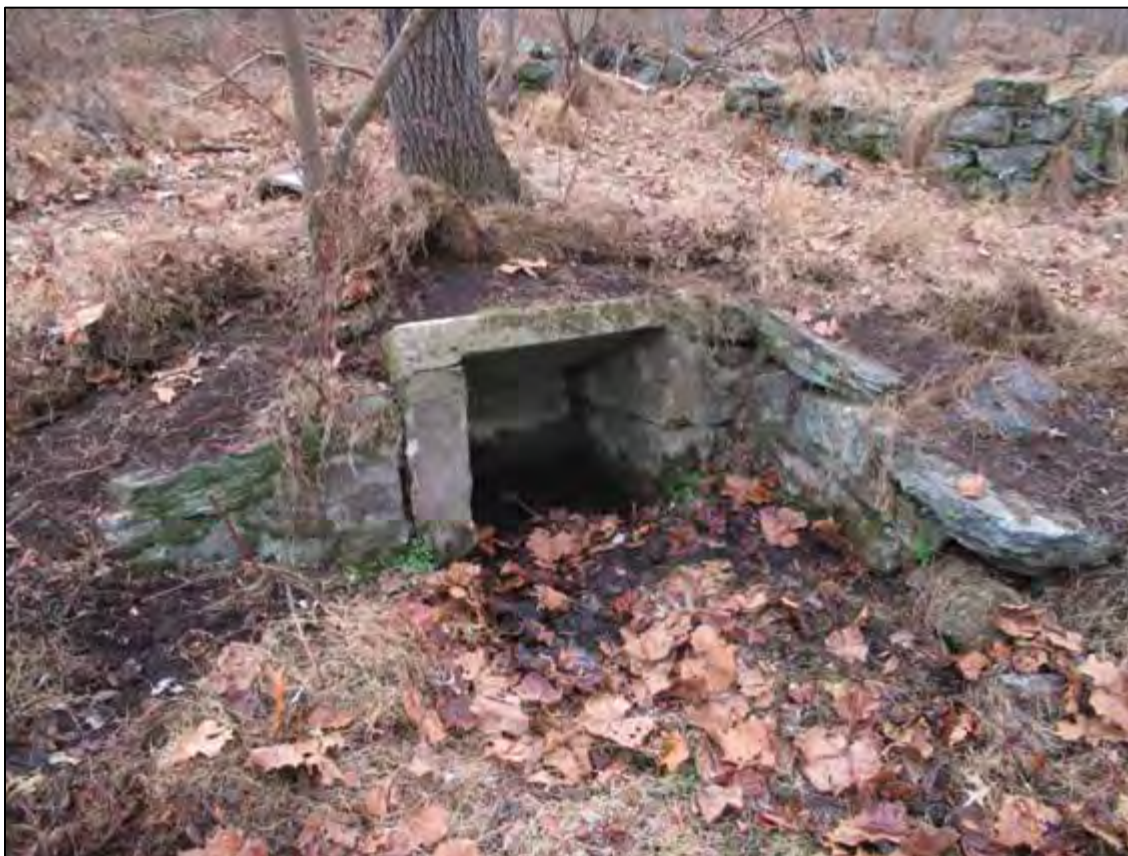
Figure 6-6. Feature 3 Facing Southwest

Feature 3 is located approximately 5 m (16.4 ft) northeast of the northeast corner of Feature 2 and represents an ell-shaped rubble stone and concrete spring box (Figure 6-6). The west side of the ell consists of a 1.3-m (4.25-ft) long, 0.4-m (1.3-ft) wide stone retaining wall built to prevent the surrounding floodplain from slumping into the head of the spring channel. The south side of the ell consists of the 1.1-by-0.75-m (3.6-by-2.5-ft) closed-top spring box flanked by small stone retaining walls. The stonework consists of randomly coursed phyllite and/or schist rubble that appears to have been set in highly degraded lime/sand mortar. The stone spring box has been resurfaced with the same kind of concrete used to build Feature 1. Stone construction similarities shared with Feature 2 suggest a nineteenth century origin. The concrete surfacing presumably indicates twentieth century maintenance. No historic or modern mapping depicts Feature 3.

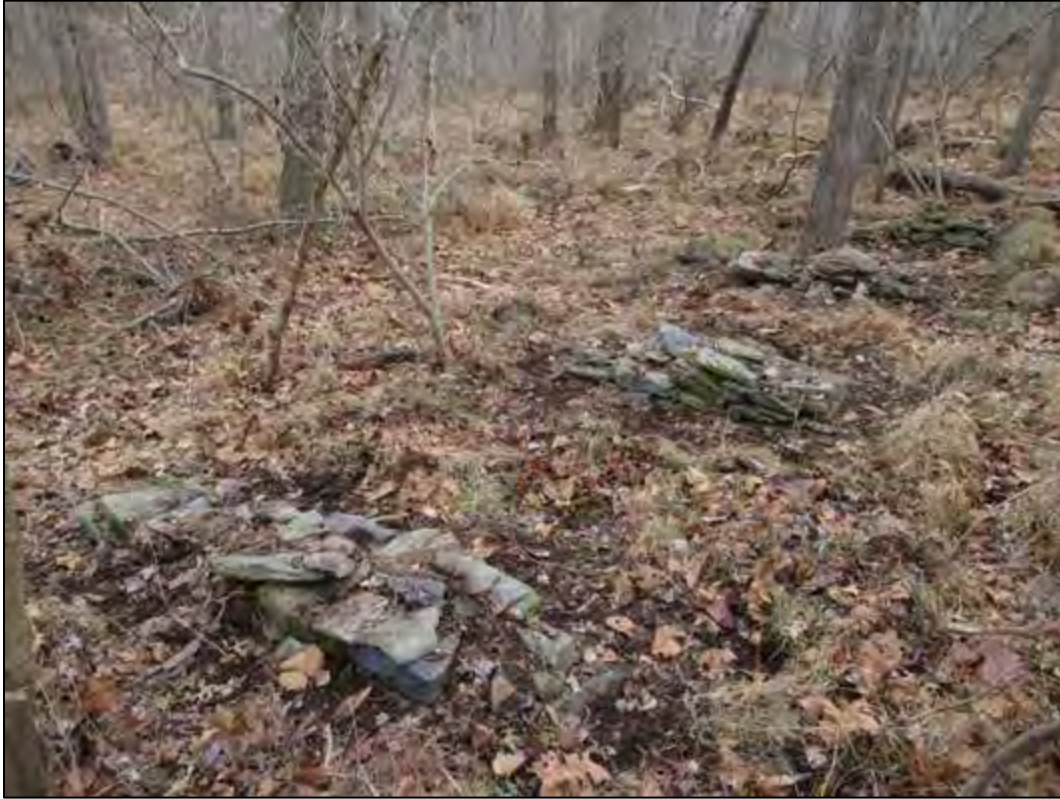
Figure 6-7. Feature 4 Facing Northwest

TU 2 was placed within Feature 4 to investigate what type of building may have existed during historic occupation of the site. Feature 4 represents the second building identified in Locus A. Feature 4 is located approximately 10 m (33 ft) southeast of Feature 2. TU 2 was placed between two of the surviving stone piers documented during the Phase I survey. Stratum I documented a brown (10YR 4/3) silt loam Ap horizon measuring 12 cm (0.4 ft) thick atop a yellowish brown (10YR 5/6) silty clay B horizon (Figure 6-14). The only artifacts recovered were 13 wire nails from Stratum I. No floor surface or burned layer was observed. The stratigraphy is representative of the non-modified landscape: a plowed level atop a culturally sterile B horizon. The frame outbuilding that had been present had rested on the stone piers without any type of cellar or foundational features below. Based on the presence of wire nails, the outbuilding may have been added at the end of the nineteenth century or early twentieth century when the property operated as a dairy farm.

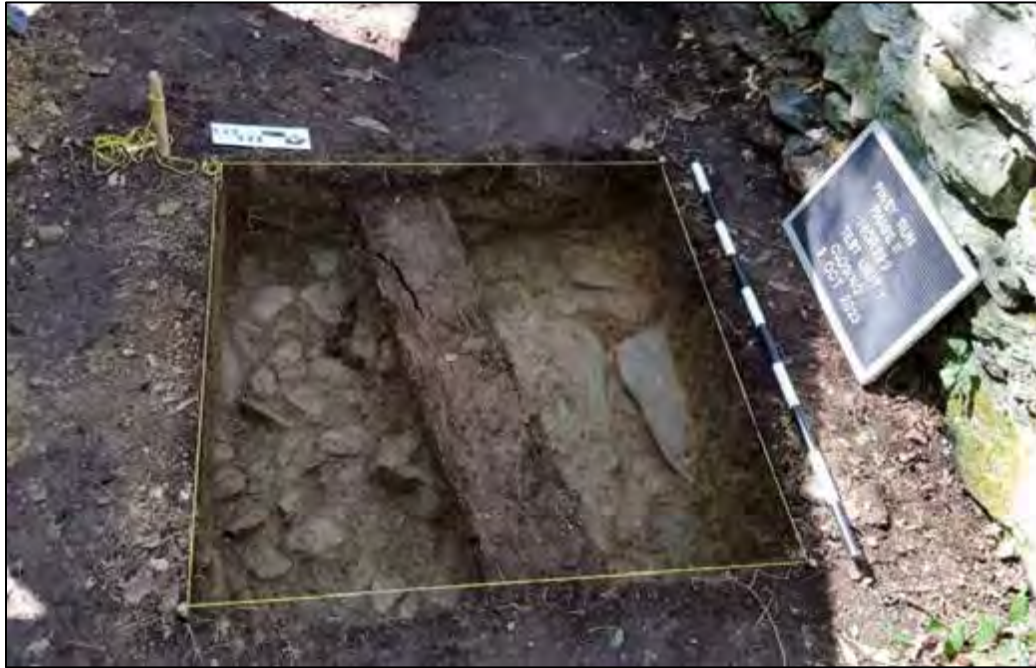
Figure 6-9. Feature 6 in TU 1, Facing West

Feature 6 is a stone road paving uncovered in TU 1 at the base of Stratum III (Figure 6-9). The historic road runs parallel to the south wall of the Feature 2 barn.

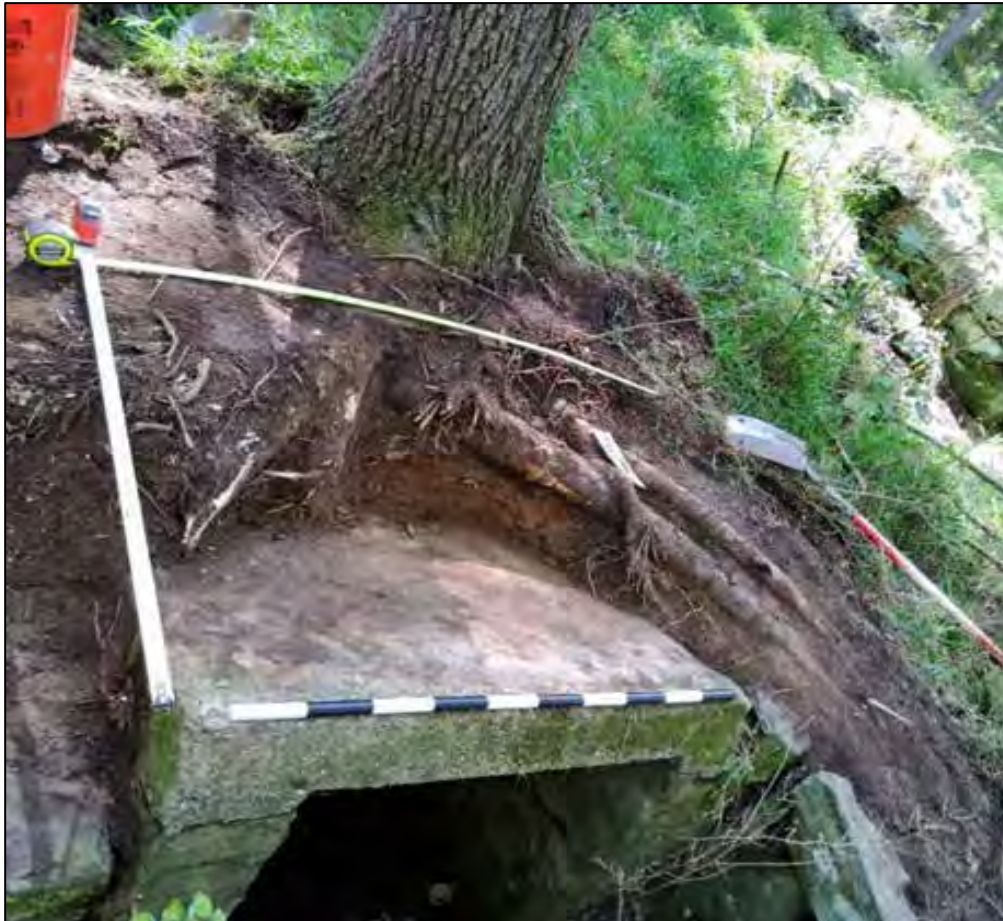
Figure 6-15. TU 3 and Feature 3 Facing South

TU 3 began as STP JUD03 but was expanded into a 1-x-1-m unit to get a better picture of the spring box identified in the Phase I survey as Feature 3. Feature 3 is located approximately 5 m (16.4 ft) northeast of the northeast corner of Feature 2 and represents an L-shaped rubble stone and concrete spring box. The south side of the L consists of the 1.1-by-0.75-m (3.6-by-2.5-ft) closed-top spring box flanked by small stone retaining walls. The top of the spring box was partially obstructed by fill and a tree. Two strata were uncovered in the unit, though these layers were clearly redeposited layers of fill atop the concrete spring box top (Figure 6-15). Stratum I consisted of a yellowish brown (10YR 6/6) silty clay loam measuring 23 cm (0.8 ft) thick above a brown (10YR 4/3) silty loam Stratum II. In total, 120 artifacts were recovered, all from Stratum I (Table 6-2). Large roots from the tree obstructed complete excavation of the unit and were not removed.
