down to earth

Environmental Restoration Quarterly • Fall 2021

Project Spotlight: Woodsyde Stormwater and Stream Restoration

Testing Innovative Ways to Remove Phosphorus from Stormwater Runoff

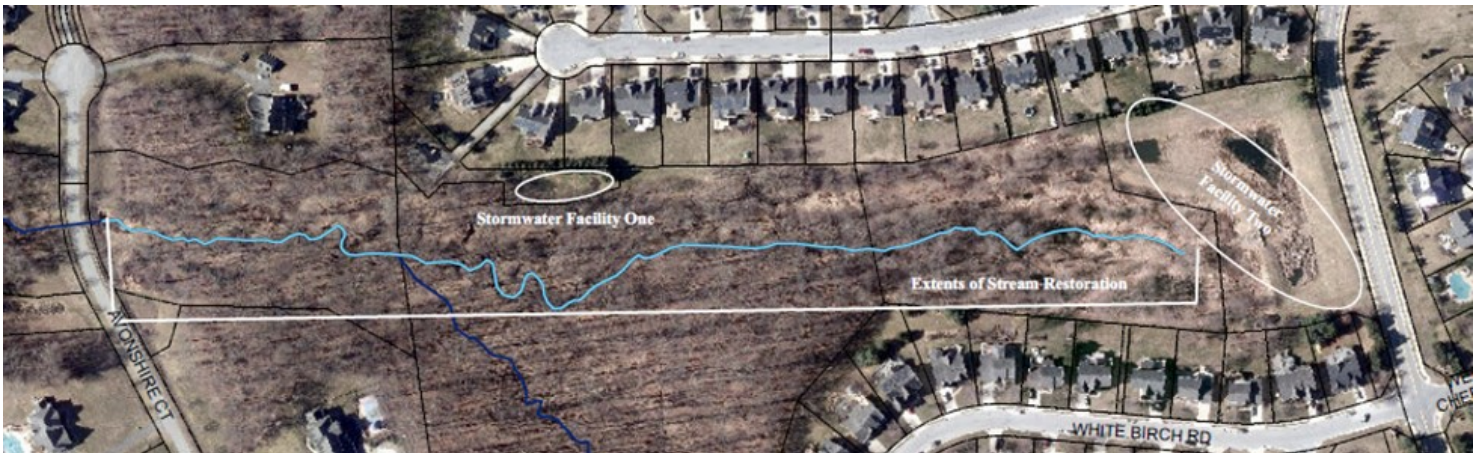
after ↻

Century Engineering was contracted for the stormwater retrofit and stream design. The County received \$50,000 from the National Fish and Wildlife Foundation to help fund project design. The stream design approach was to raise the stream as much as possible while providing a sustainable stream and floodplain system and minimizing forest impacts of construction. The majority of the stream bed was raised by 5-6 vertical feet, with the channel meandering mostly within the original channel footprint. The nested floodplain terrace was designed to convey the majority of the 50-year storm event.

The restored channel has low banks to allow the rooting system of floodplain vegetation to extend into the nutrient rich hyporheic zone. Grade control log structures, cut-off sills, and clay channel plugs were also designed to raise the groundwater table for floodplain reconnection and nutrient processing. The new plantings will complete the construction phase for Magstone Construction; however, the larger rewards will be visible as the stream and floodplain system settles and becomes more established over the next two to three years. The County received a grant award from the Maryland Department of the Environment Bay Restoration Fund towards construction of this project.

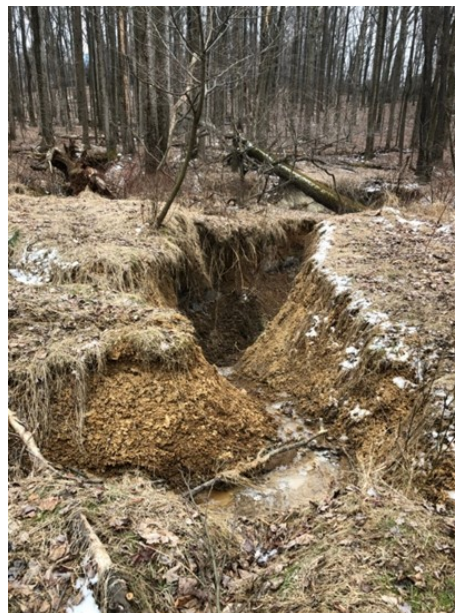
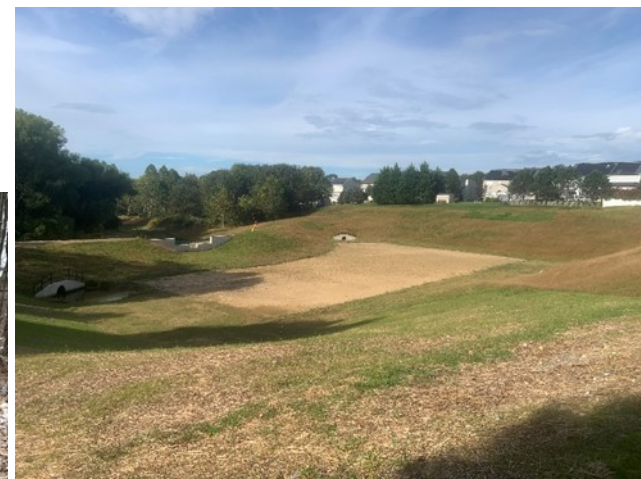
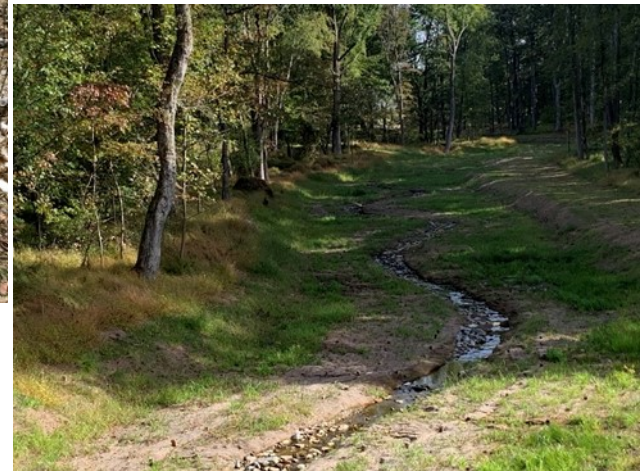
before ↻

These facilities did not provide adequate storage to buffer the impacts of the stormwater runoff from eroding the receiving stream channels. As a result, the once very small stream was eroded vertically by 8-10 feet, with the top of bank width now 30 – 35 feet across.

While the tiny stream once allowed flood flows to reach the floodplain on an annual basis, the eroded gully contained nearly all flood flows, taking with them the banks and a high concentration of nutrients and sediment.

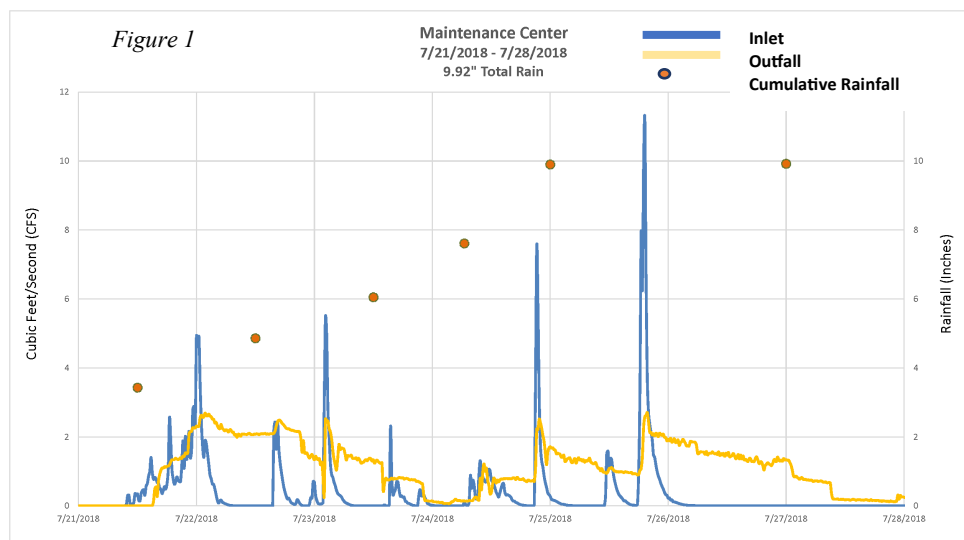
accounting for stormwater wasteload allocations, the current standard filter, which is designed to treat 2.5" of runoff from paved areas, reduces 62% of the total phosphorus. Maximizing treatment depths also provides channel protection volume by reducing the magnitude, duration and frequency of erosive flows as seen in Figure 1 during a week in the summer of 2018 when the facility received 9.92" of rain beginning on July 21st.

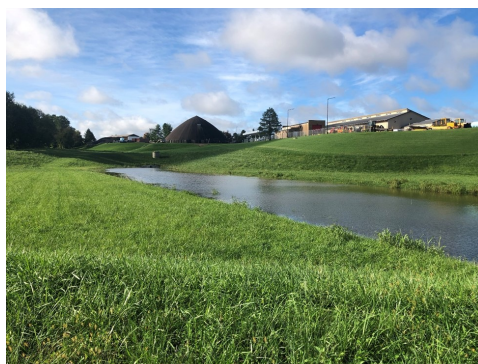
Post storm event

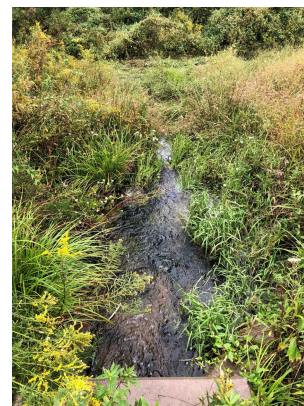
Stable outfall discharge dewatering facility

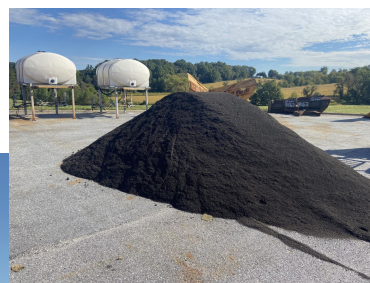
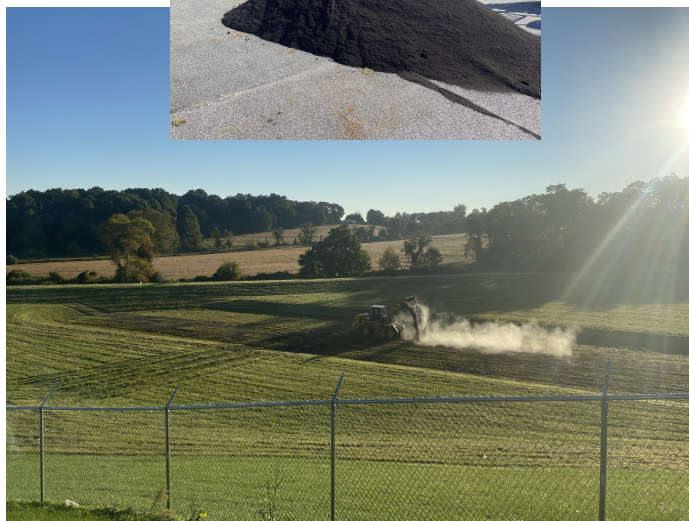
For this study, the enhanced sand filter design utilizes an iron (Fe) additive sourced from Charah Solutions, a "national leading provider of environmental services and byproduct sales". Kibler Construction performed the media conversion, which involved incorporating 5 percent (by volume) of the iron rich material into the upper six inches of the sand filter media.

Iron rich media (above); media being added to the sand filter (right)

Theoretically, the enhanced media will increase the removal of total phosphorus from stormwater runoff as the phosphate will bond with oxygen and iron as it passes through the aerobic zone forming an insoluble iron-orthophosphate compound that will precipitate out into the sand as nodules. It is expected that the iron enhanced filter will remove 85%-90% of phosphates from stormwater as it passes through the filter. According to MDE's
